December 4, 2015

RMEA: 15-0123

Re: Building Materials Inspection of Asbestos Containing Building Materials and Lead-based Paint for the structures at the Ashton Fish Hatchery located at 3330, 3332, and 3334 East 1200 North, in Ashton, Idaho 83420.

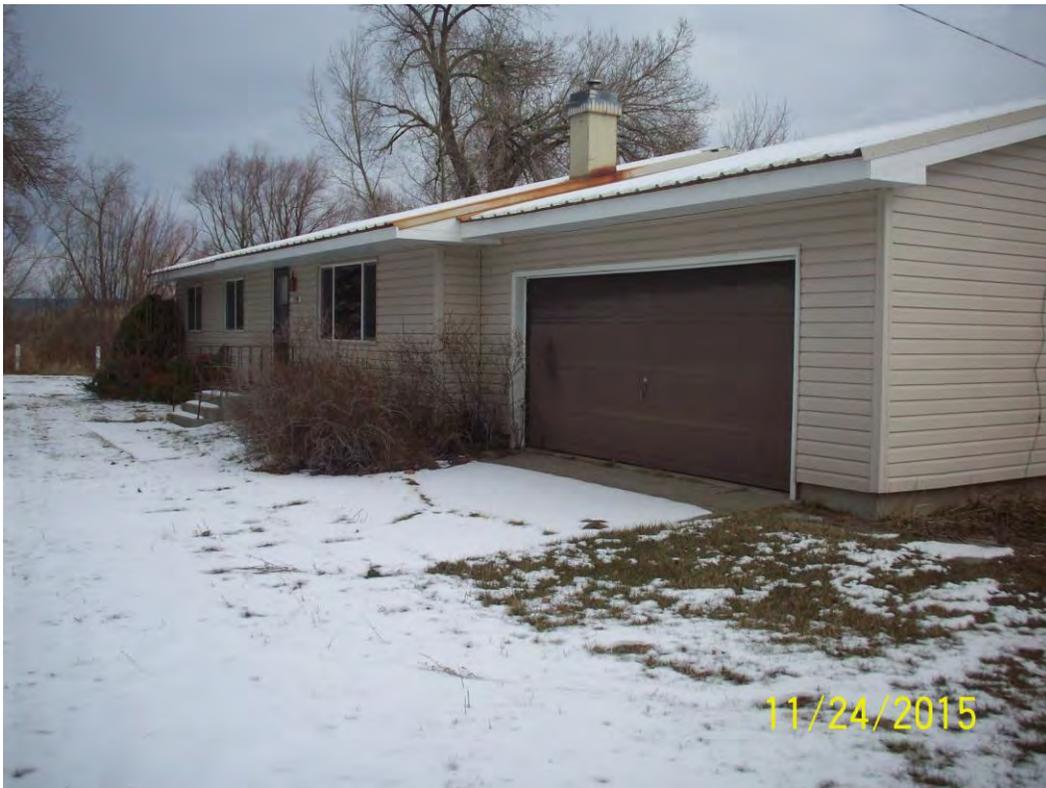
**Photograph 1.** New Residence (building 1 on Site Sketch) located at north end of complex.

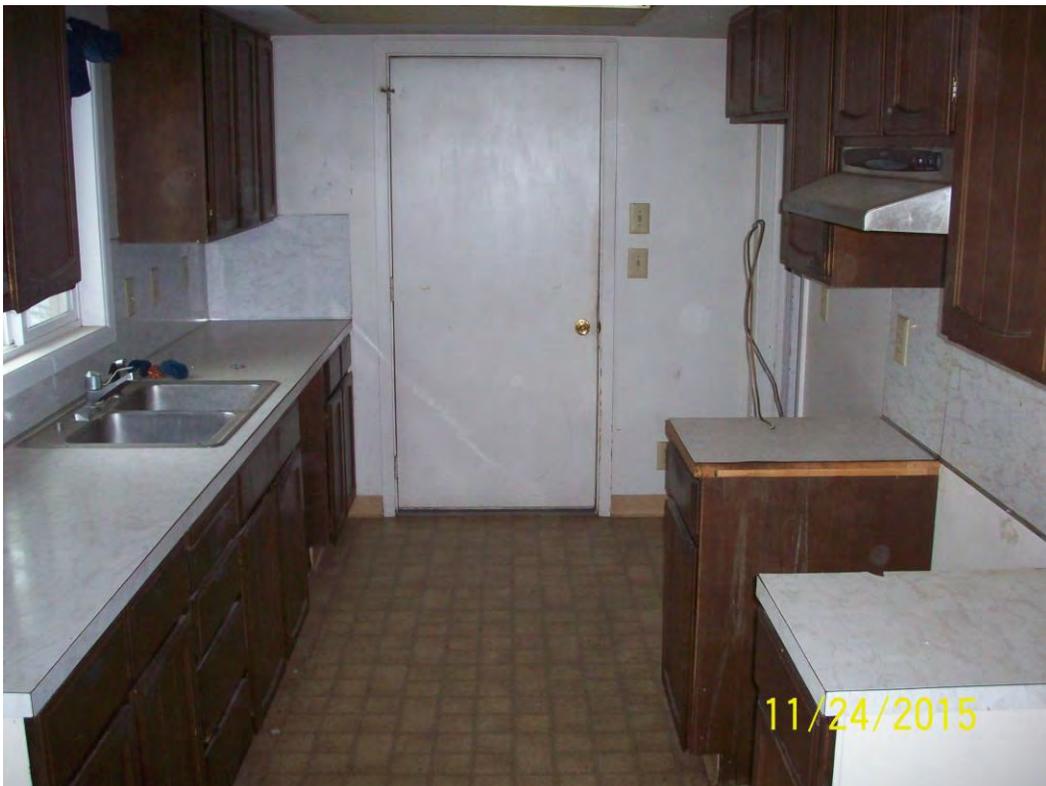
**Results from the laboratory indicate that a previous underlying layer of kitchen flooring, and flooring in the main and master bathrooms in the New Residence (building 1), and commercial-type flooring in basement and hallway coving on main level of Old residence**

**Photograph 2.** Kitchen of New Residence. The brown floor is a second layer. A green vinyl floor lies underneath.

Present use of buildings 1 & 4 are not considered to present a risk. However, remodeling or replacement of affected flooring does present risk and will require care and/or appropriate abatement.

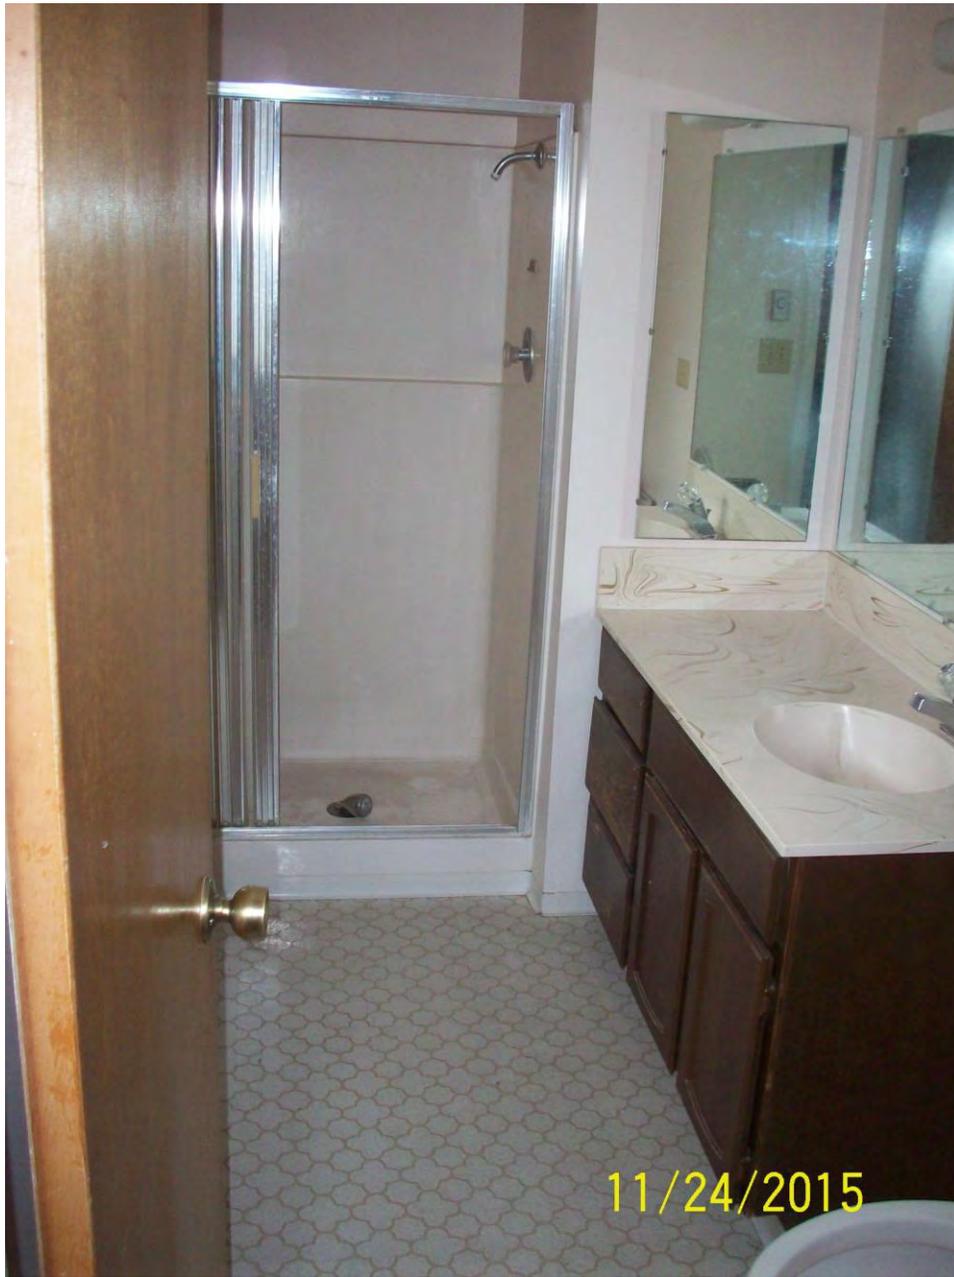
**Photograph 3.** Master bathroom inside New Residence.

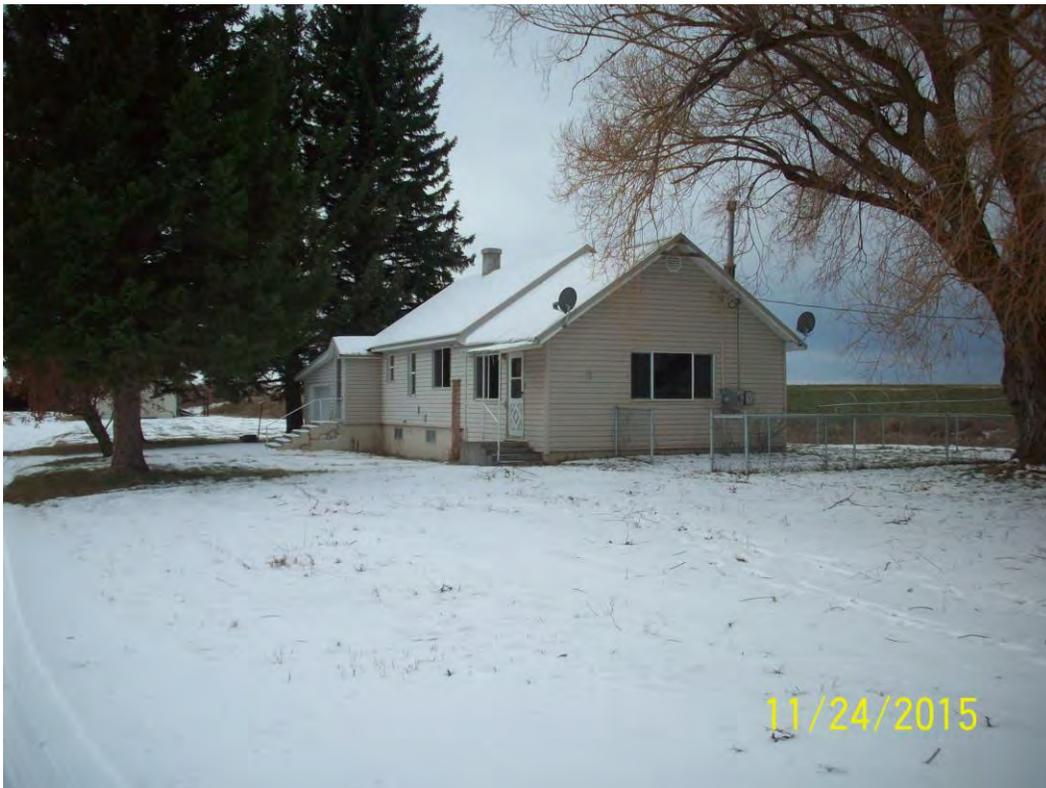
**Photograph 4.** Old Residence (building 4 on Site Sketch) dwelling that sets on a concrete foundation with a full basement.

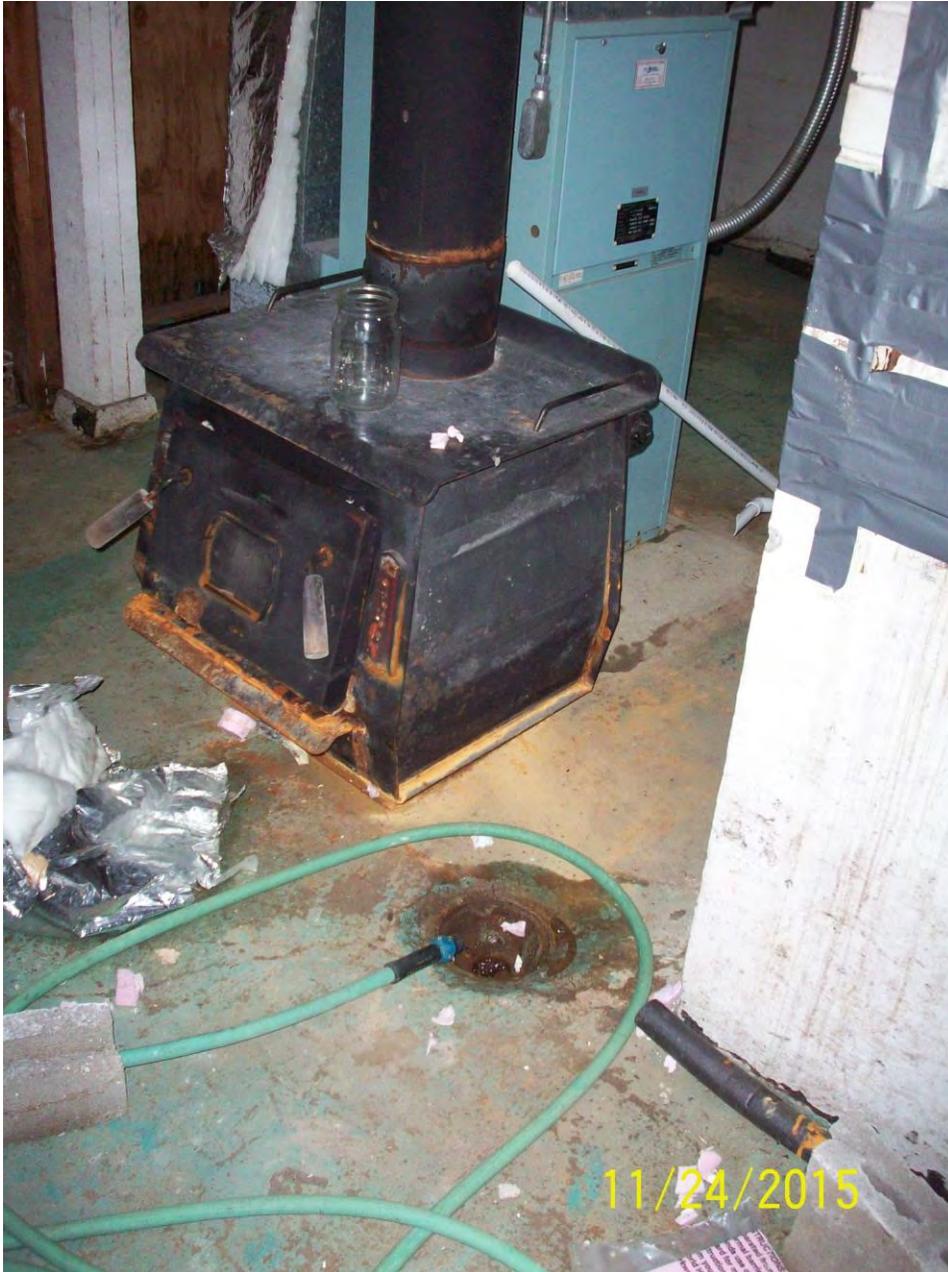
FH4-8-Mastic	Bathroom Tubsurround		NO
FH4-15	Basement Floor	4% Chrysotile, 100 ft <sup>2</sup>	YES

**Photograph 5.** Basement floor inside Old Residence. Electric forced-air furnace in background (blue) and old wood-fired fireplace in foreground. Commercial floor tile is located in adjacent storage room.

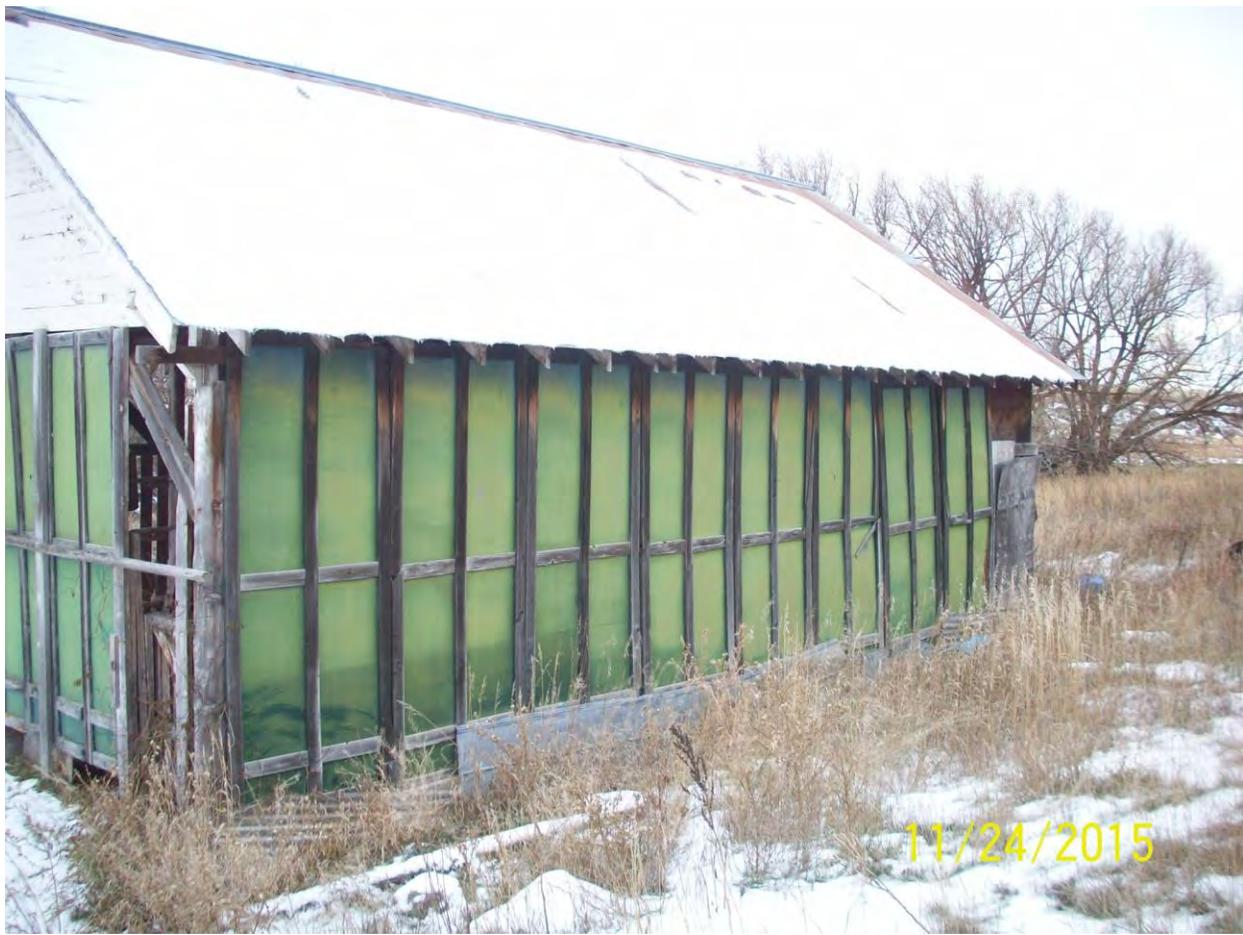
It is noted that exterior paint coatings that are in poor shape and are in process of failing (i.e. north gable end of Hayshed, building 6) may result or have resulted in lead contaminated soils below and surrounding the Hayshed, presenting a risk of ingestion by human or animal presence. Similar but less risk is present for the Hatchery building (building 7) since the tan paint coating also tested positive for lead. Presently, the paint coatings on the Hatchery building are in good shape.

**Photograph 6.** Hayshed (building 6 on Site Sketch). Note flaking paint on north-facing gable.

In terms of demolition and removal to an approved landfill facility, the quantity of the lead present relative to the disposal weight of the building materials would likely be below regulatory thresholds (0.50% by weight), but this largely depends on the future disposition of the facility. If demolition or partial demolition is foreseen, then it may or may not require special treatment or abatement prior to demolition and removal to a landfill. However, if remodeling of the facility becomes the chosen option, care should be taken for worker protection to prevent lead dust exposure to occupants and/or workers. We recommend consultation with a qualified industrial hygienist before remodeling or demolition.
