Technical Memorandum

To:	Ken Bouwens Idaho Dept. of Fish and Game 2885 W. Kathleen Ave. Coeur d'Alene, ID 83815	Project:	Clark Fork Hatchery
From:	Randy Presleigh, PE William Zimmerman, PE	cc:	Derek Nelson, PE
Date:	May 27, 2016	Job No.:	16-046
Subject:	Site Evaluation Technical Memorandum

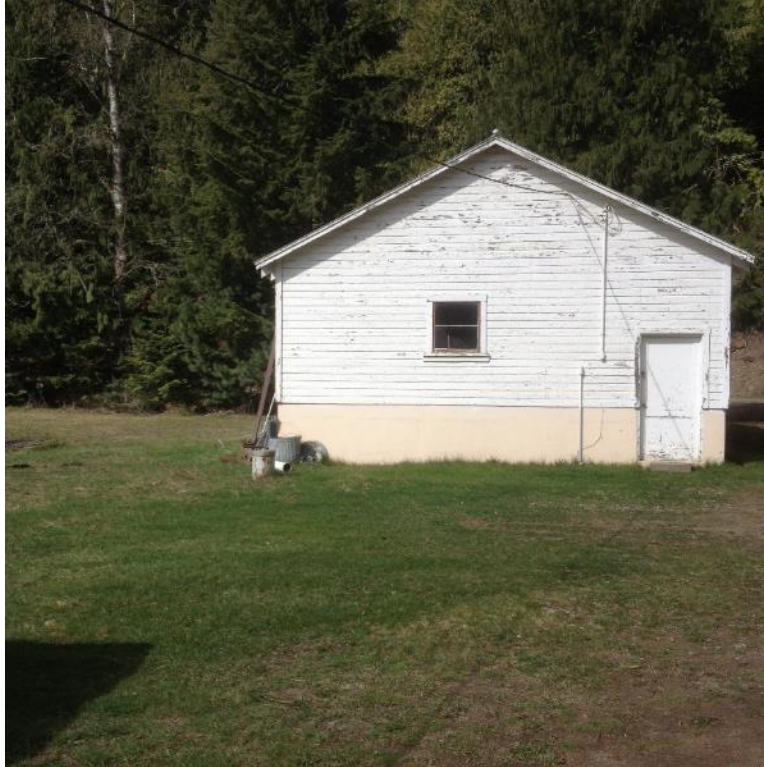
Immediately adjacent to the main facility entrance is an existing garage with two stalls and a storage area. The garage is constructed of a concrete slab-on-grade foundation with perimeter concrete stem walls that extend above grade, wood-framed siding, wooden roof trusses, and a corrugated metal roof. The corrugated metal roof is attached to a slip-sheeted roof membrane over the wood trusses. The top surface of the metal roof showed signs of rusting and appeared to allow water leakage to the interior of the structure. In general, the structure appeared to be in a satisfactory condition structurally with no immediate concerns about the short-term integrity of the garage. At a minimum, if the building is selected for long-term use by the project, the following actions are recommended:

Photo 1. Building 1 – Garage and Storage Exterior.

- Removing existing paint and repaint the building (\$7,500 – \$10,000)
- Removing corrugated metal roof, install continuous plywood roof membrane and new metal roof (\$30,000 - \$40,000)

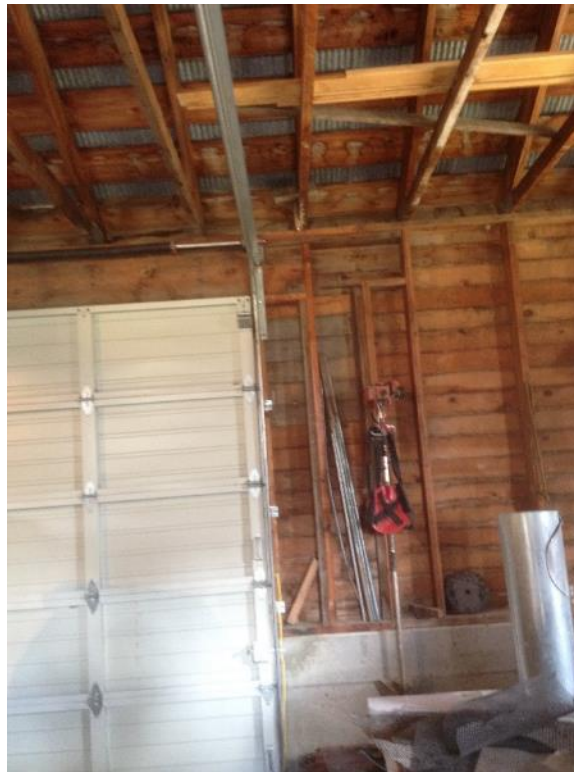
The garage is currently used by IDFG for dry storage of equipment including boats and trailers. The space is unheated and also houses the electrical panels and controls for the existing groundwater pumps. These panels and controls appear to operate the main facility domestic water pumps.

Photo 2. Building 1 – Garage and Storage Interior.

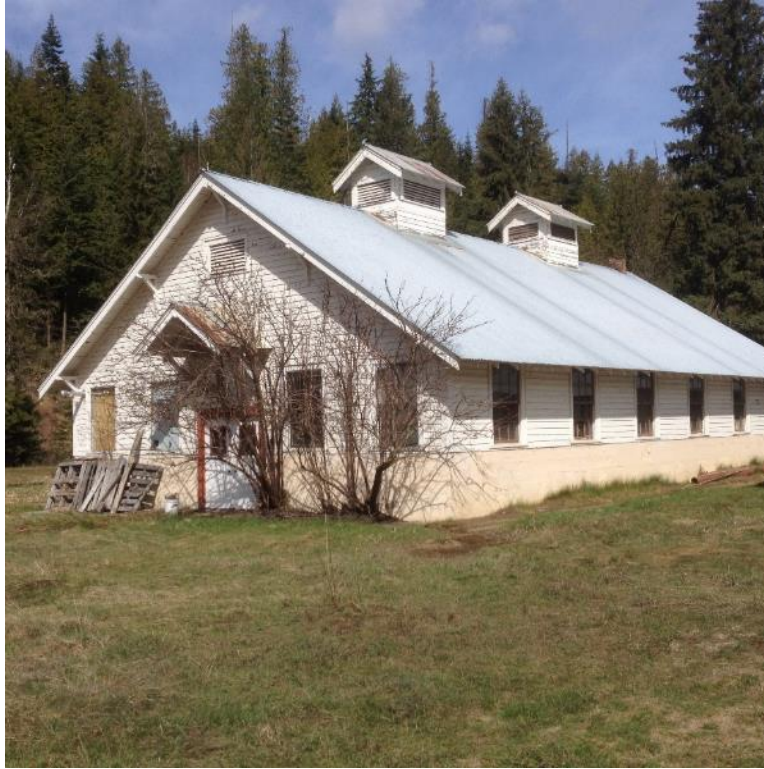
The hatchery building was one of the structures originally constructed with the facility. It is constructed of a concrete slab-on-grade foundation with perimeter concrete stem walls that extend above grade, wood-framed siding, wooden roof trusses, and a corrugated metal roof. The top surface of the metal roof did not appear rusted, but the underside of the roof membrane was not able to be observed. The structure generally appears to be in satisfactory condition with no immediate concerns about the short-term integrity of the structure; however, it should be noted that the existing brick chimneys on the front of the building appear to be of unreinforced masonry construction and may not meet current seismic code. There is also a concrete pedestal supporting a wood column within the hatchery building that has been damaged. At a minimum, if the building is selected for long-term use by the project, the following actions are recommended:

Photo 3. Building 2 – Hatchery Exterior.

- Examining seismic stability of the existing brick chimneys and, if determined to not meet current code requirements, removing or stabilizing the chimneys (\$10,000 to \$20,000)
- Repairing or stabilizing the interior concrete support pedestal (\$5,000)
- Removing existing paint and repainting the building (\$10,000 to \$15,000)

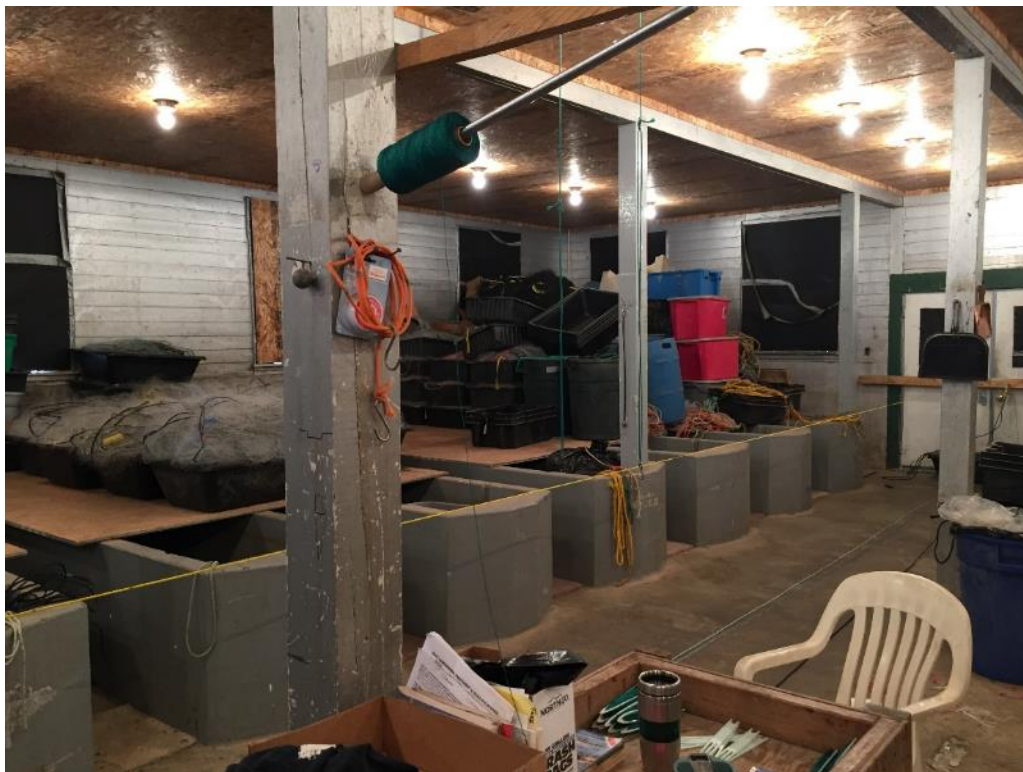
forward, HBR has requested that the existing concrete raceways inside the hatchery building be removed to provide more space, and that the existing windows be replaced.

Photo 4. Building 2 – Hatchery Interior. Concrete Raceways, nets & misc. item storage, and office space with desk.

The existing hatchery building would be upgraded to include installation of new windows, removal of the concrete rearing troughs, upgrades to the electrical systems from the panel to the lighting system, and repair of the damaged concrete pedestal. Further study of the brick chimney would be required to determine whether or not it should be removed or stabilized to comply with seismic concerns.

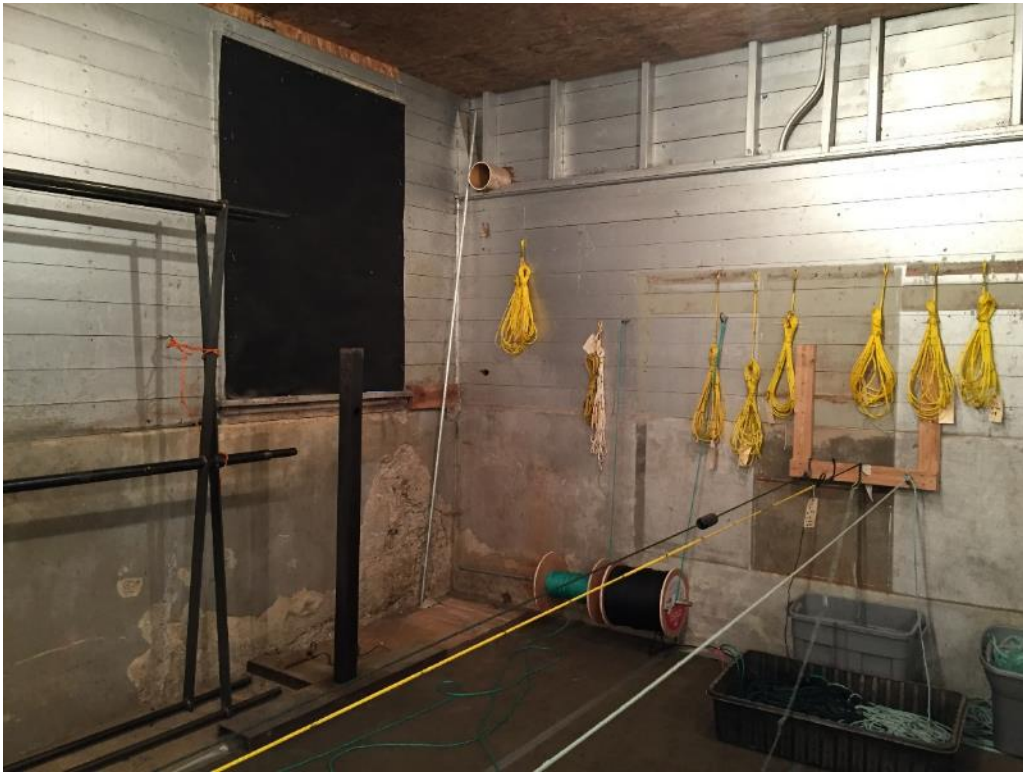
Photo 5. Building 2 – Hatchery Interior. Concrete spalling.

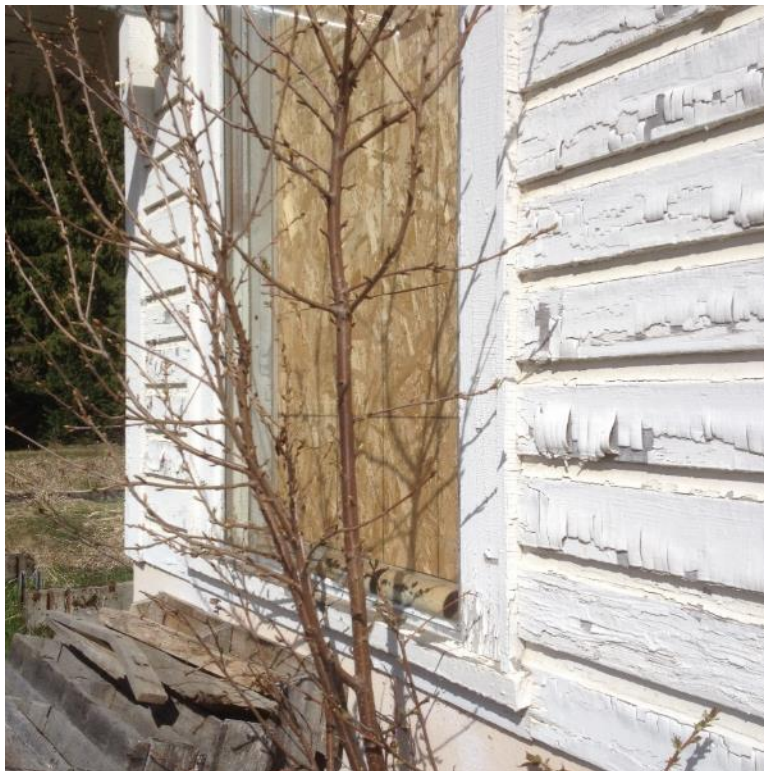
Photo 6. Building 2 – Hatchery Exterior. Peeling Paint.

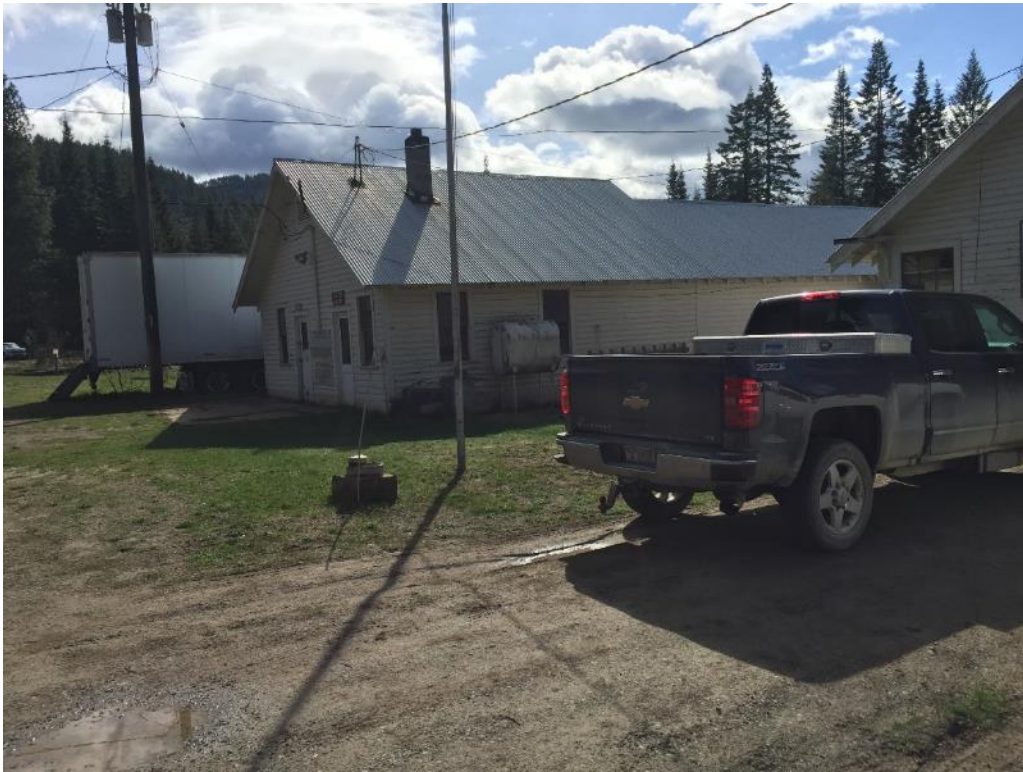
Adjacent to the hatchery building is a building originally constructed for cold storage and includes both a walk-in freezer and a cooler. The building has a concrete slab-on-grade foundation, wood-framed above-grade construction, and a corrugated metal roof. The freezer and cooler both include large doors, as well as insulated construction that appears to be finished with a tar-type material. It is suspected that there may be asbestos within the insulation for the freezer and cooler. The building appears to be in a satisfactory condition with no immediately obvious signs of lack of structural integrity. At a minimum, if the building is selected for long-term use by the project, the following actions are recommended:

Photo 7. Building 3 – Cold Storage Exterior.

- Removing existing paint and repainting the building (\$7,500 - \$10,000)

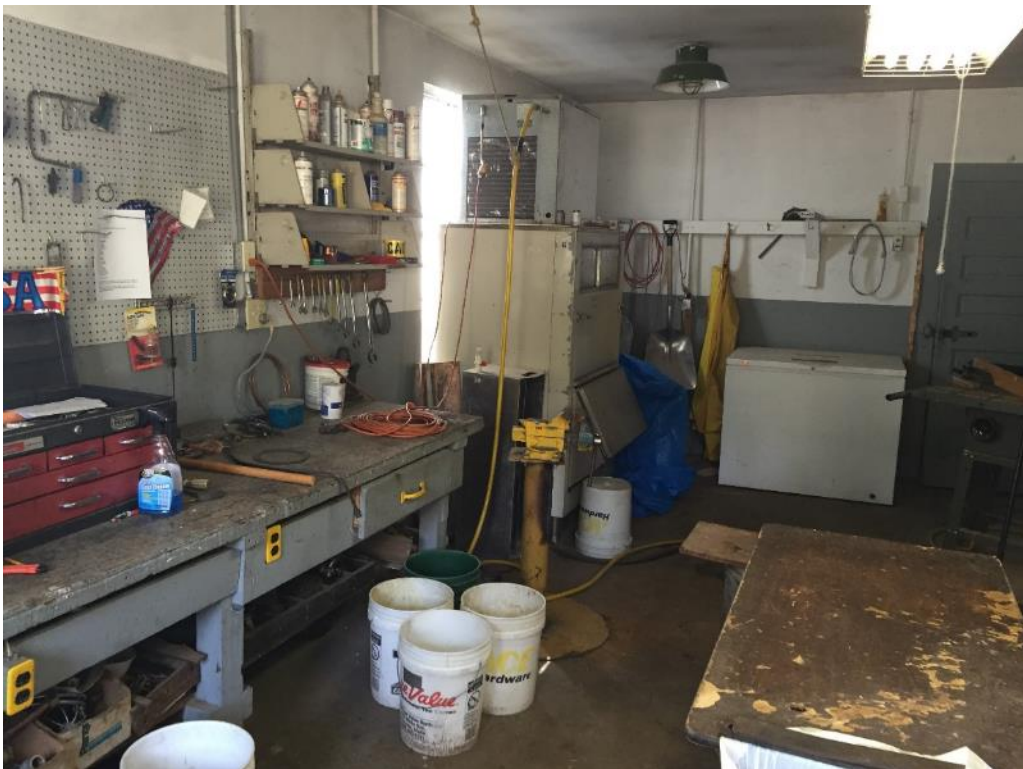
Currently, the building is used as storage and a small workshop for project personnel. The cooler and freezer have not been used for an extended period of time and are simply used as dry storage. The small workshop is also used by facility staff for fish study work.

Photo 8. Building 3 – Cold Storage Interior.

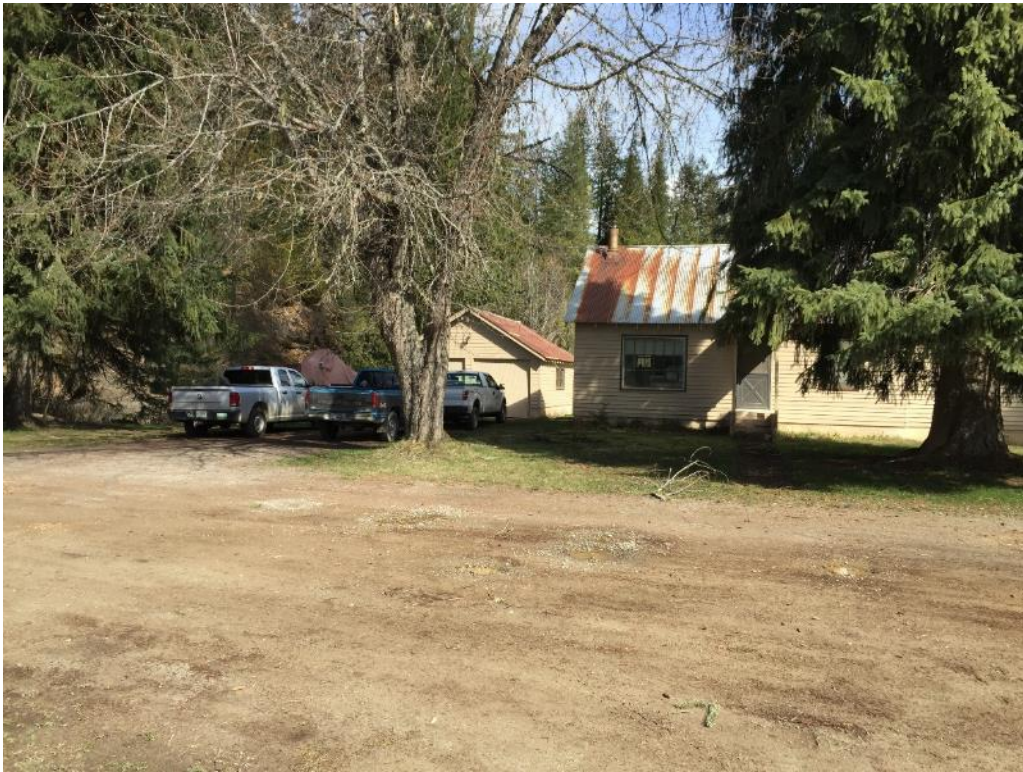
This residence and detached garage are located on the north side near the facility entrance. The garage is currently being used for storage and the residence is currently being used for office space and storage. They both have concrete foundations, above-grade wood-framed construction and a corrugated metal roof. The top surface of the metal roof at the garage showed signs of rusting and appeared to allow water leakage to the interior of the structure. A crack was observed at the foundation stem wall for the garage, but did not appear to be a cause for major concern. The structures both generally appear to be in satisfactory condition with no immediate concerns about the short-term integrity of the structures. The residence and garage were constructed shortly after the hatchery completion and are expected to have materials that contain lead and asbestos. At a minimum, if the buildings are selected for long-term use by the project, the following actions are recommended:

Photo 11. Building 4 – Garage (left). Building 5 – Residence (right).

- Removing existing paint and repainting both buildings (\$7,500 - \$10,000 Each)
- Removing corrugated metal roof at garage, installing continuous plywood roof membrane and new metal roof (\$30,000 - \$40,000 Each)

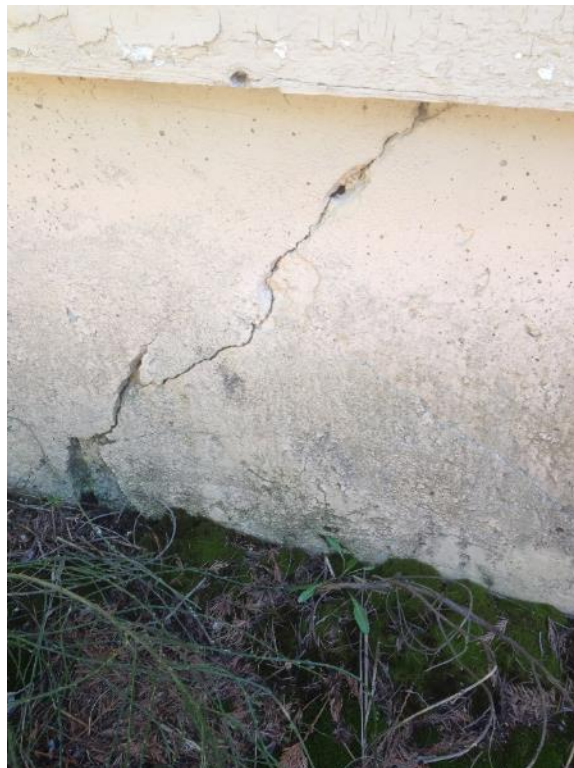
Photo 12. Building 4 – Garage. Crack in foundation.

The existing garages (bldg. 1, 4, and 7) would be maintained to provide the necessary dry, cold storage that the program requires. These structures would need to be stripped and repainted if long-term integrity of the structures is desired. These stripping activities could be more cumbersome than a typical repaint due to the possibility of lead paint being present. Additionally, some roofing upgrades would need to be performed to ensure long-term integrity of bldg. 1 and 4.

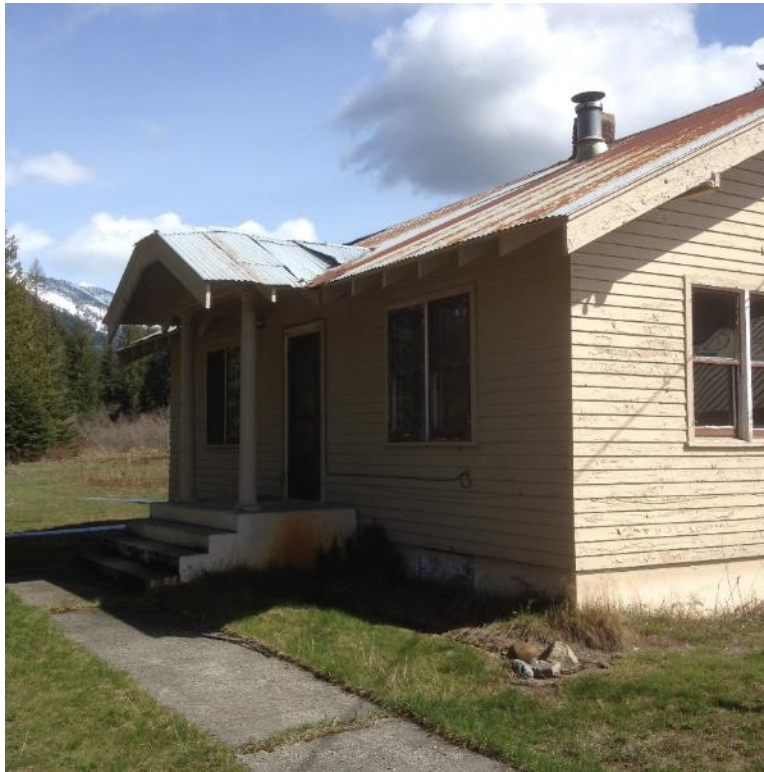
This residence and detached garage are located on the north side of the facility, adjacent to one of the water diversion and weir structures. They are both constructed with a concrete slab-on-grade foundation, and wood-framed siding. The residence has a corrugated metal roof; the garage has a modern standing-seam metal roof. This residence differs from the one near the entrance as it has a basement which regularly floods throughout the year. During inspections of the house during the site visit, a long vertical

crack was seen at an upstairs living room wall. This crack appears to be a settlement crack potentially caused by high groundwater levels and basement flooding. Both the flooding and the settlement crack raise concerns with the long term integrity of the residence. The garage showed no immediate signs of structural concern. At a minimum, if the buildings are selected for long-term use by the project; the following actions are recommended:

Photo 13. Building 6 – Residence Exterior.

- Removing existing paint and repainting garage (\$7,500 - \$10,000)
- Long-term use of the residence is not recommended

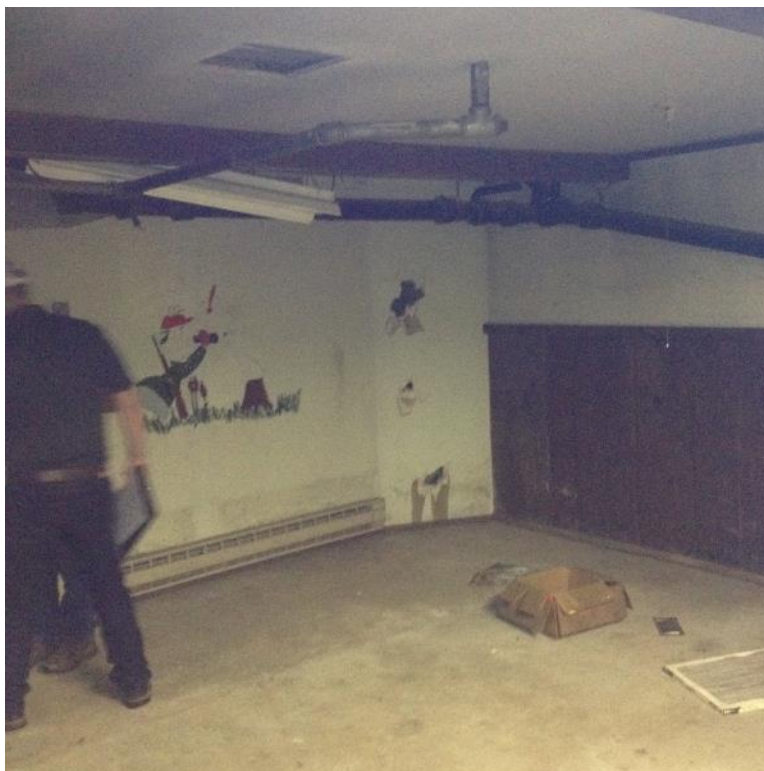
Photo 14. Building 6 – Residence Interior.

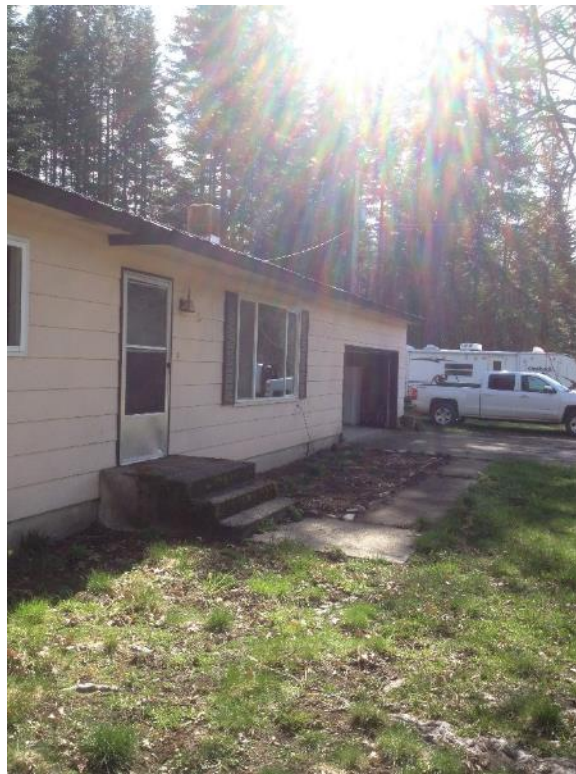
This residence is located on the east edge of the project site and is the most recently constructed building on the site. It shares an access road with an adjacent property that will need to be maintained during any construction activities or future rehabilitation of the hatchery site. The residence includes an attached garage and is constructed with a concrete foundation, wood framing, and asphalt shingle roof. The residence appeared in overall good shape and there were no immediate structural or integrity concerns.

Photo 17. Building 8 – Residence Exterior.

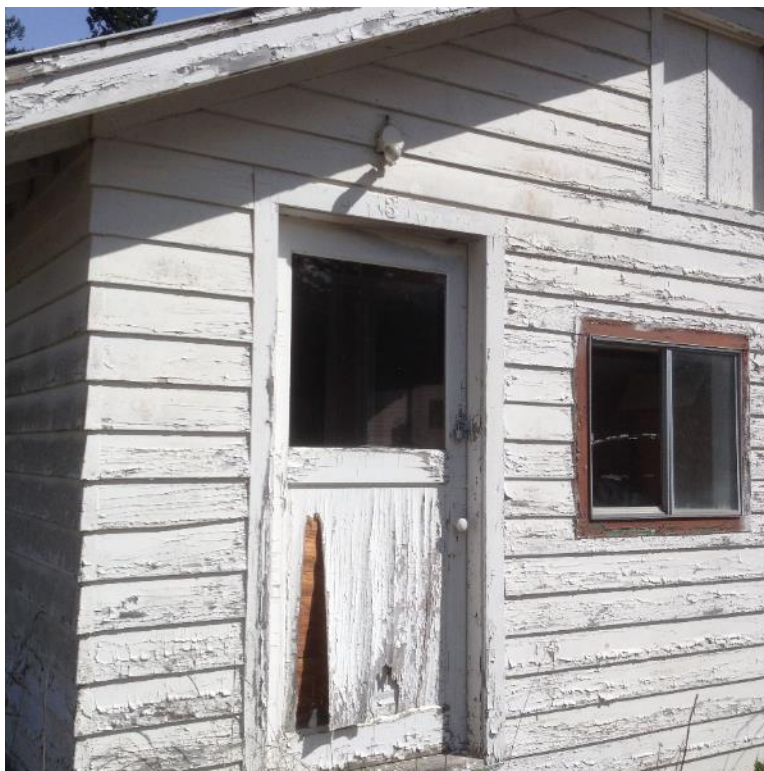
Located adjacent to the existing large raceways is a summer quarters building. This building is constructed with a concrete foundation, wood-framed siding, wooden roof trusses, and a corrugated metal roof. The interior of the building is currently unused; however, the roof line extends off one side of the structure over an open storage area that is being used. Wooden roof trusses and the interior ceiling framing are exposed to the elements via the attached storage area and a large opening on one of the gabled ends. Spotting caused by water leakage could be seen on the interior ceiling. The exterior siding, windows and doors are in poor condition with significant paint peeling and some wood warping. The exposed elements of the structure cause concern for the long-term integrity of the structure. Additionally, the electrical system within the building is in poor condition and has been prone to failure in the past. It is not expected that this building could be used for any future program needs.

Photo 18. Building 9 – Summer Quarters Exterior.

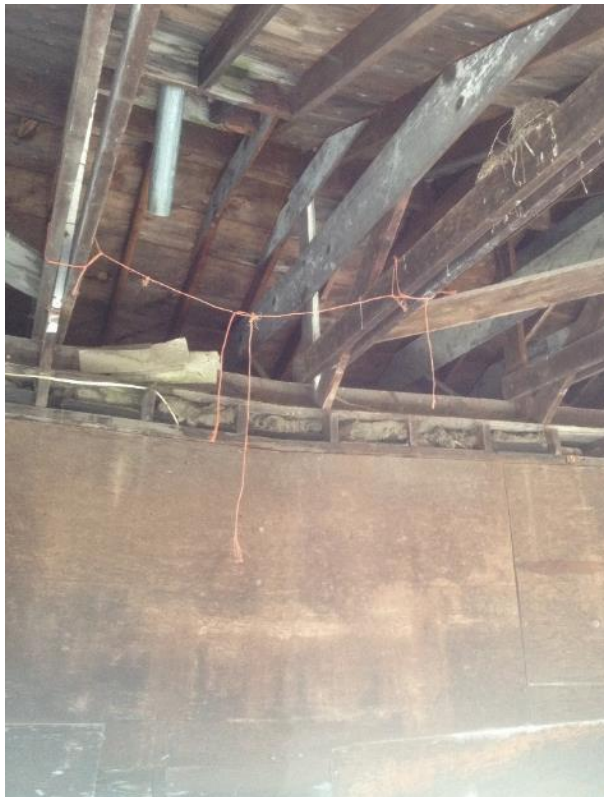
Photo 20. Building 9 – Summer Quarters Exposed Roof Trusses and Interior Ceiling Framing.

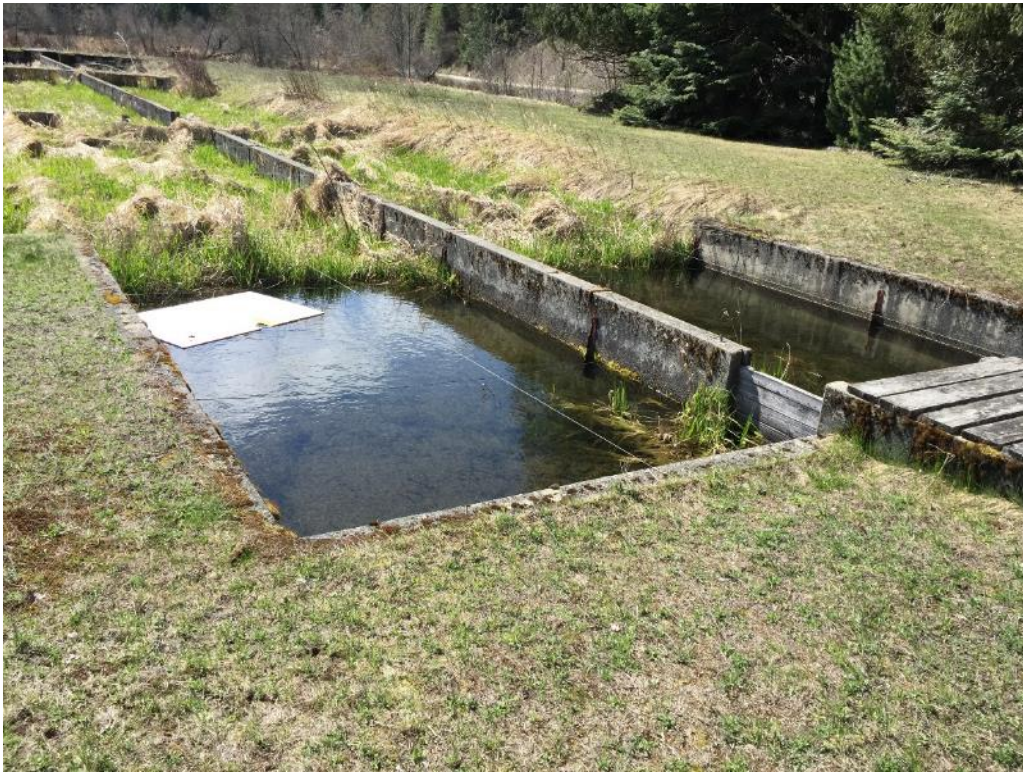
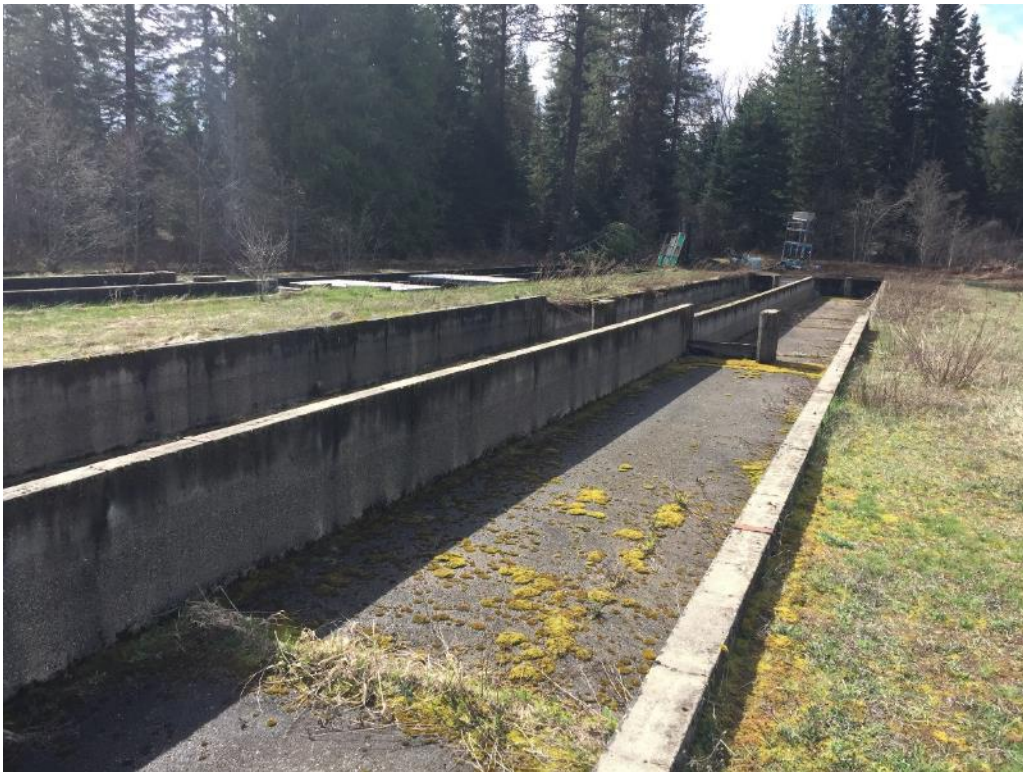
On the southern and eastern sides of the facility there are numerous raceways and ponds once used for fish-rearing purposes. The eastern-most large raceway is still currently utilized for fish rearing, while all of the others have been abandoned. The raceways are in various states of disrepair and would need extensive rehabilitation if they were to be utilized in the future.

Photo 21. Structure 10 – Large Raceways.

The existing raceways and ponds, as well as bldg. 3, 7 and 9, could either be abandoned in place or demolished in the future as funding becomes available. The shop space within bldg. 3 is not adequate and does not meet the current program needs. The raceways and ponds could simply be filled in with gravel or fill material and brought up to site grade.
