**DPW PROJECT 17905**  
**CLARK FORK FISH HATCHERY COMPLEX - 9 Buildings**  
**IDAHO DEPARTMENT OF FISH AND GAME**  
**CLARK FORK, IDAHO**

**ASBESTOS-CONTAINING BUILDING MATERIAL AND LEAD PAINT**  
**SURVEY AND ASSESSMENT REPORT**

September 2016

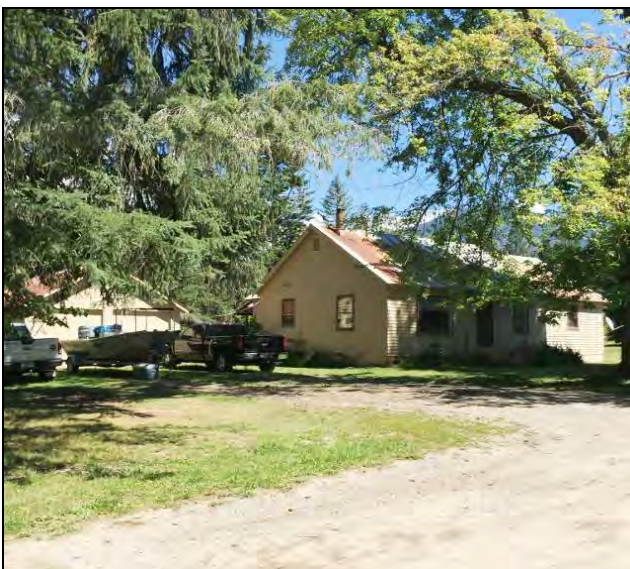
1. View of the Office Building (right) and the Office Garage (left) shows the lead-containing exterior beige and brown trim paint.

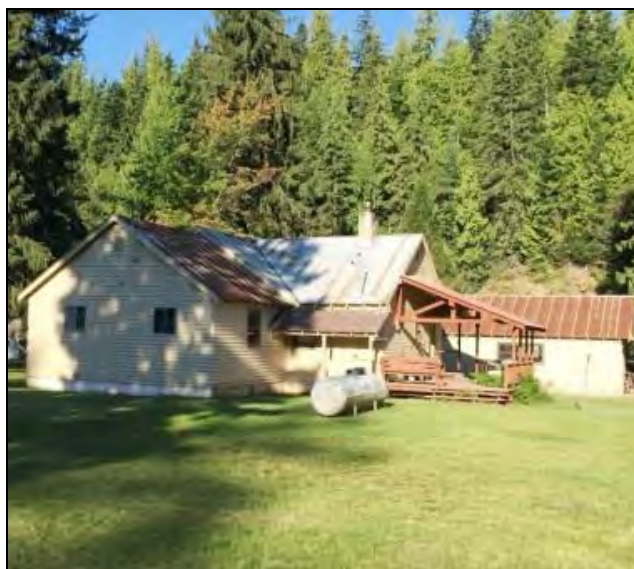
2. View of the northeast elevation (rear) of the Office Building and Office Garage showing the corrugated metal roofing and exterior wood siding.

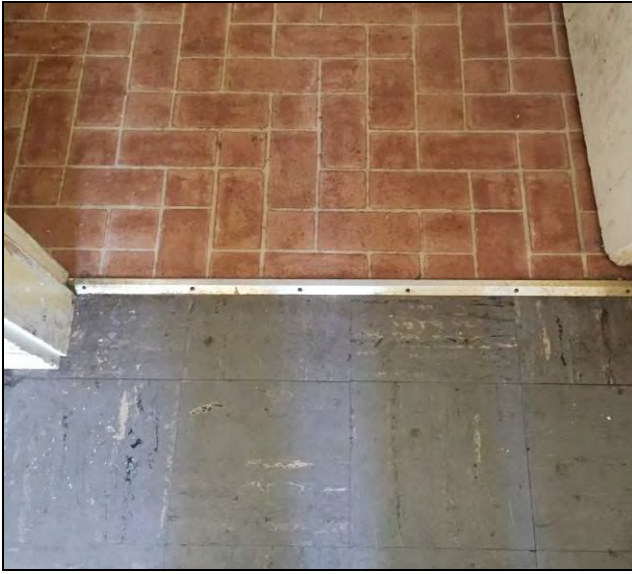
- 3. View of the grey asbestos-containing 9-inch vinyl floor tile located within the rear porch. Also shows the non-asbestos brown (reddish-brown brick pattern) sheet vinyl flooring found in the kitchen of the Office Building.**

The asbestos-containing materials found within the Office and Hatchery Buildings, the Main House and the Netters House are in fair-to-good condition (less than 10% damage or non-friable) and can be managed in place. Place the asbestos-containing materials in an operation and maintenance program and maintain in-place until the materials can be removed and disposed of properly.

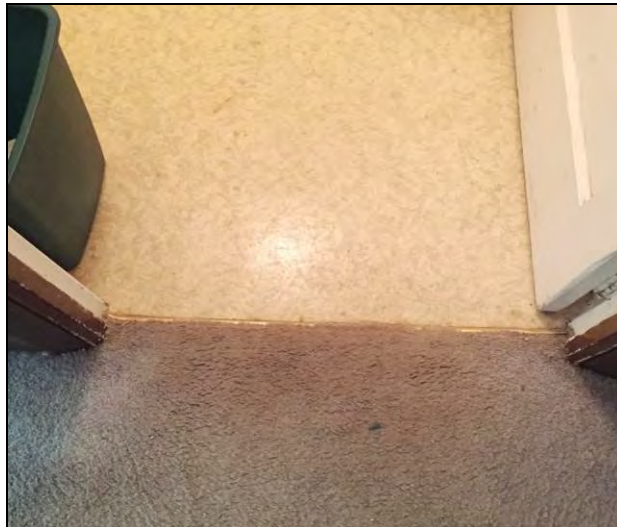
- 4. View of the asbestos-containing sheet vinyl found within the Office Building's bathroom.**

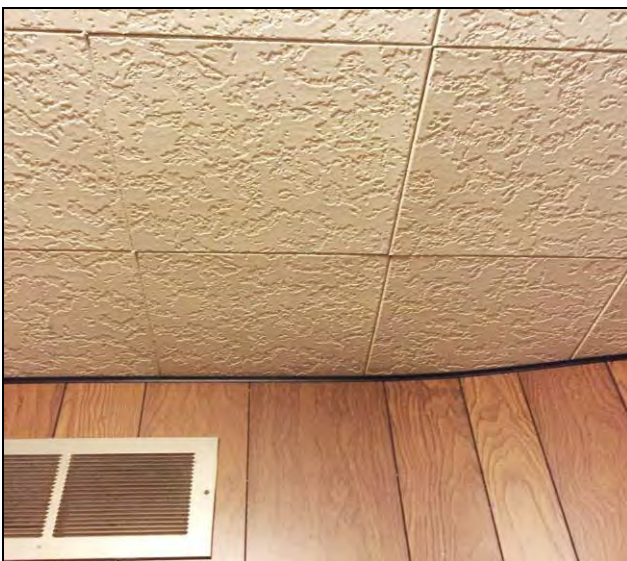
- 5. View of the non-asbestos 12-inch ceiling tile found within the Office building's northwest bedroom.**

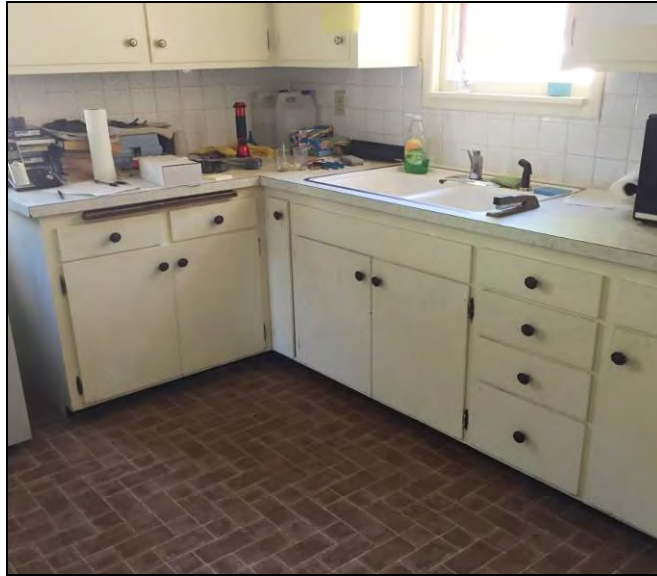
6. View of the non-asbestos ceramic tile grout found within the kitchen. Also shows the lead-containing off-white paint found on the exterior of the kitchen cabinets within the Office Building.

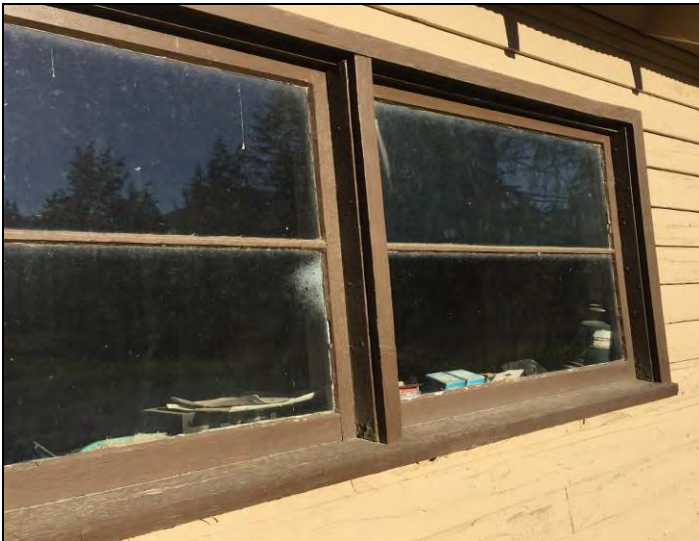
7. View of the non-asbestos-window glazing found on the exterior of the Office. Also shows the exterior beige and brown trim that were found to contain lead levels above the EPA/HUD guideline regulatory limit. These materials are similar to those found on the Office Building.

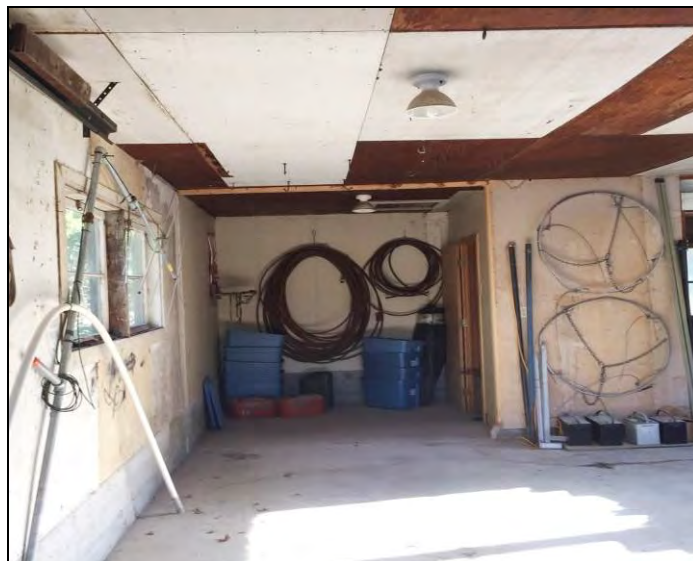
8. View of the interior of the Office Garage showing the non-asbestos drywall found on the walls and on the ceilings in various locations.

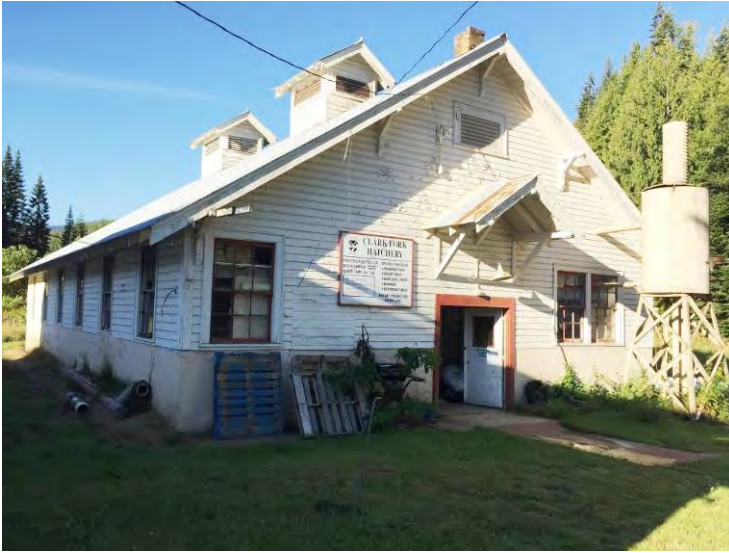
**9. View of the Hatchery Building showing the off-white paint that contains lead levels above the EPA/HUD guideline regulatory limit. Also shows the non-asbestos stucco finish applied to the concrete foundation walls.**

However, the lead-containing paint present on the exteriors of the West Garage, Hatchery Building, Shop/Freezer Building, and the Main House is in fair-to-poor condition (unstable, >10% to <25% flaking or damage). In addition the majority of the exterior paint found on the Summer Quarters and East Garage are in poor condition (extremely unstable >25% damage). A substantial amount of the paint is loose and peeling (flaking) off of these buildings. The flaking paint needs to be stabilized and cleaned up as soon as possible, and the associated waste disposed of properly at an approved landfill. Once the damaged and flaking

exterior paint has been stabilized place the remaining lead-containing paint in an operation and maintenance program and maintain in-place until the material can be removed and disposed of properly.

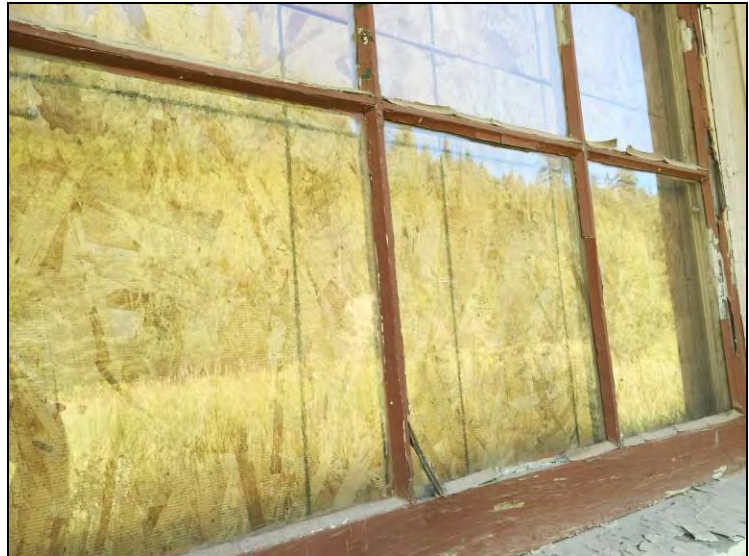
**10. View of the asbestos-containing window glazing found on the exterior windows of the Hatchery Building. Also show the reddish-brown trim paint that contains lead levels above the EPA/HUD guideline regulatory limit.**

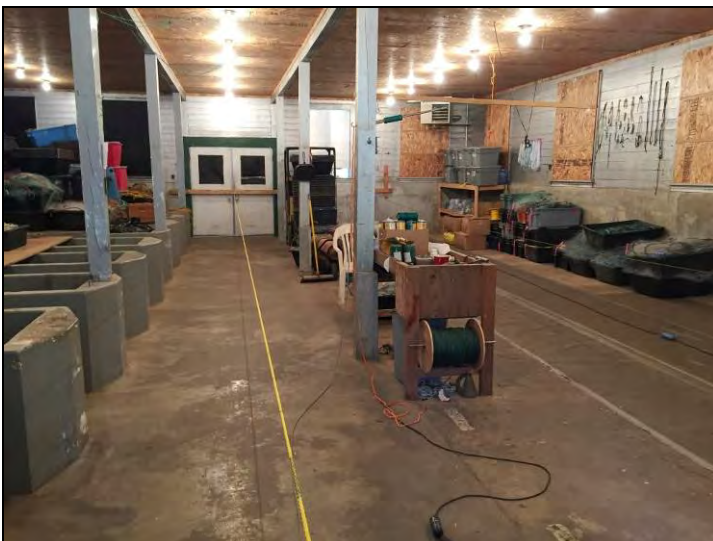
**11. Interior view of the Hatchery Building showing the grey and green paint that was found to contain lead levels below the EPA/HUD guideline. The grey coating applied to the inside and outside of the fish raceways was found to be non-asbestos containing.**

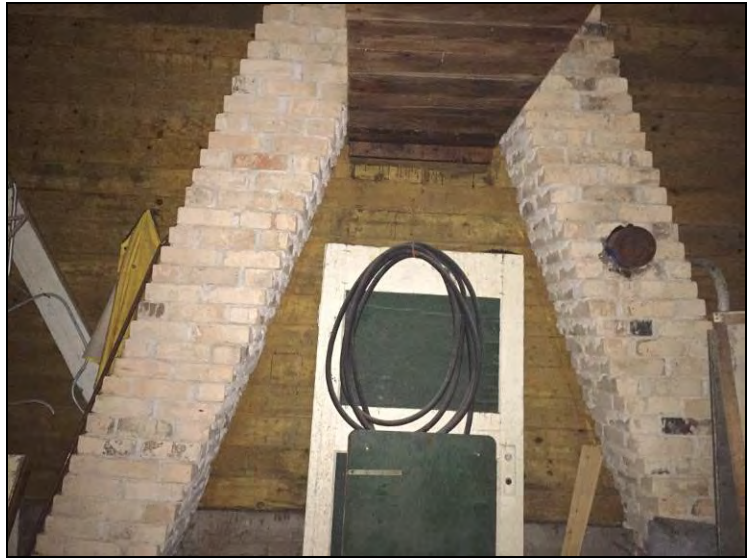
**12. View of the non-asbestos brick and mortar found on the chimney located within the Hatchery Building.**

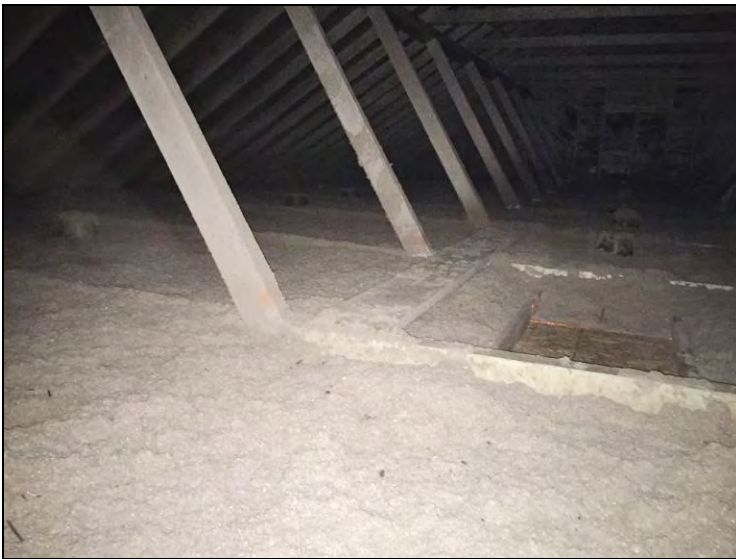
**13. View of the non-asbestos blown-in insulation found in the attic of the Hatchery Building.**

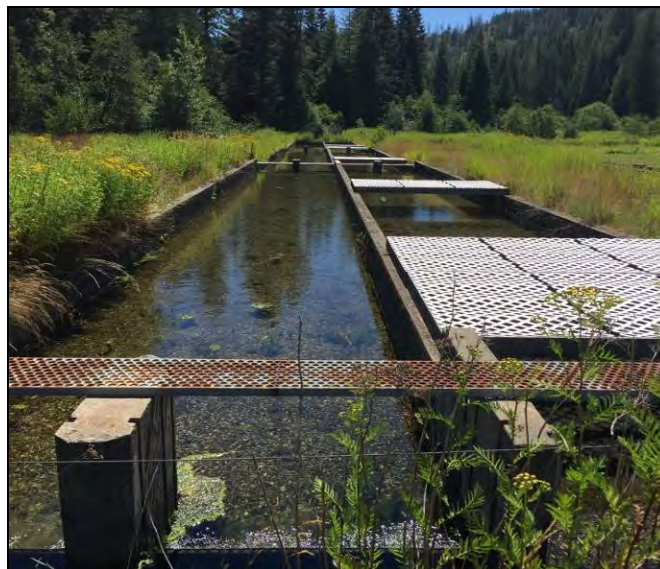
**14. View of concrete fish raceways at the Clark Fork Fish Hatchery. The concrete was found to be non-asbestos.**

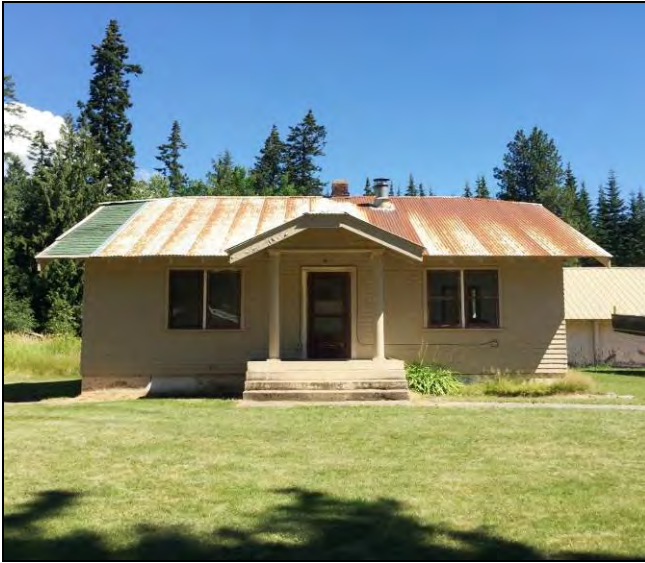
**15. View of the Main House showing the corrugated metal roofing. Also shows the beige paint applied to the exterior wood siding that was found to contain lead levels below the EPA/HUD guideline.**

**However the reddish-brown trim paint found on the exterior of the windows was found to contain lead levels above the EPA/HUD guideline.**

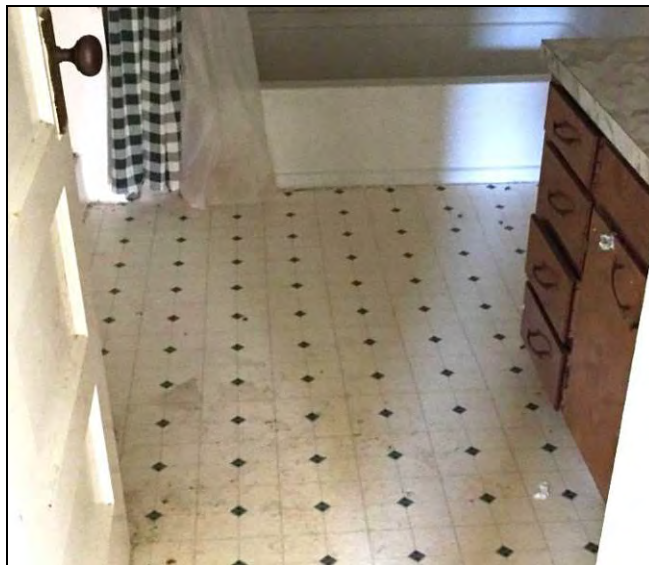
**16. View of the newer non-asbestos sheet vinyl found in the bathroom. This material has been installed over old yellow asbestos-containing sheet vinyl flooring.**

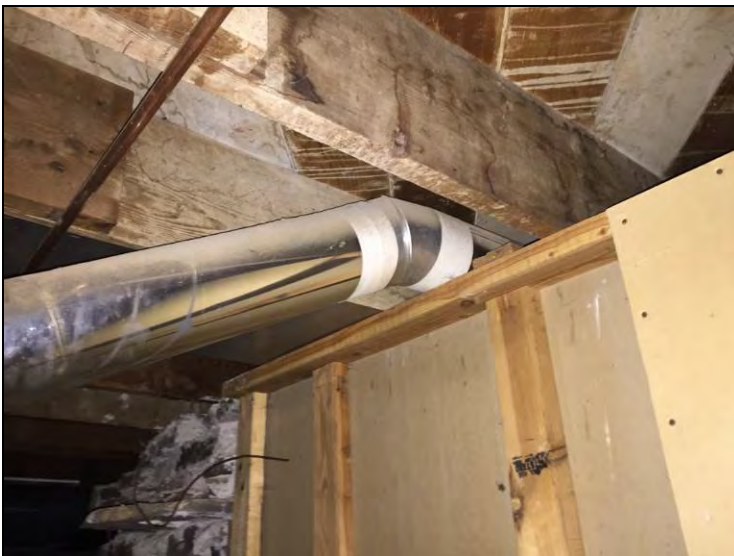
**17. View of the asbestos paper duct tape applied to the exterior of the metal heat ducts found within the basement and crawlspace areas located within the Main House.**

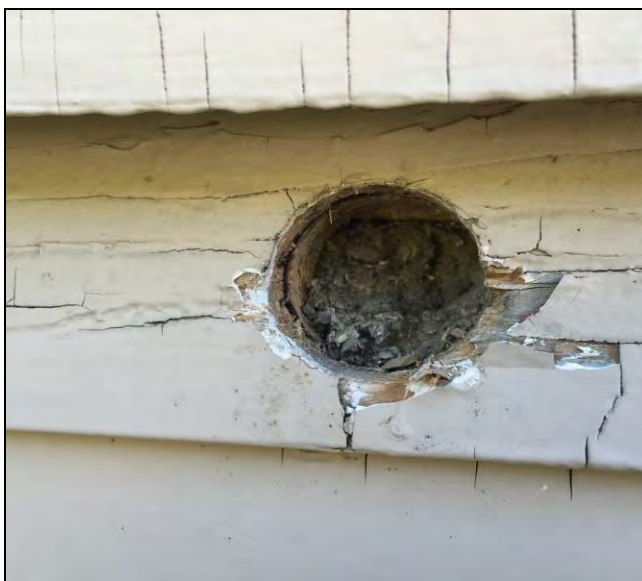
**18. View of the non-asbestos blown-in insulation found within the exterior walls of the Main House. This material is similar in appearance and texture to that found within the attic space.**

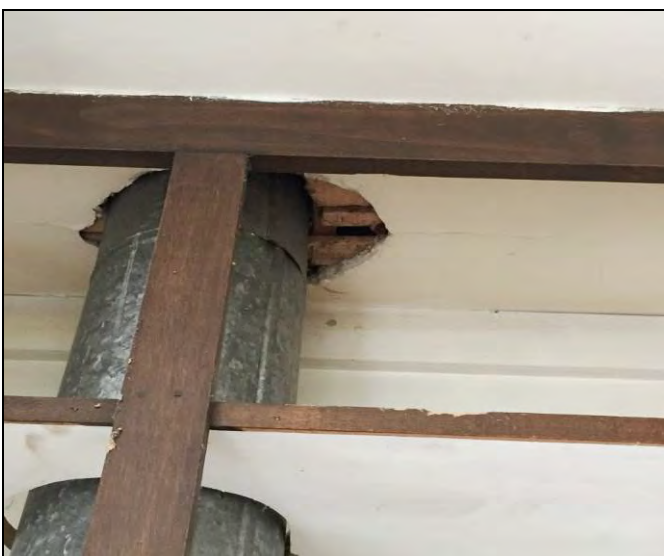
**19. View of non-asbestos plaster finish applied to wood lath. The plaster finish is found on the interior walls and ceilings throughout the upper level of the Main House.**

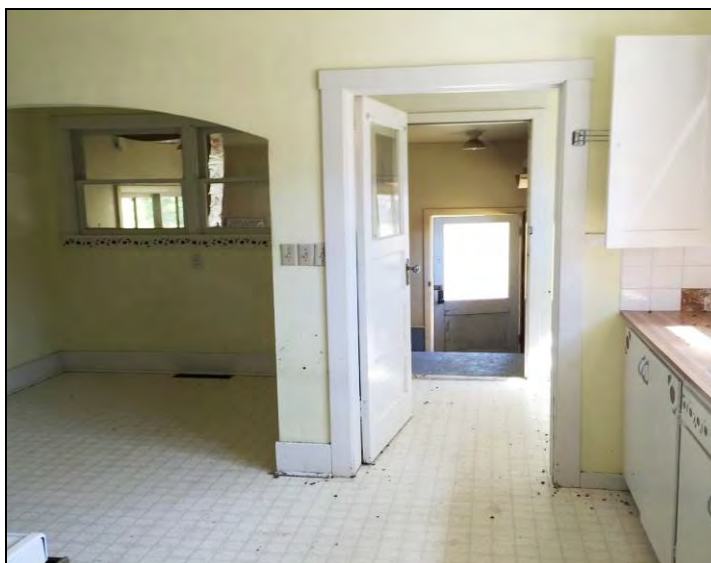
**20. Interior of the Main House kitchen, dining and laundry areas located on the main level, showing the newer non-asbestos sheet vinyl flooring and non-ACM ceramic tile grout.**

**Also shows the lead-containing off-white paint found on the kitchen cabinets.**

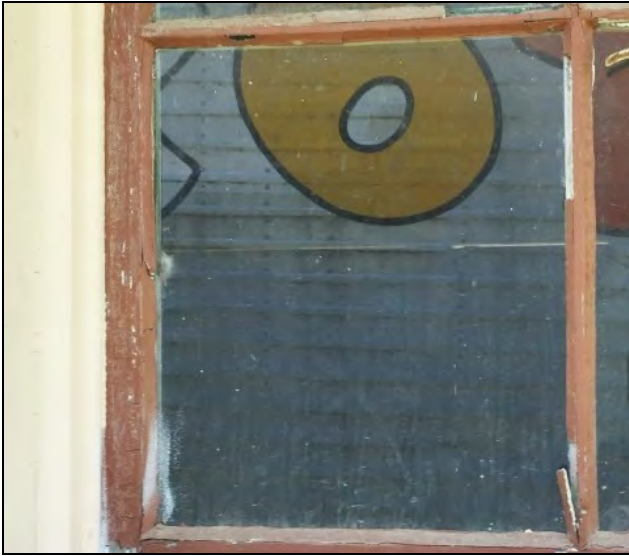
**21. View of the asbestos window glazing found on the exterior of the East Garage. The reddish-brown trim paint contains lead levels above the EPA/HUD guideline.**

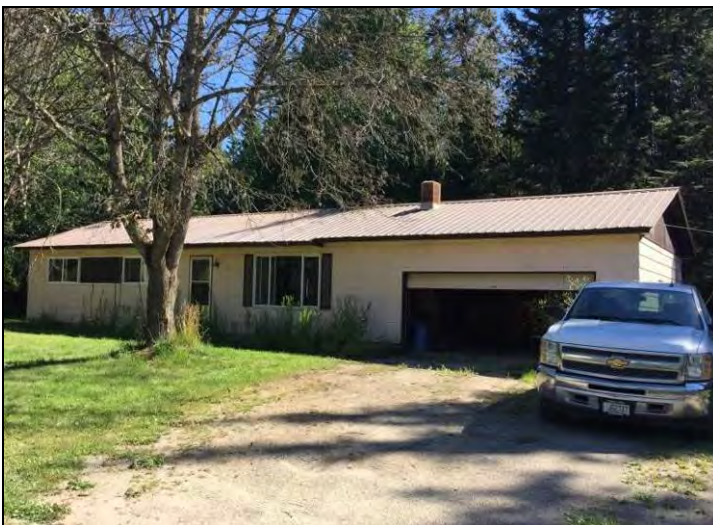
**23. View of the Netters House showing the exterior beige and brown trim paint that contains lead levels below the EPA/HUD guideline regulatory limit.**

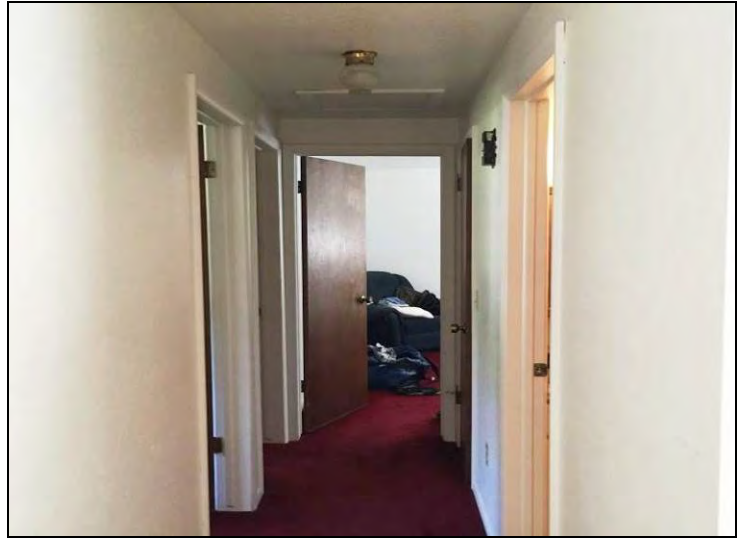
**24. Interior view of the Netters House showing the non-asbestos drywall texture applied to the walls and ceilings throughout the building.**

**The off-white interior paint contains lead levels below the EPA/HUD guideline regulatory limit.**

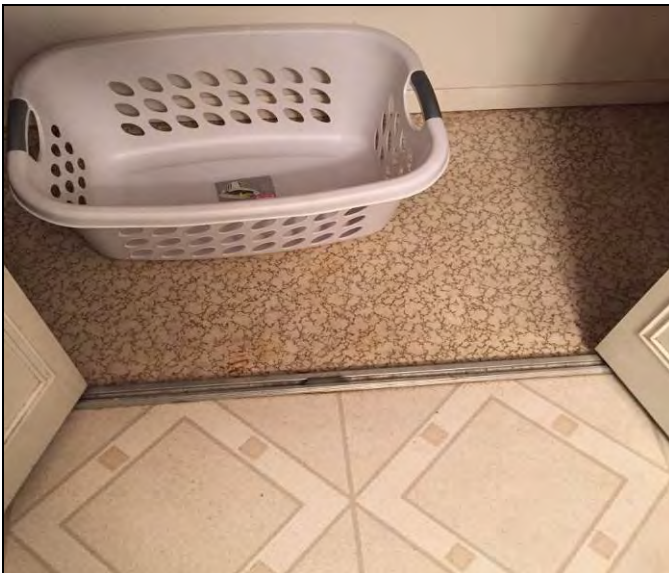
**25. View of non-asbestos sheet vinyl found within the bathroom of the Netters House.**

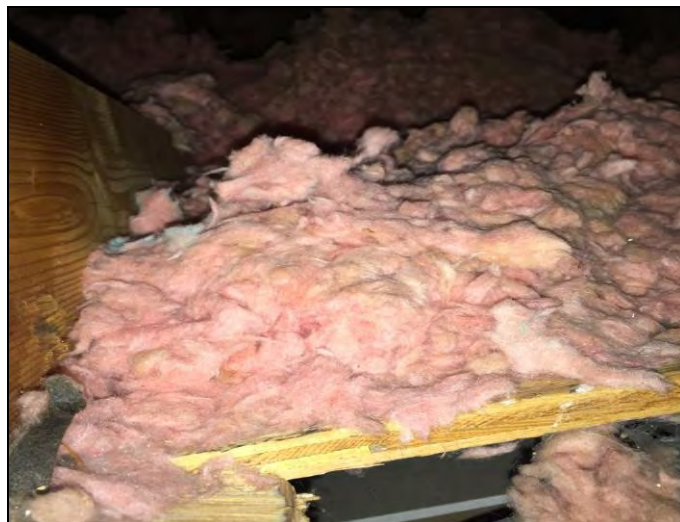
**26. View of the blown-in insulation found within the Netters House attic space.**

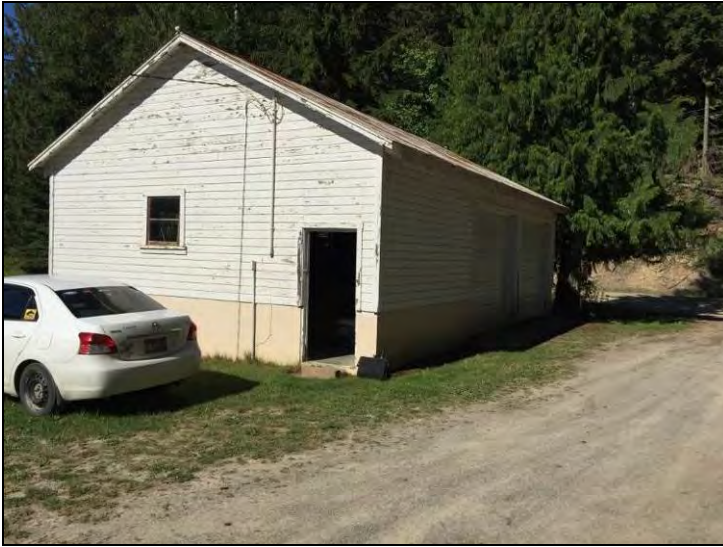
**27. View of the West Garage showing the off-white exterior that was found to contain lead levels above the EPA/HUD guideline regulatory limit.**

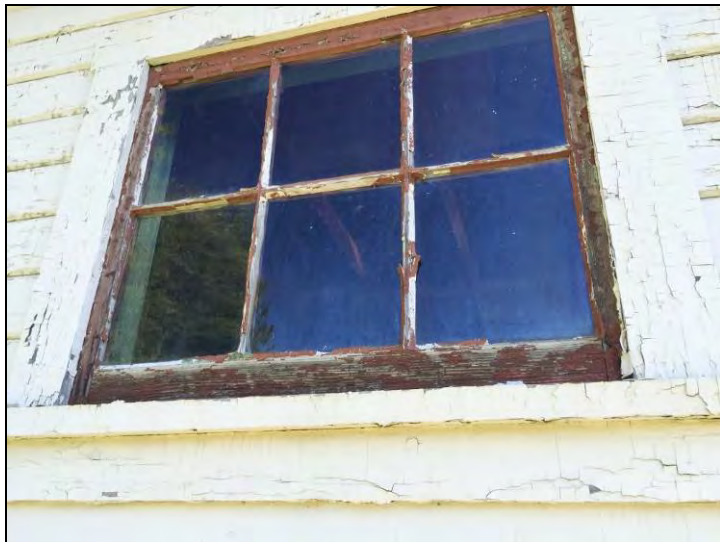
**28. View of the West Garage showing the non-asbestos window glazing compound used on the exterior windows.**

**The reddish-brown paint is presumed to contain lead levels above the EPA/HUD guideline regulatory limit as does the exterior off-white paint.**

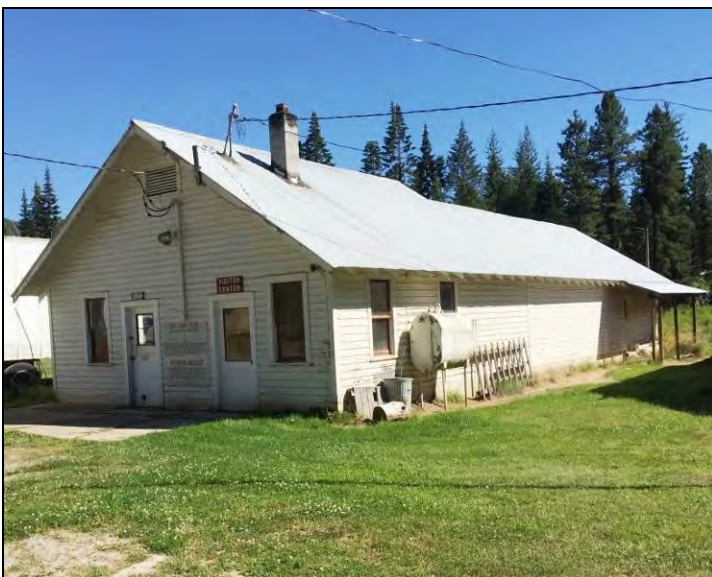
**29. View of the Shop/Freezer Building showing the off-white paint that was found on the exterior siding and trim found to contain lead levels above the EPA/HUD guideline regulatory limit.**

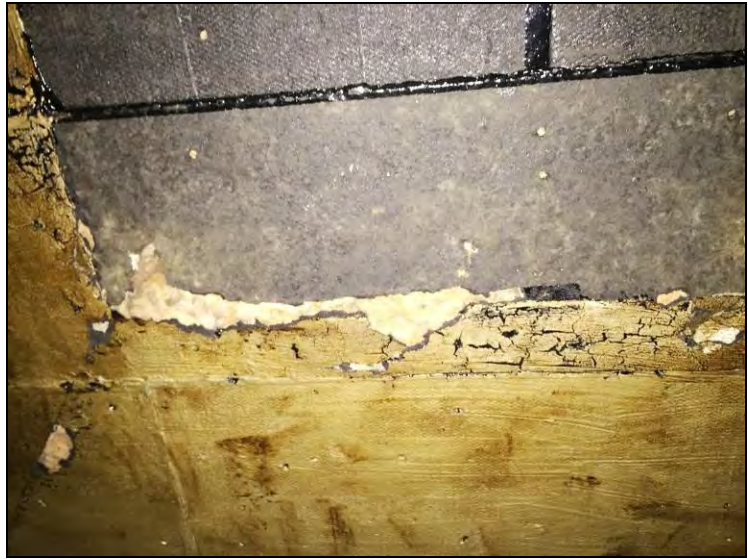
**30. View of the non-asbestos rigid fiberglass insulation found on the interior ceilings of the freezers.**

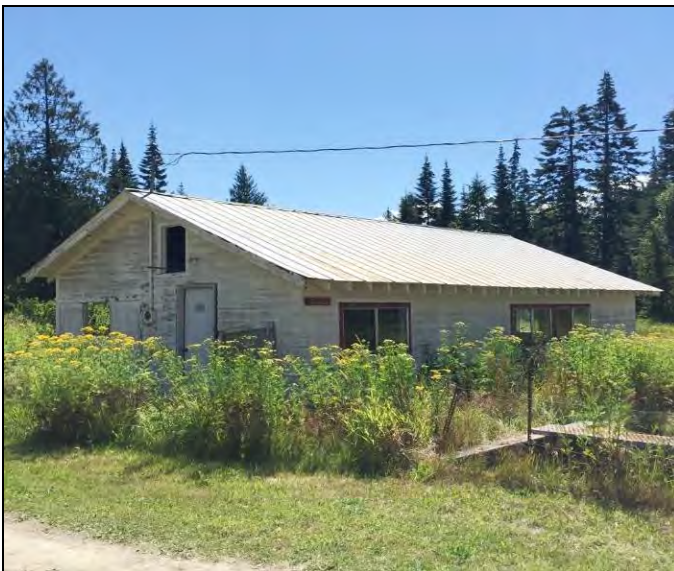
**31. View of the Summer Quarters showing the off-white and reddish-brown trim that was found to contain lead levels above the EPA/HUD guideline regulatory limit.**

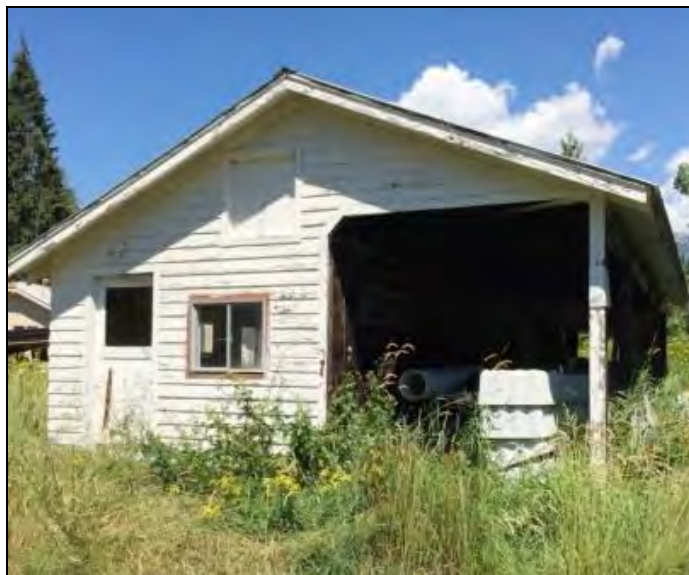
**32. View of the peeling and flaking exterior lead-containing paint found the rear of the Summer Quarters.**

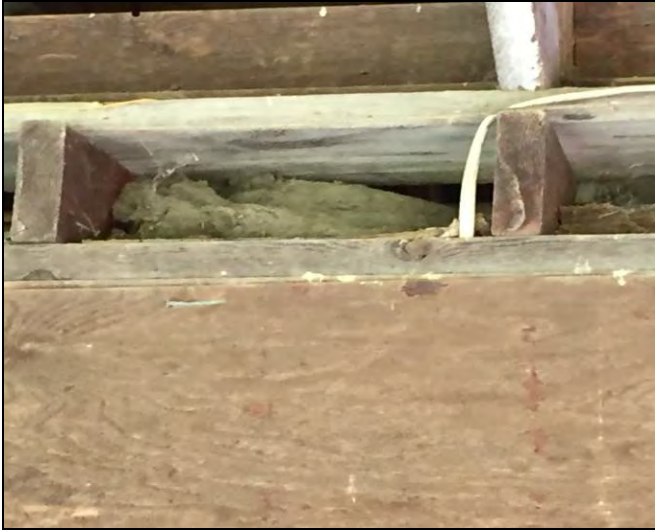
**33. View of the non-asbestos grey batt insulation found within the Summer Quarters attic space.**

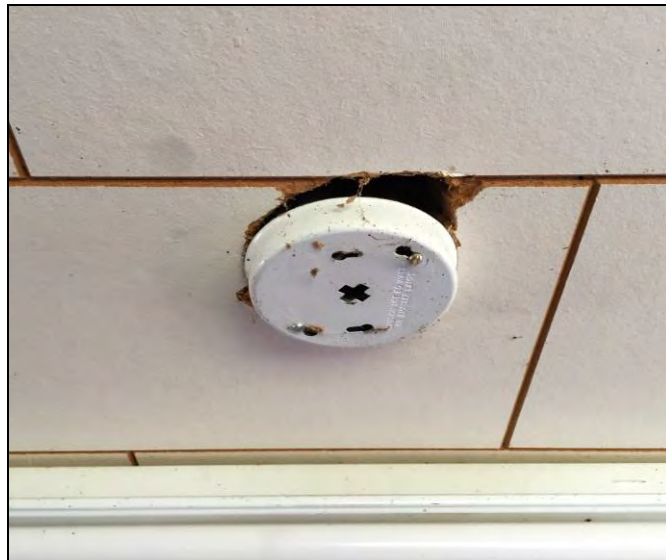
**34. View of the 12-inch by 20-inch ceiling tiles found within the Summer Quarters.**

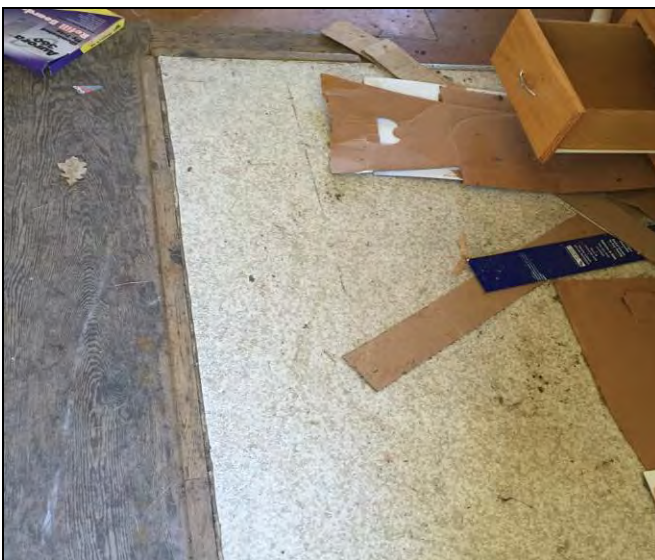
**35. View of the non-asbestos sheet vinyl flooring found within the Summer Quarters.**
