Idaho 2024 Interagency Forest Practices Water Quality Audit

State of Idaho Department of Environmental Quality

January 2025

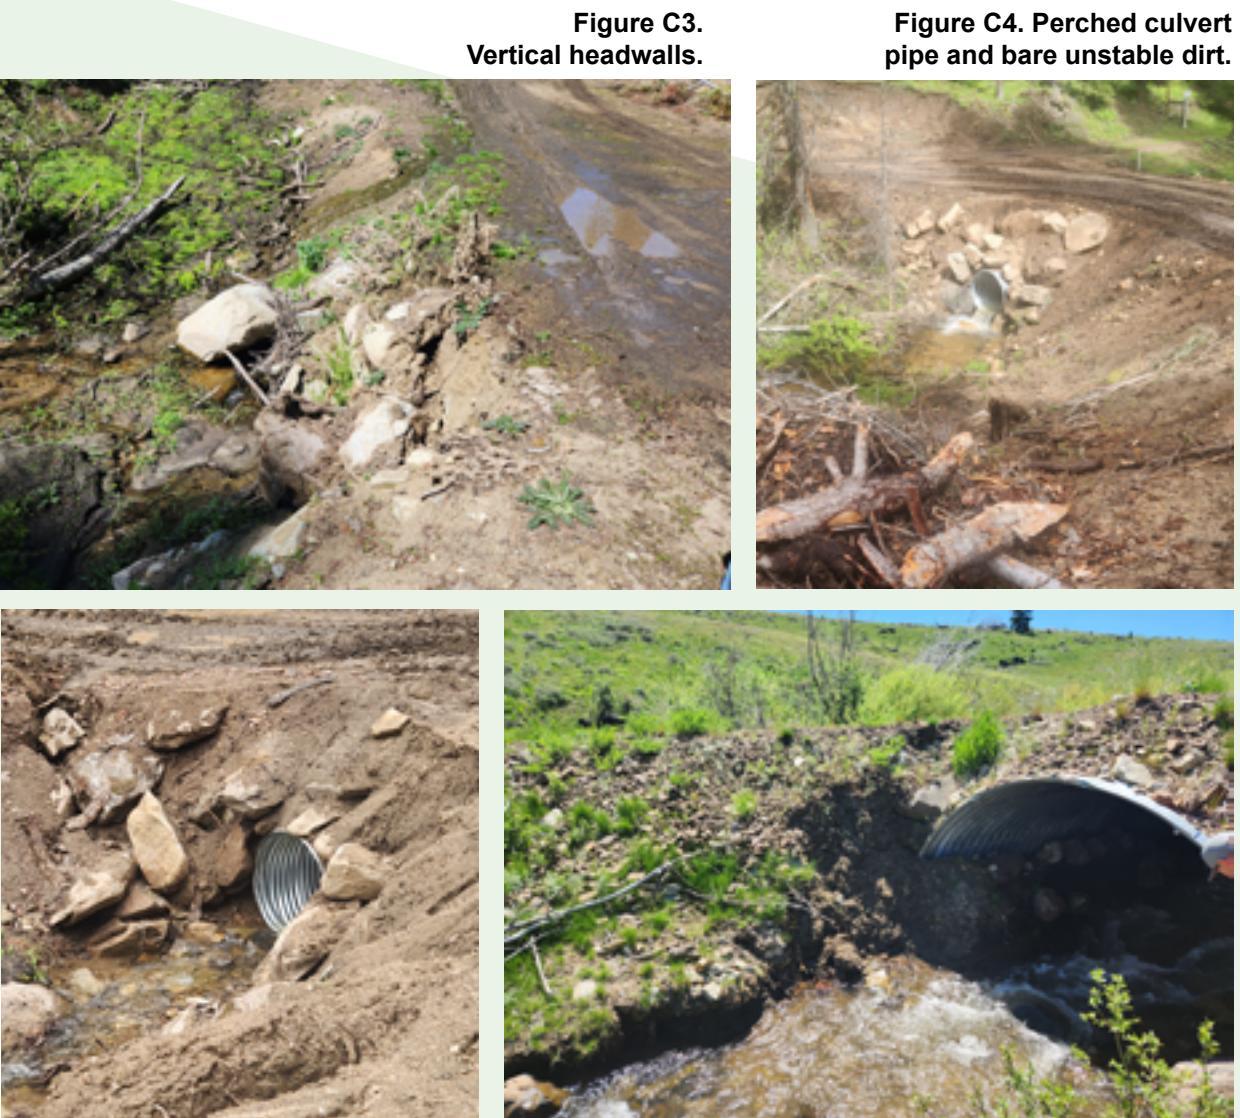
On three occasions, the auditors found that stream crossing culvert pipes were too short. This meant the fill had to be steeper than otherwise required, and often bare dirt reached to the very end of the pipe. This then encouraged erosion directly into the water.

Figure C3. Vertical headwalls.

Figure C6. Erosion of the fill.

Figure C5. Short culvert pipe, vertical headwalls.

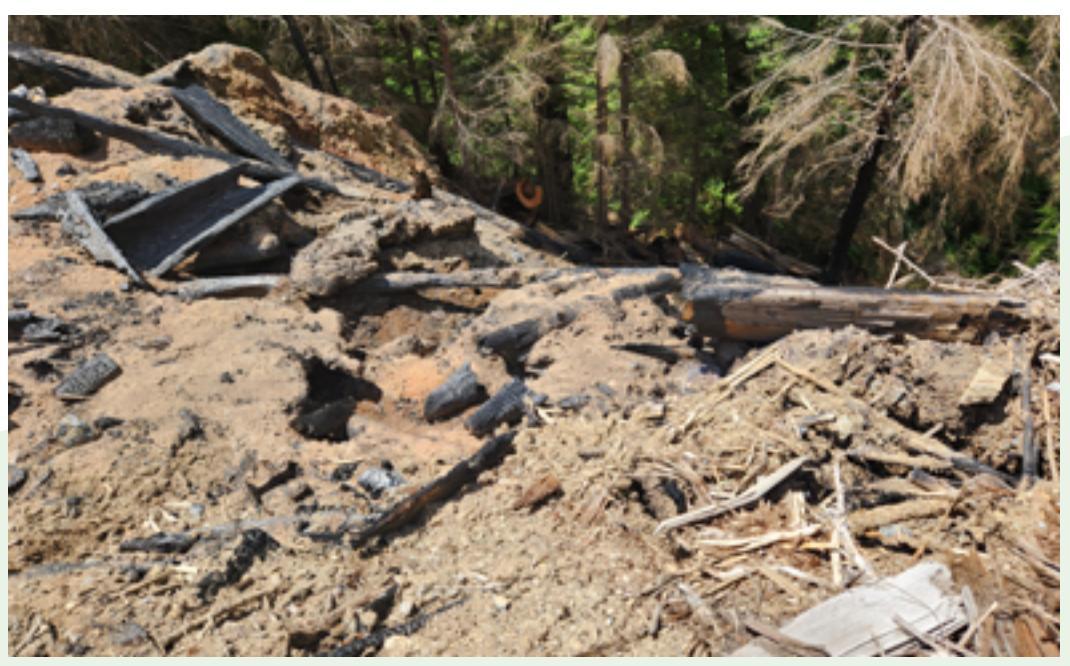
In one case, large amounts of slash in a stream contributed to the failure of a culvert. In another case, several Class II streams were ignored. While they may not have been flowing at the time and were not on the (outdated) area map, the streams were clearly identifiable by their bed and banks. They should have been protected. The audit team visited when the creeks were flowing, and the skid trails and slash piles in the SPZs had caused significant sedimentation of the creeks.

Figure C7. Slash pile burned and eroded next to creek.

Figure C8. Blown out culvert (blocked by slash).

Figure C9. Slash in the creek.

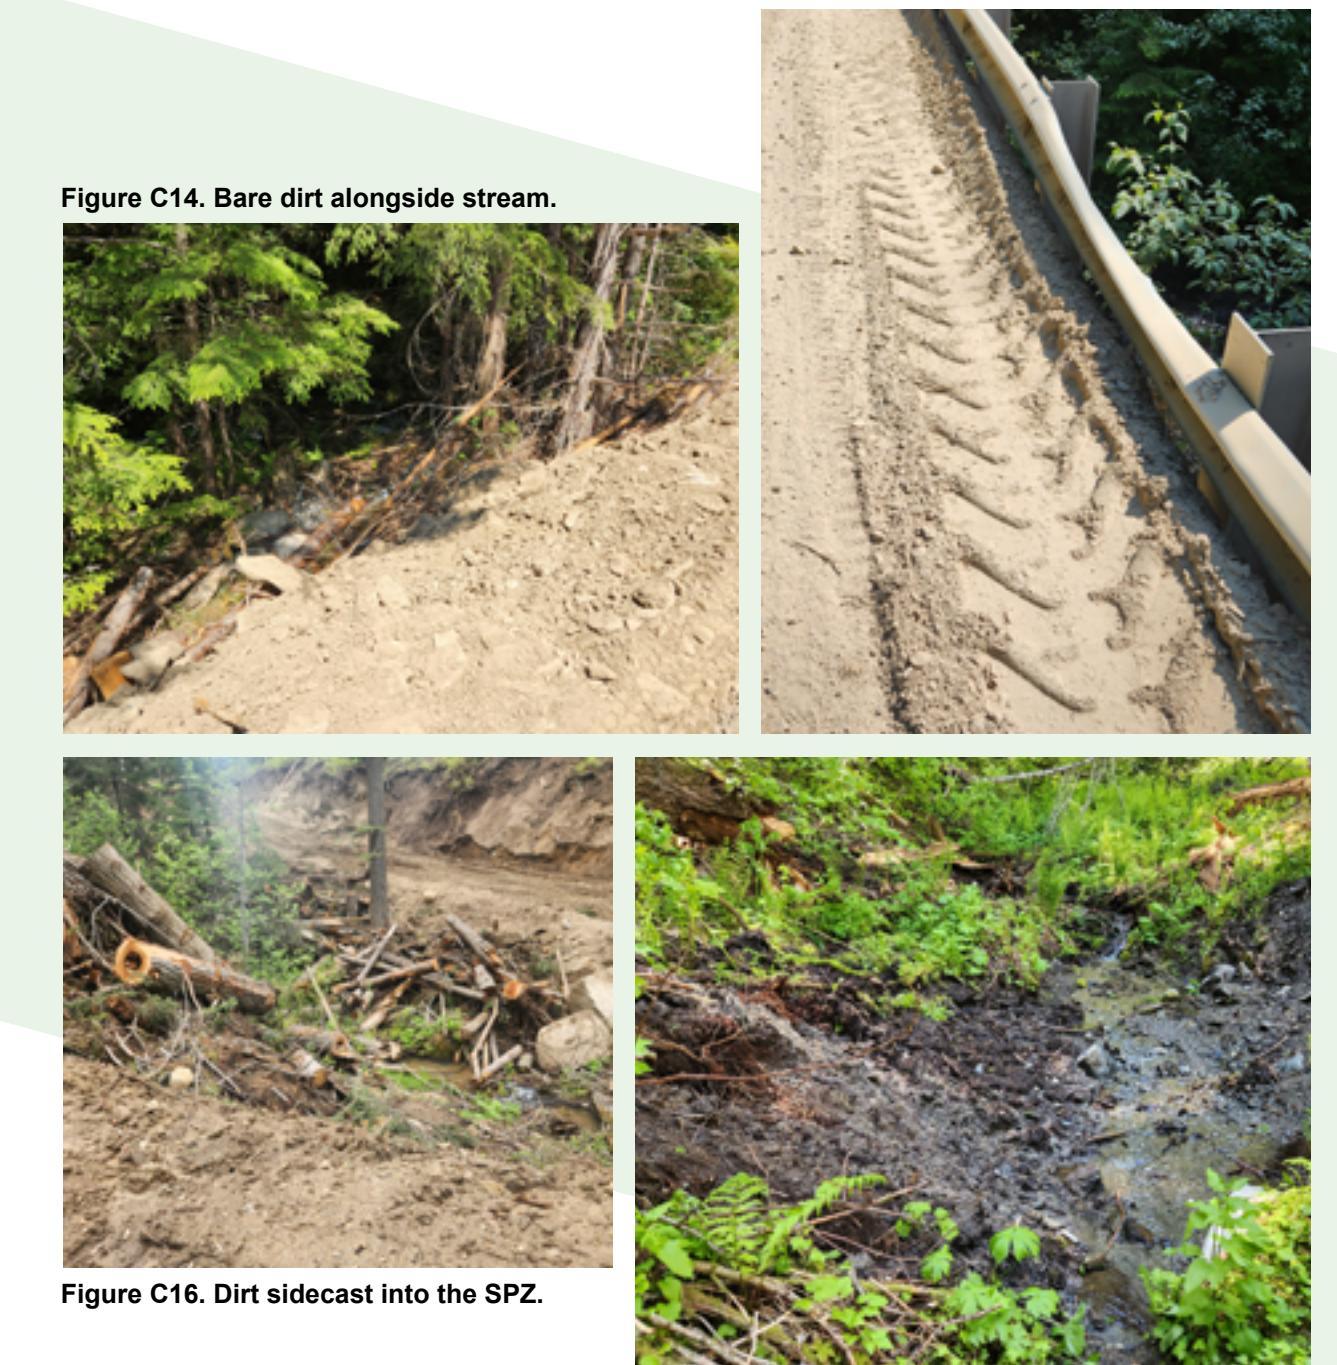
The audit team found rule 040.04a (governing maintenance debris) violated five times. On most of these occasions, debris from cleaning culvert entrances was left immediately next to the stream, where it was vulnerable to being washed back into the stream. Twice, auditors found

Figure C15. Dirt graded off edge of bridge.

Figure C17. Culvert cleaning debris in stream.
