## PHASE I ENVIRONMENTAL SITE ASSESSMENT

ASHTON FISH HATCHERY  
3330, 3332, & 3334 EAST 1200 NORTH  
ASHTON, IDAHO 83420

**ROCKY MOUNTAIN ENVIRONMENTAL PROJECT No.: 15-0124**

December 4, 2015

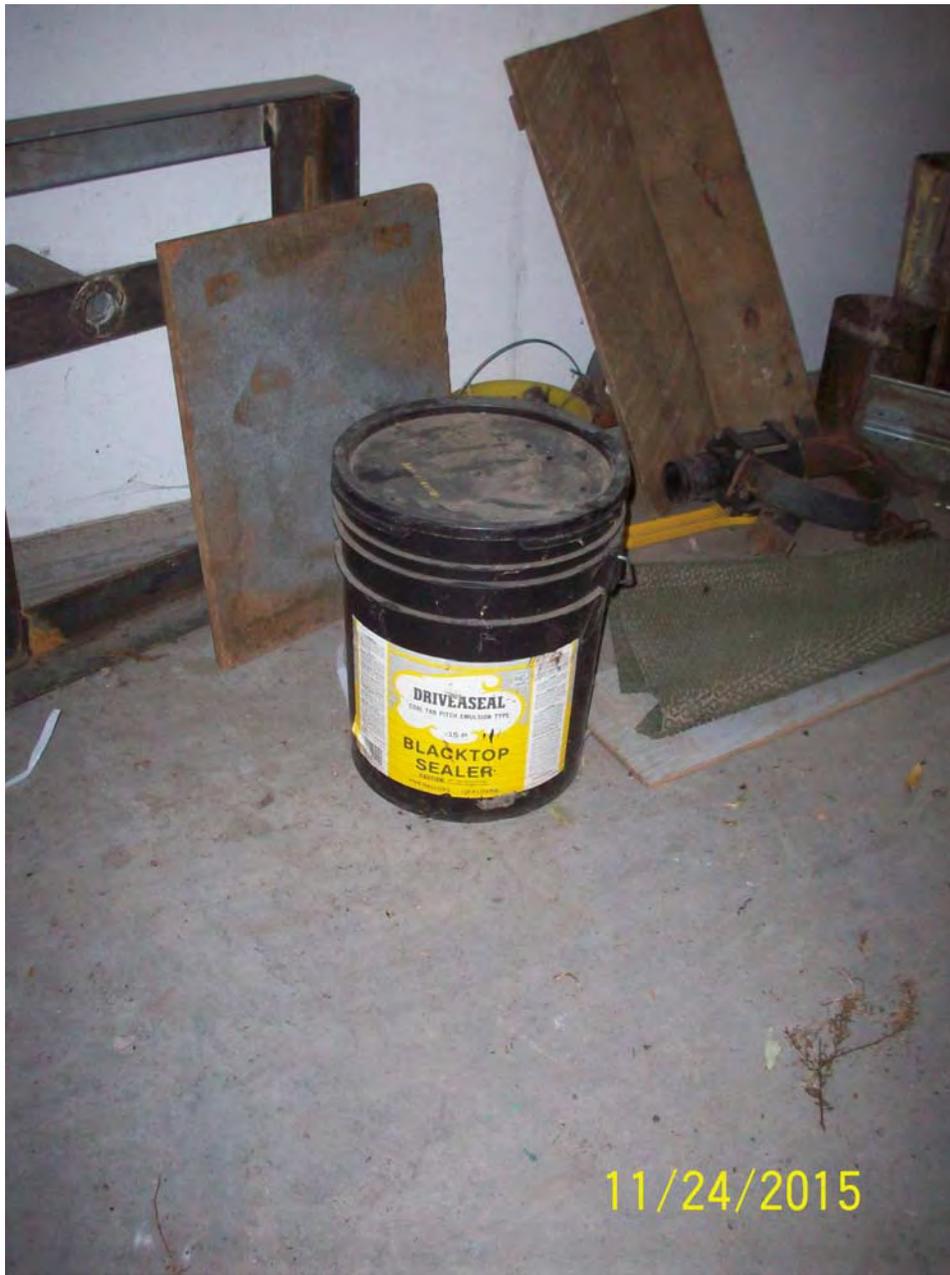
Household quantities of paints were found in the utility sink of the New Residence. A 5-gallon bucket of blacktop sealer and 1-gallon can of roofing cement, PVC glue, 3-in-one oil, ATF oil, and motor fuel additive are found in the shop building.

**Photograph 13.** Bucket of driveway sealer setting on Shop floor.

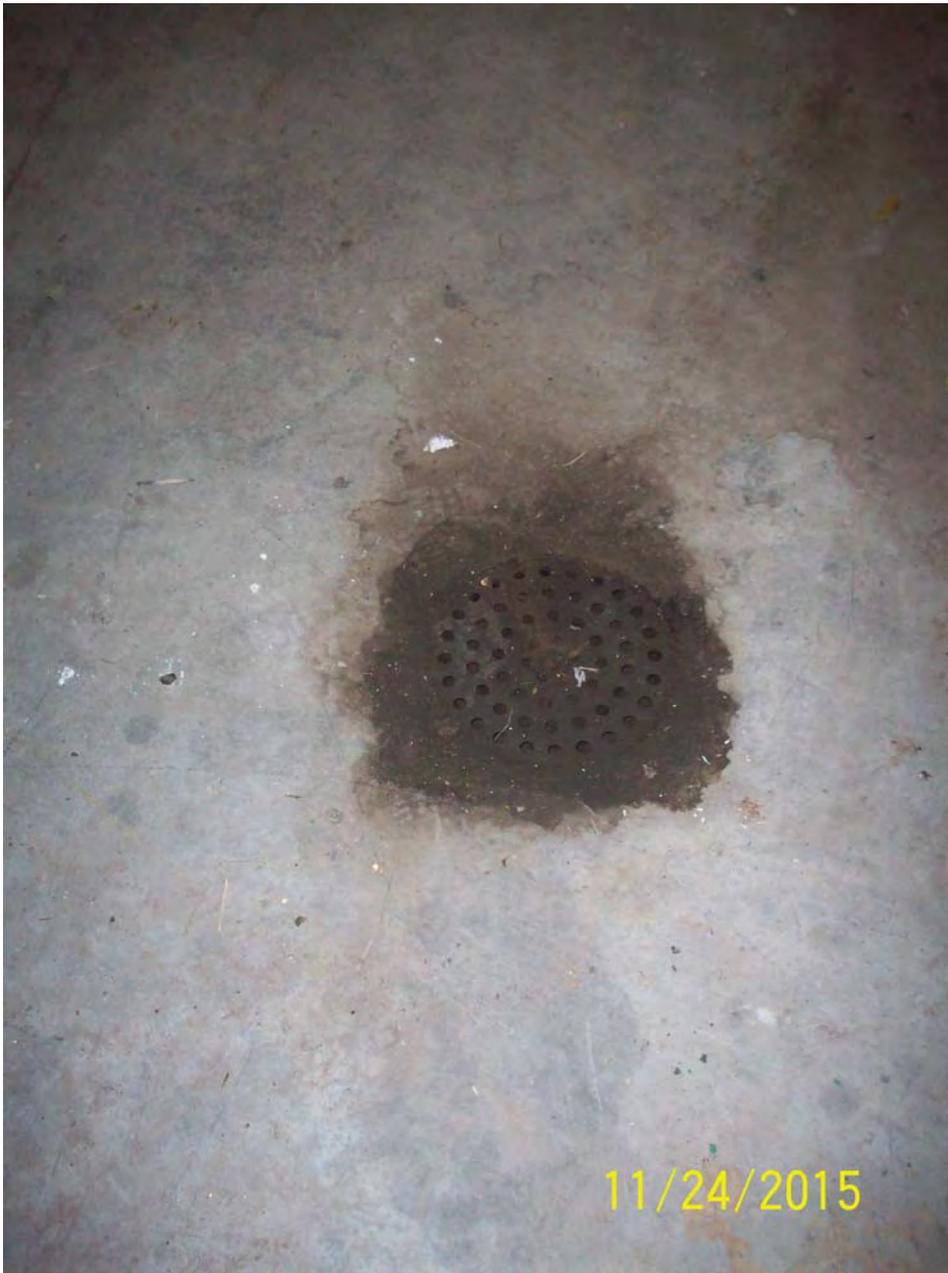
No significant evidence of staining was identified in the interior portions of the property during the site visit. A minor stain exists around the west bay drain inside the Shop building. Reportedly, there was a diesel fuel tractor equipped with a snow blower that was routinely parked in the bay. Snow melted off of the tractor and onto the floor and flowed to the drain along with incidental oils and greases originating from the tractor. No used motor oil was known to purposely have been dumped into the drain. Routine maintenance of vehicles were reportedly contracted to local businesses located in nearby Ashton.

**Photograph 14.** Oil stains surrounding drain on Shop floor.

- A buried oil/water separator is reportedly located on the east side of the Shop building. Oil staining on the concrete surrounding the west bay drain suggests that an unknown quantity of oil has entered the drain. Reportedly, the oil/water separator has never been pumped since it was installed when the Shop building was constructed circa 2010.

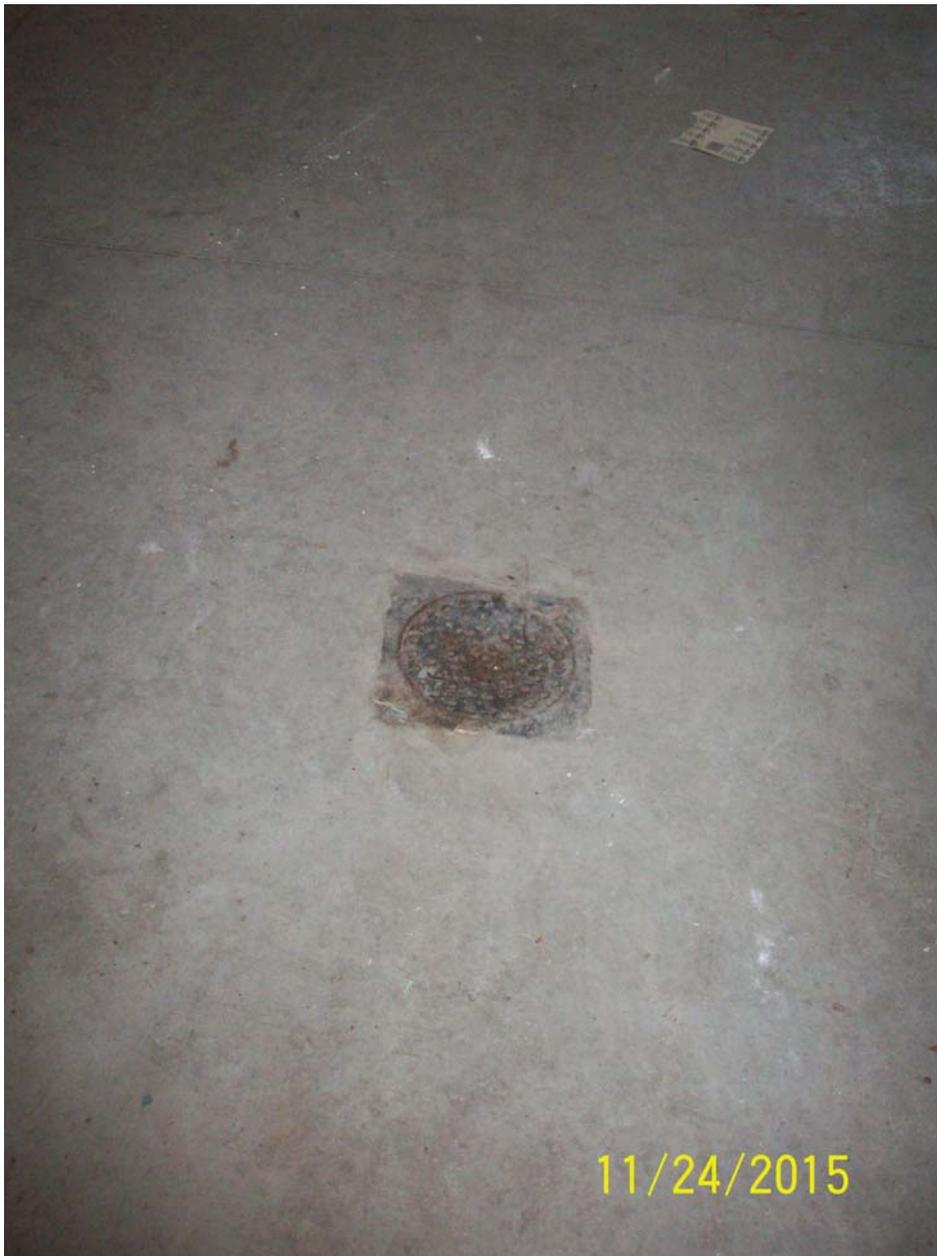
**Photograph 15.** Other drain in Shop floor (no stains).

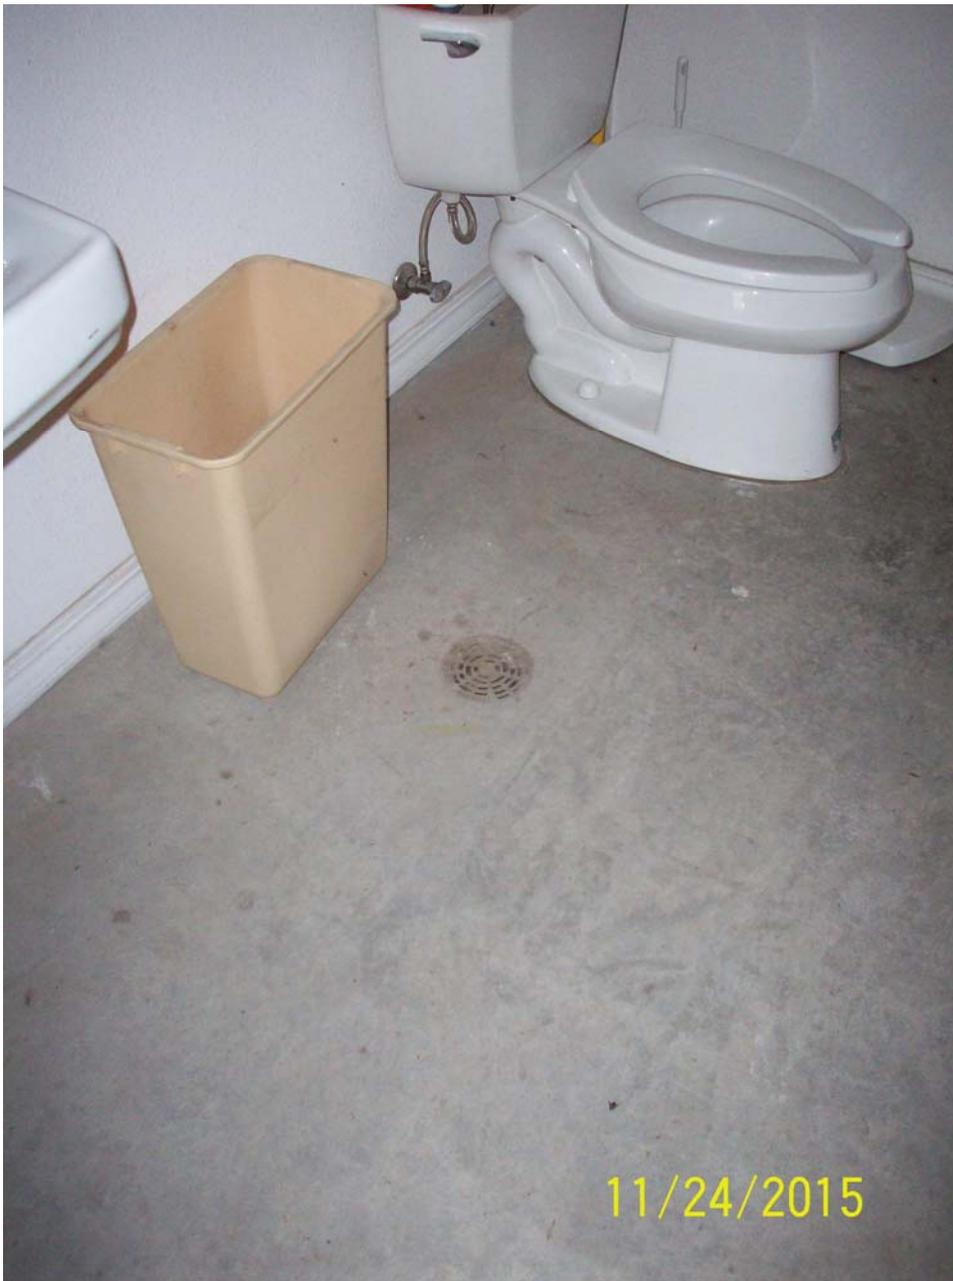
**Photograph 16.** Floor drain inside bathroom facility in Shop building.

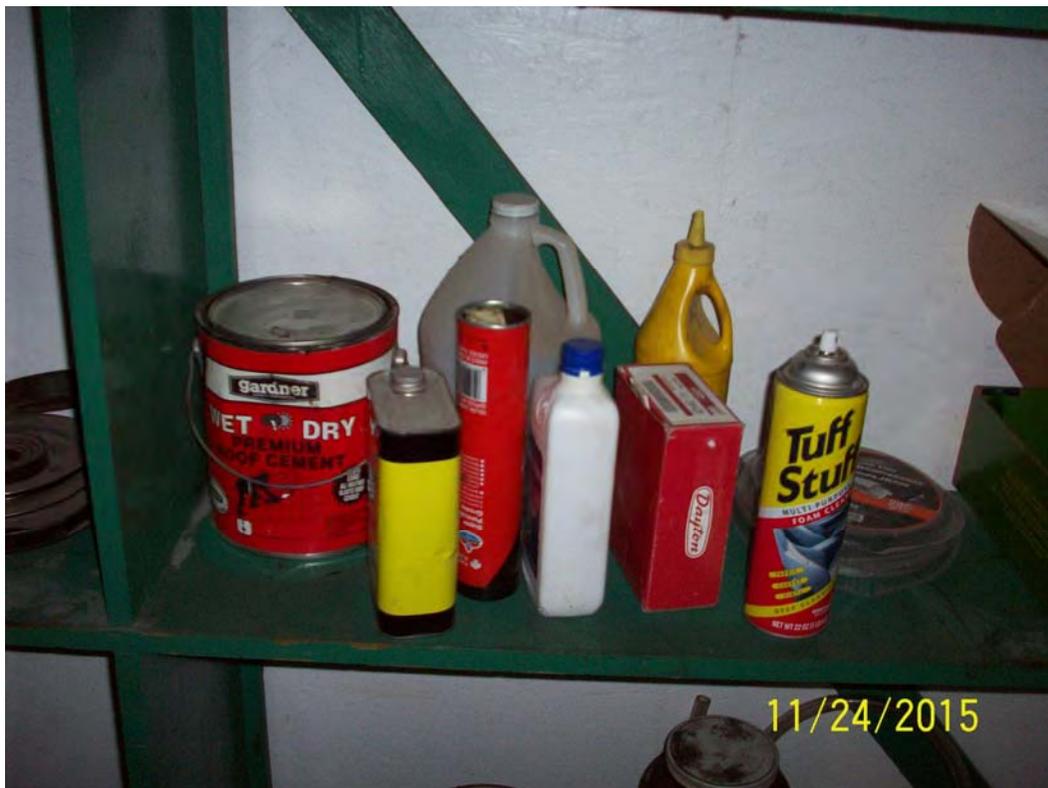
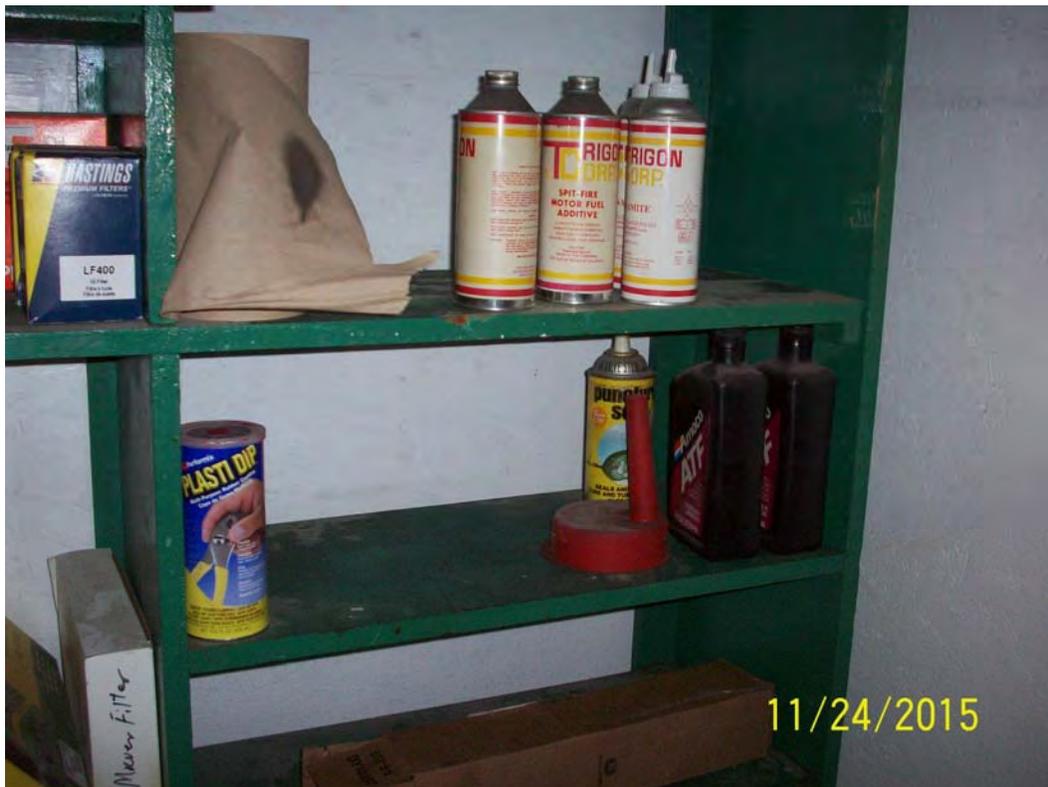
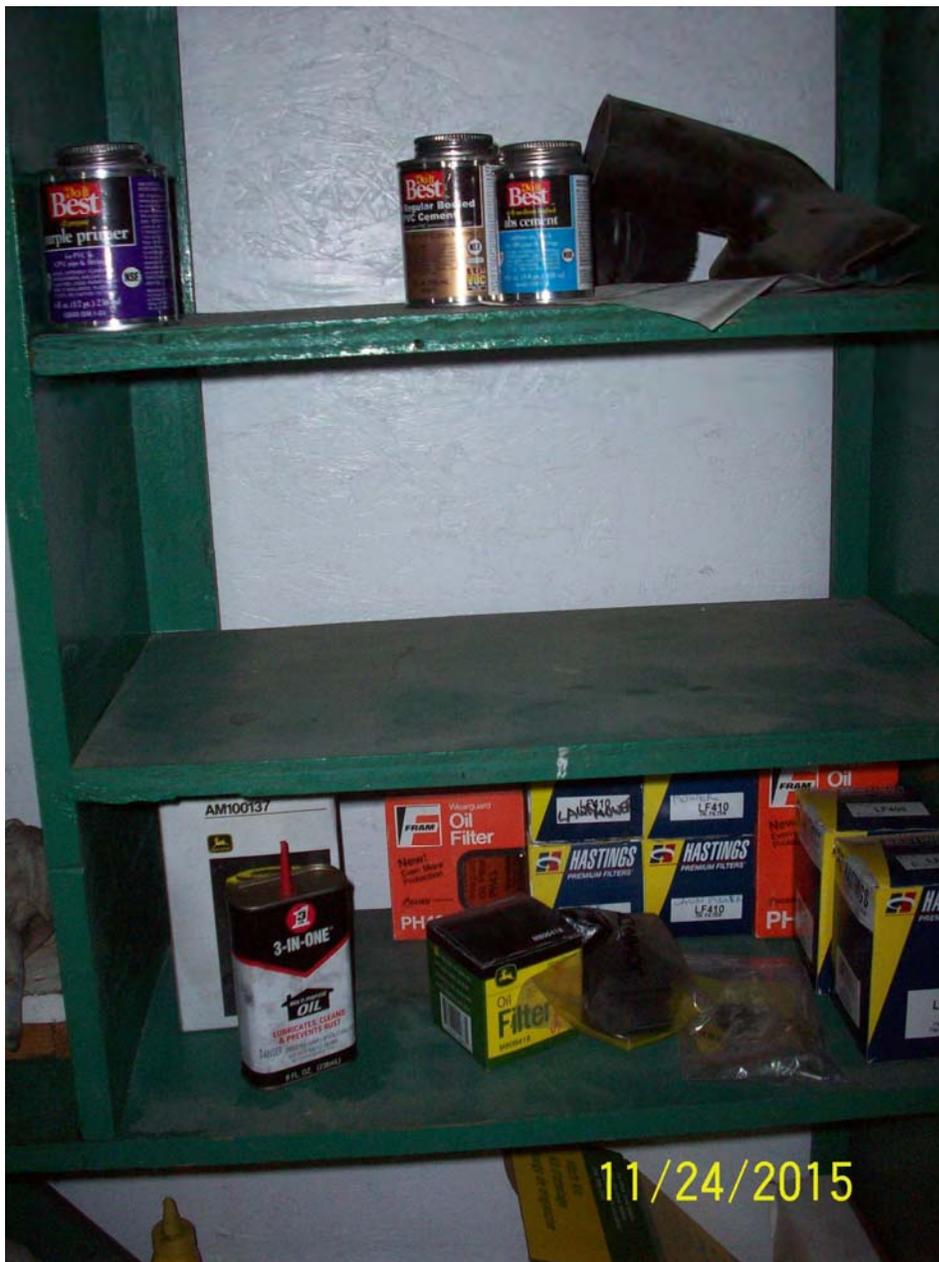
Photograph 17. Maintenance chemicals stored in the Shop building.

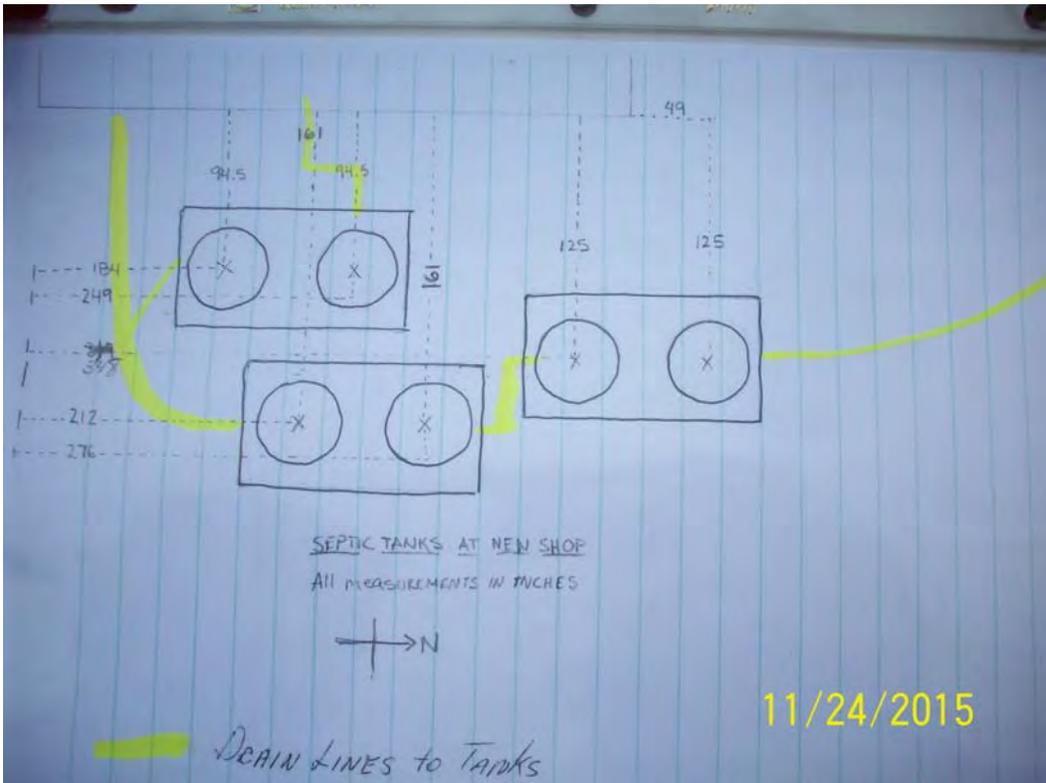
Three floor drains were located inside the shop building, one floor drain was present in the basement of the Old Residence, and one drain was located in the clean room of the Hatchery building. The drains inside the shop are connected to an oil/water separator tank buried outside of the east wall of the shop building. The floor drain in the basement of the Old Residence was used to accept water condensation collected from the adjacent forced air furnace. Current nonuse of the hatchery complex has resulted artesian conditions of the domestic well. The pressure created by the domestic well is relieved by allowing water to flow from pressure tanks to the basement floor drain. This was represented as a temporary condition. The floor drain in the clean room inside the Hatchery building was reportedly connected to the septic system used for the shop and New Residence.

**Photograph 21.** Schematic of location of oil/water separator and septic tanks located buried just east of Shop building. Oil/water separator was reported to be the top tank in the drawing.

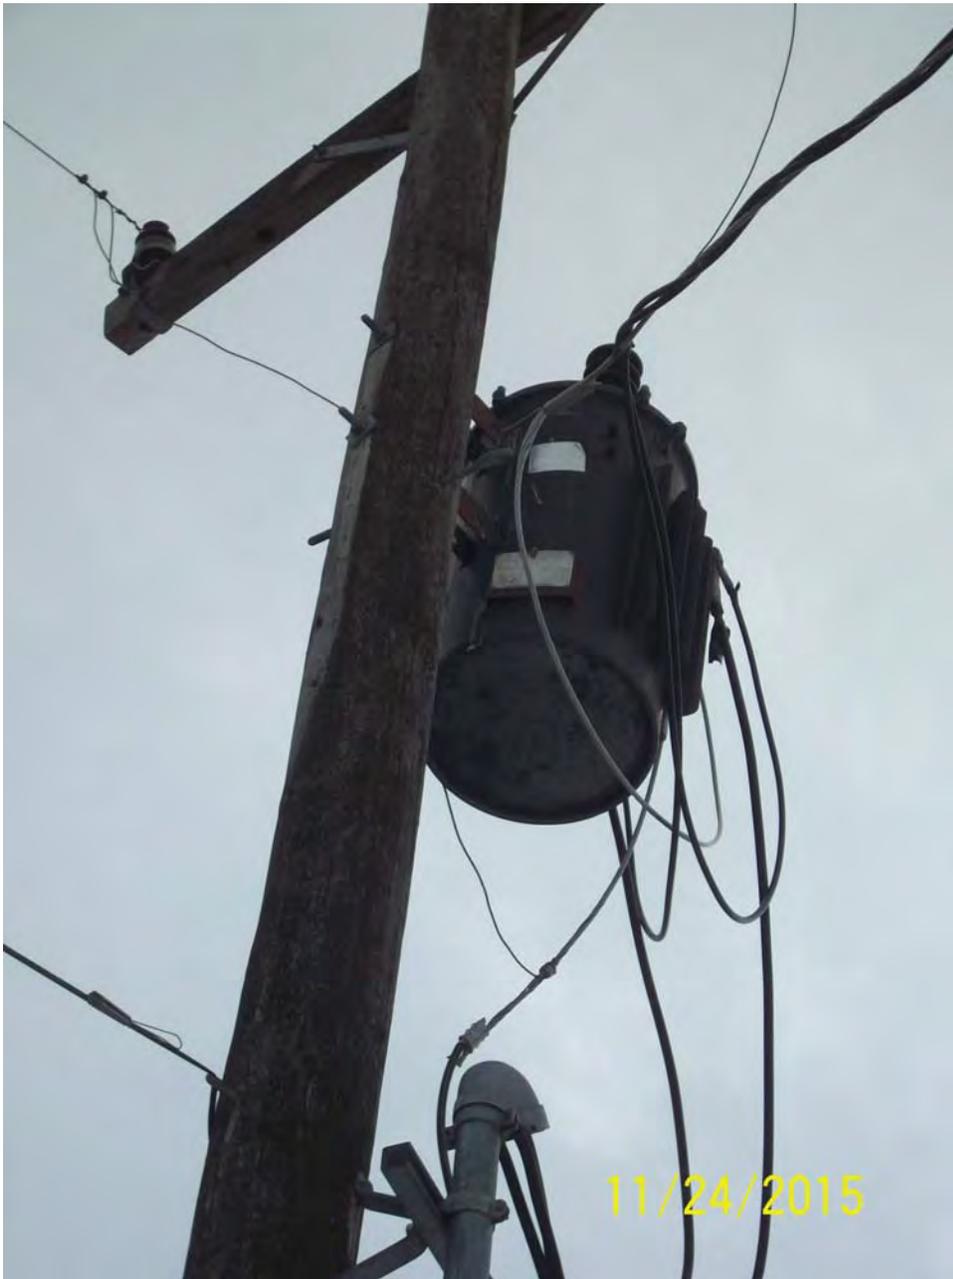
The area is supported by Rocky Mountain Power Company. Two pole-mounted electrical transformers supply electrical power to the Property and are located on the east and west side of the hatchery complex. The transformers did not appear to have NON-PCB labels but did not present visible signs of leakage.

**Photograph 23.** Transformer above Pump house.

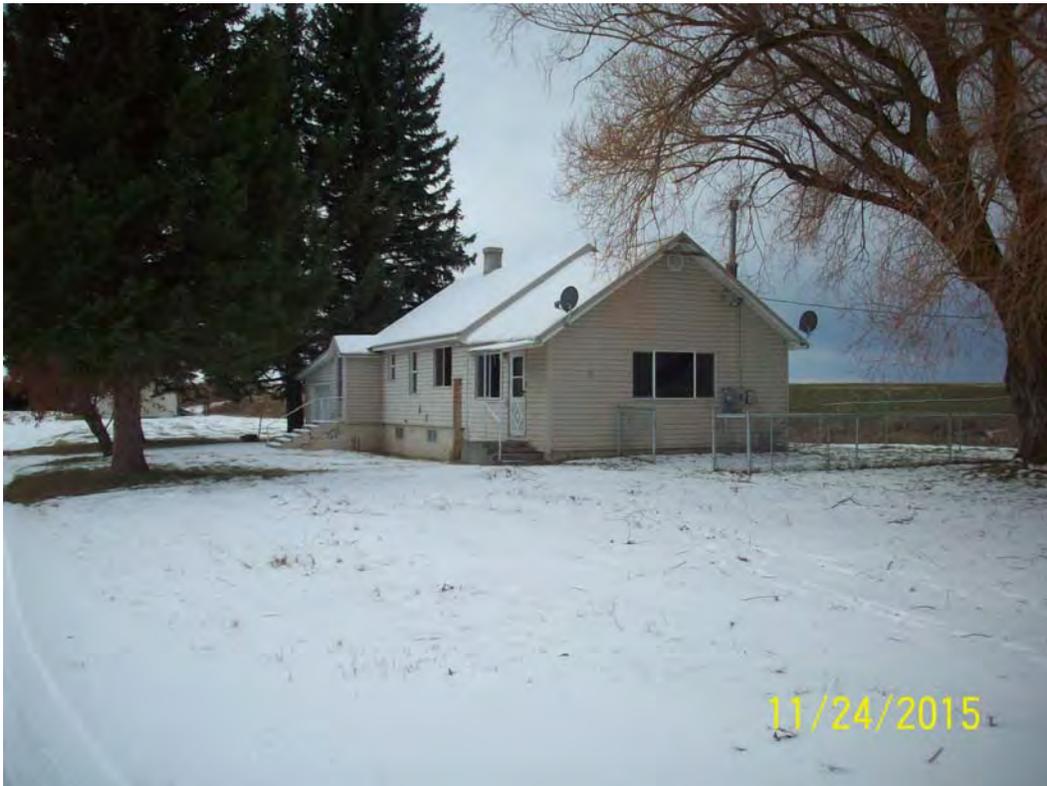
The “Old Residence” is a one-story residential dwelling on a concrete foundation with a basement. The dwelling consists of steel roofing and vinyl siding although from appearance inside the garage, it is likely that the vinyl siding covers an older painted clapboard siding. It has a one-car attached garage located on the south side. Located off the southwest corner of the garage is the sole drinking water domestic well for the hatchery complex. The septic drain field is located under lawn space located on the north side of the residence.

**Photograph 26.** Old Residence. Septic tank and drain field located in lawn areas of the foreground.

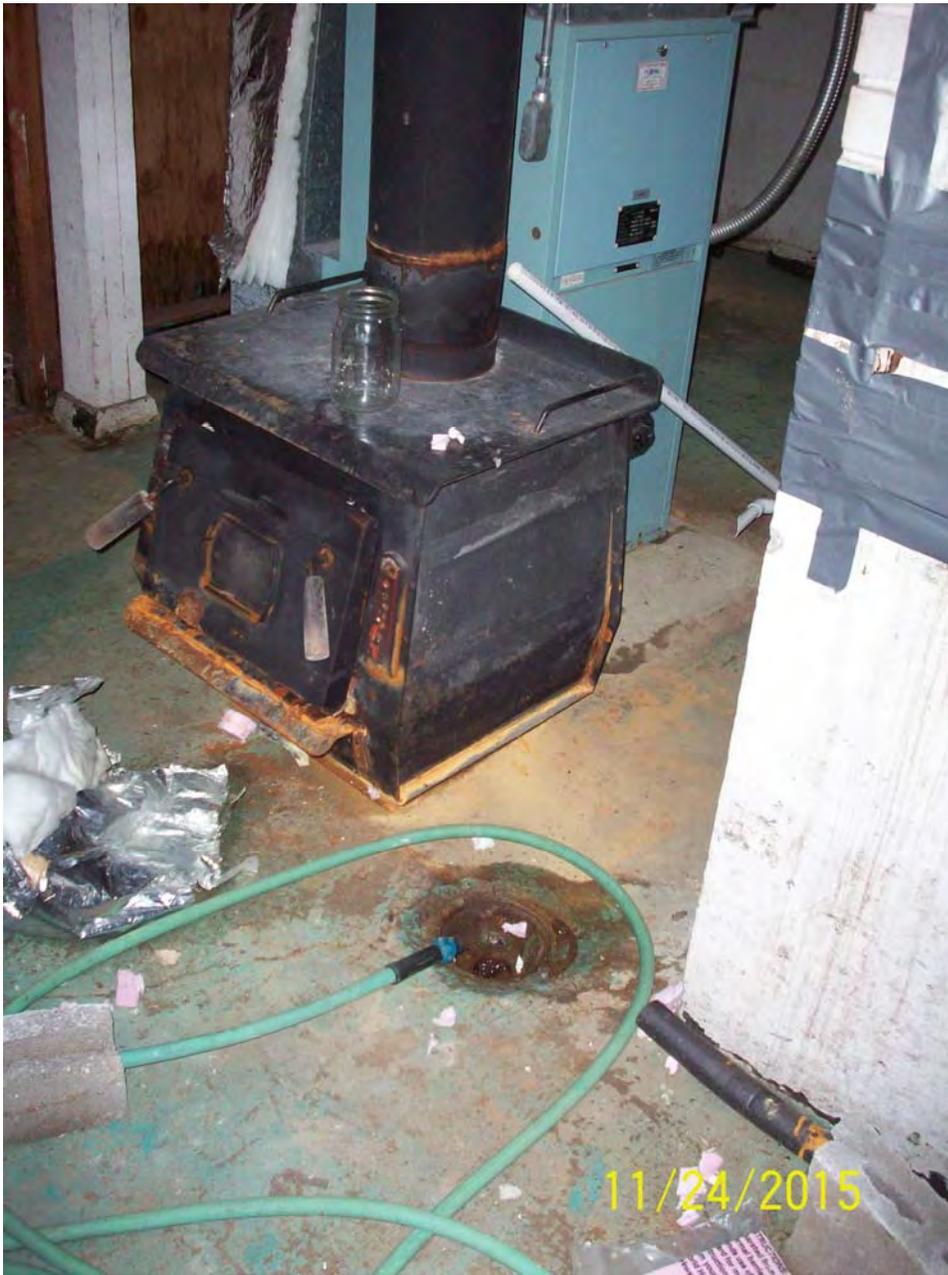
**Photograph 29.** Basement floor drain inside Old Residence. Electric forced-air furnace in background (blue) and old wood-fired fireplace.

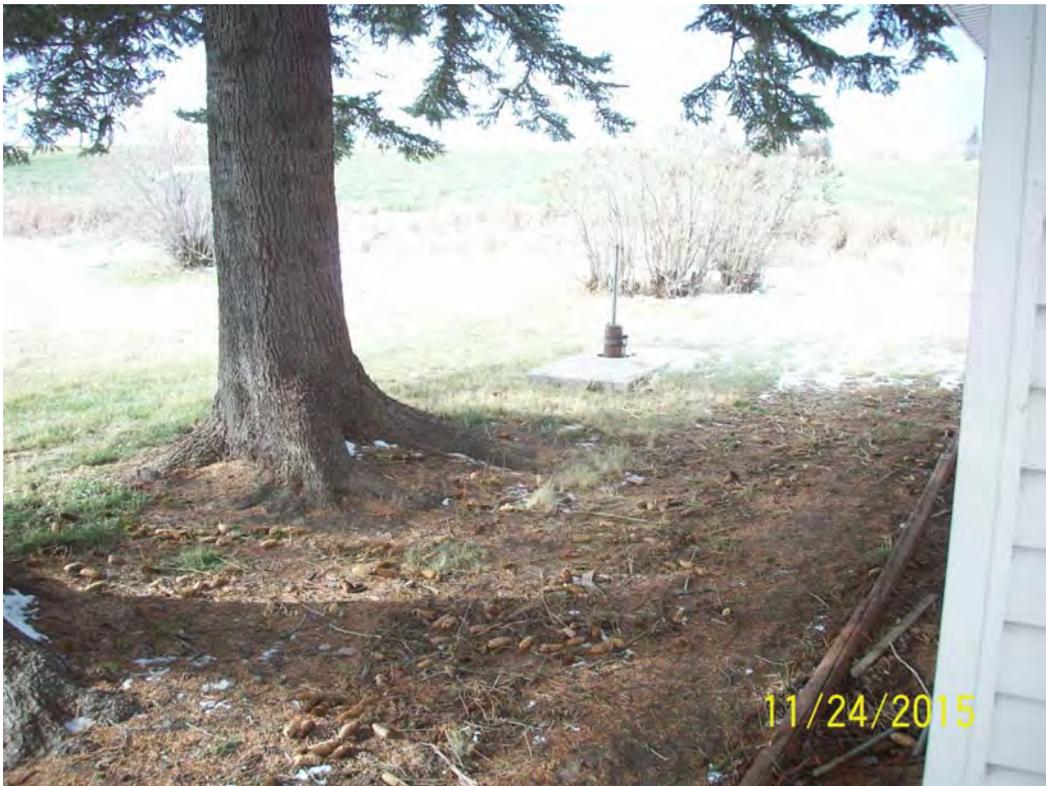
**Photograph 31.** View of domestic well that supplies drinking water for entire hatchery complex. The well is located at the southwest corner of the Old Residence.

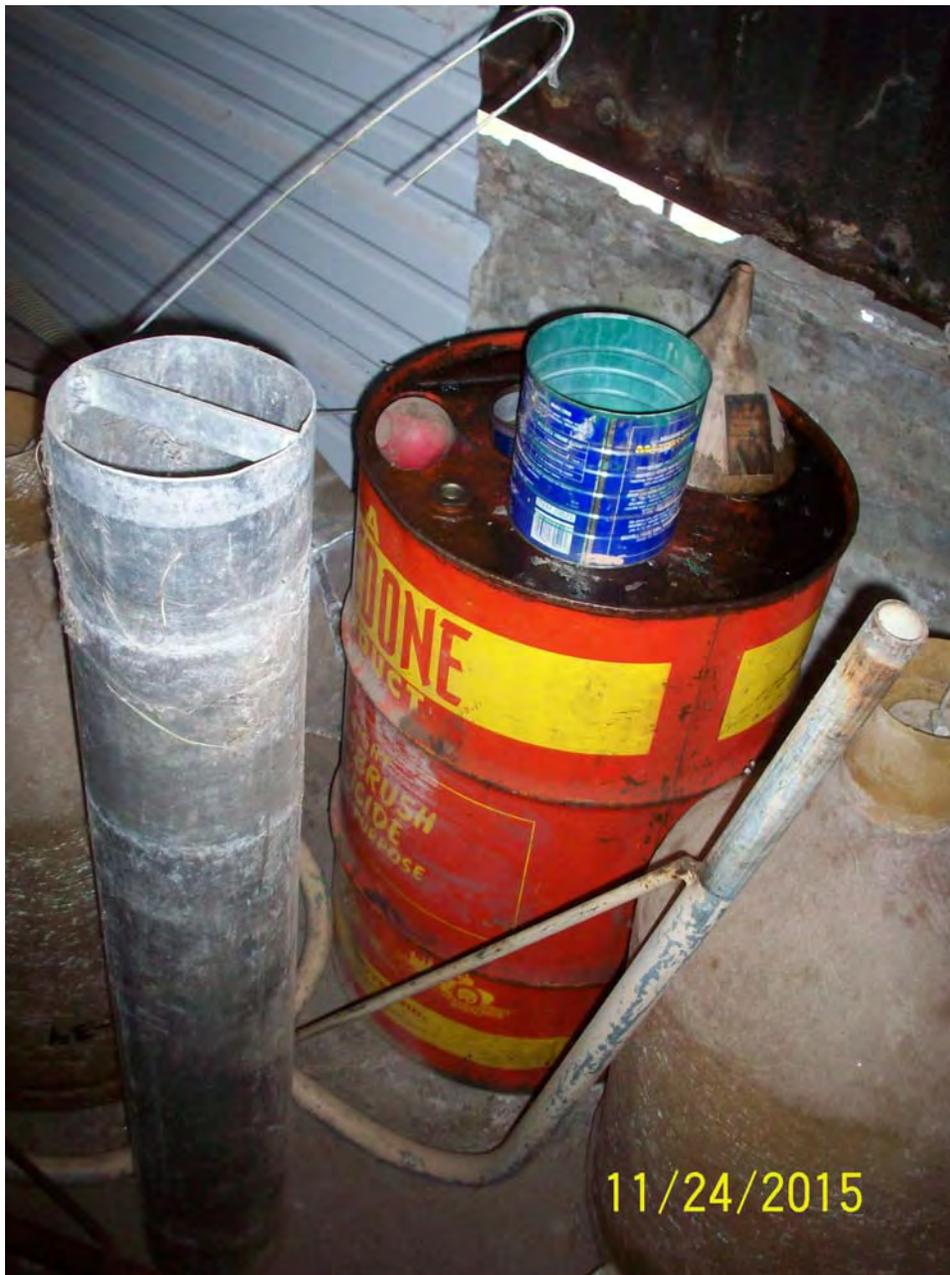
**Photograph 34.** Used motor oil storage drum located inside Steel Quonset Shed. Used oil was recycled offsite by contractor.

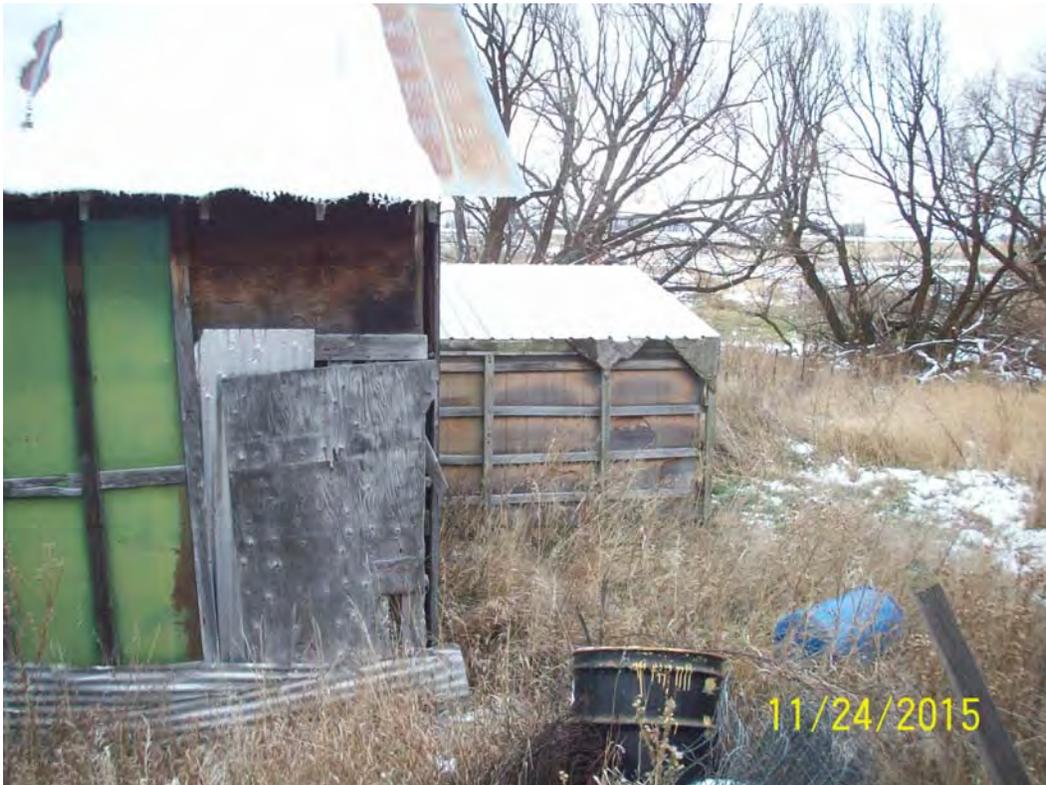
Empty steel and plastic 55-gallon drums were observed during the site visit located just west of the Hayshed. The drums were all empty and did not have any labels. There does not appear to be any risk associated with these drums. Another 40-gallon drum was observed inside and along the east wall of the Steel Quonset Shed. The drum was reportedly used for temporary storage of used motor oil for equipment maintenance. The used oil was reported to have been collected by a contractor and recycled offsite. The drum did not appear to present any significant risk to the Property.

**Photograph 38.** Looking east southeast at lean-to located behind Hayshed. Note steel and plastic drums in foreground.

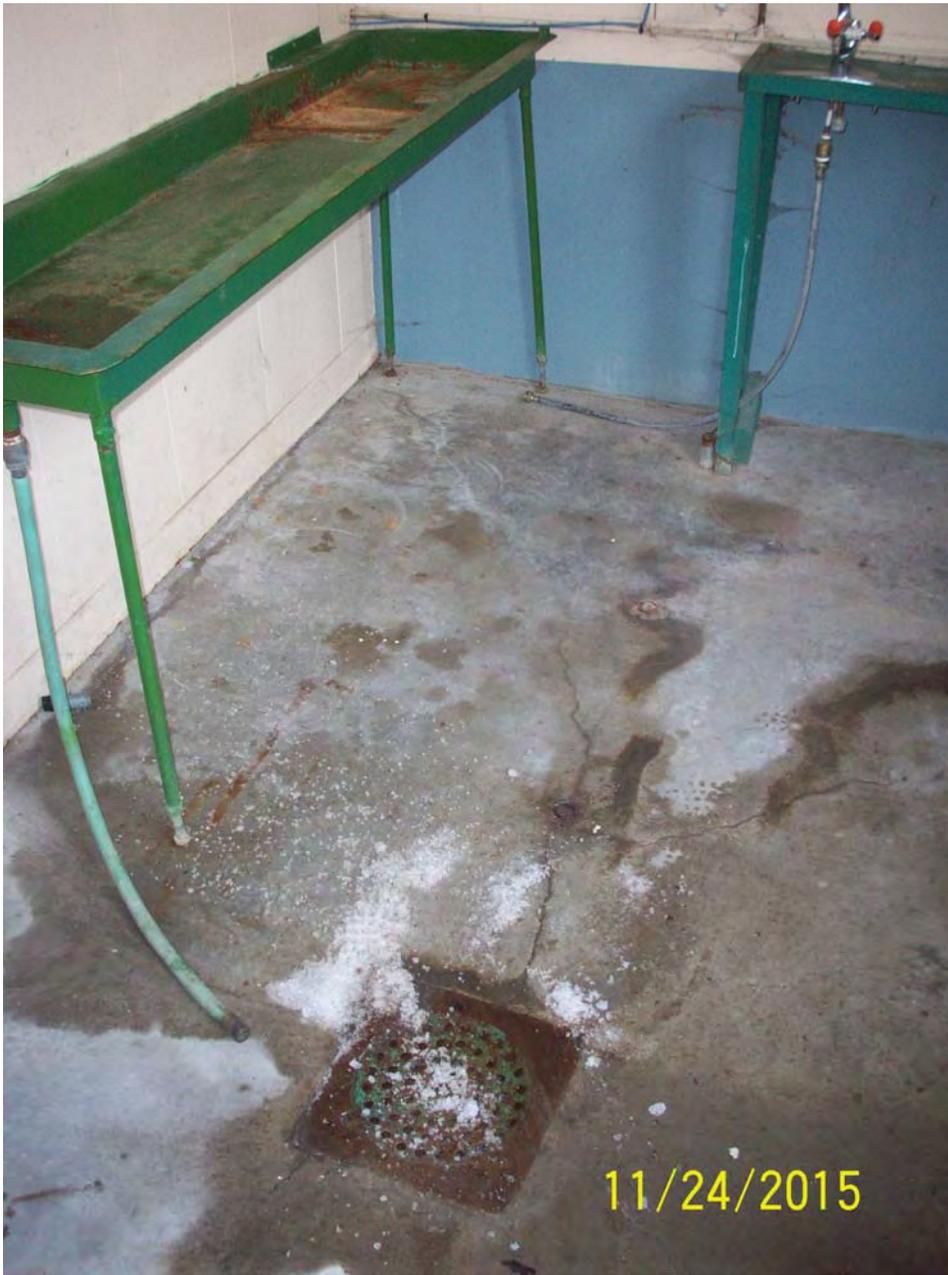
**Photograph 45.** Floor drain located in the clean room inside the Hatchery building.

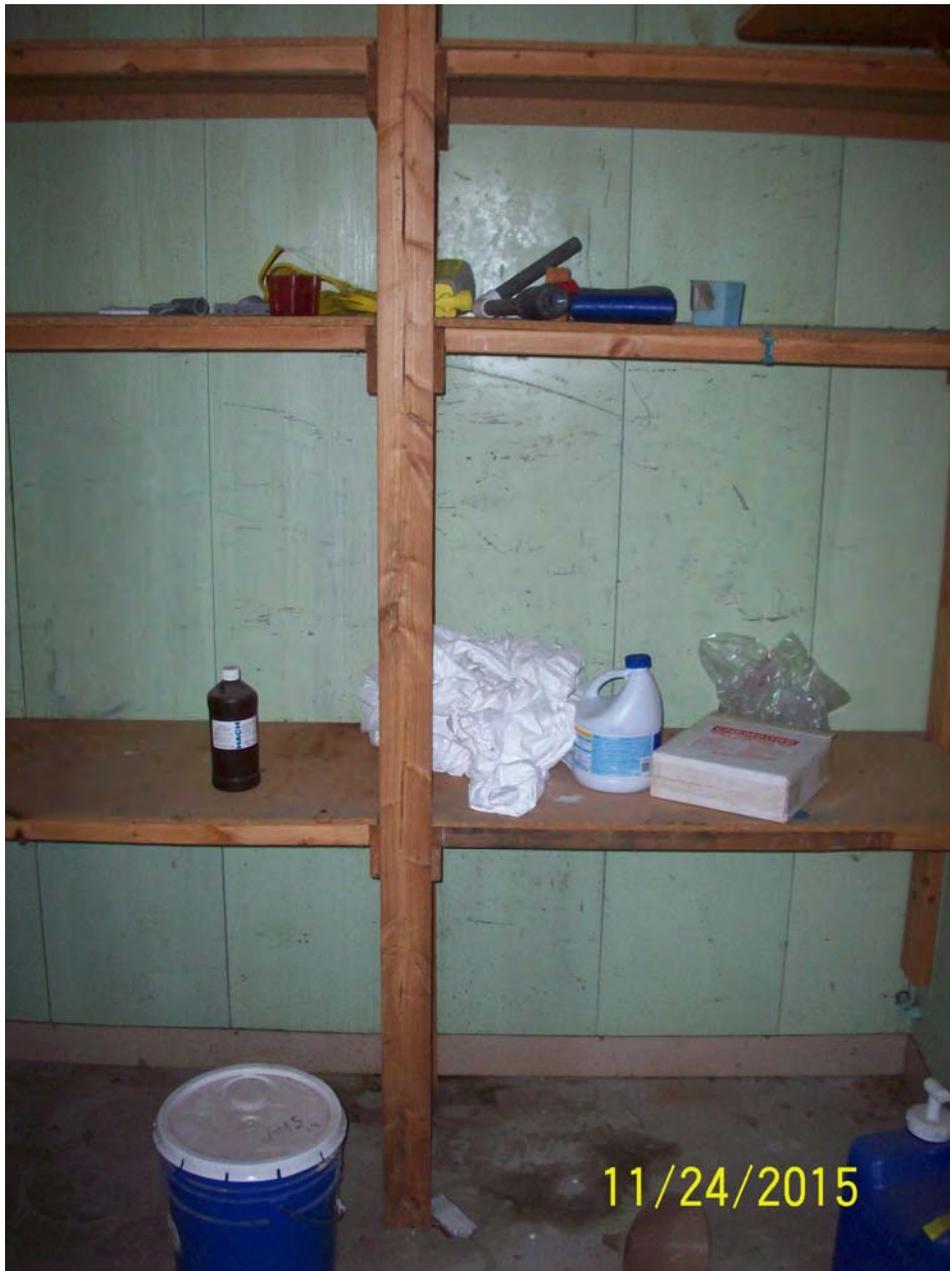
Besides common, albeit limited, household products found, there were empty 5-gallon plastic containers of Formalin that were identified in the chemical storage room located just south of the bathrooms in the hatchery building. Chemicals reportedly stored included both salt and chlorine in a dry crystalline form, Formalin, Sodium Thiosulfate, and buffered iodine.

**Photograph 51.** Shelving inside Chemical storage area.

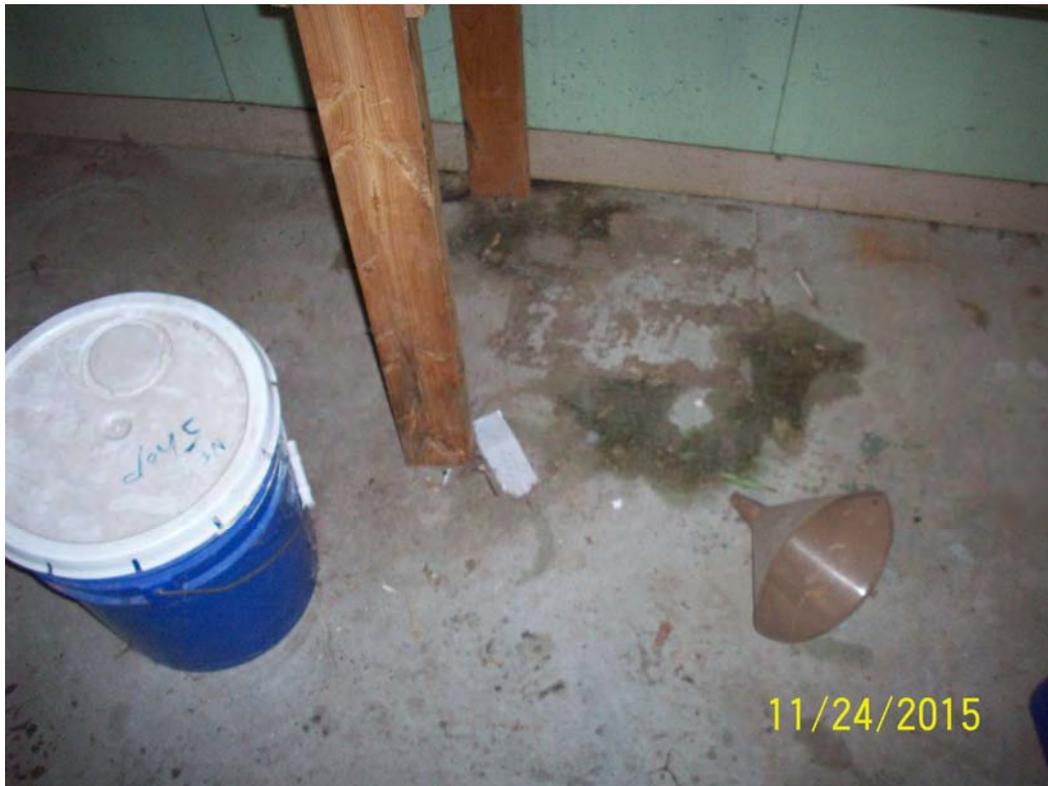
**Photograph 52.** Minor staining below shelves in the chemical storage area inside the Hatchery building.

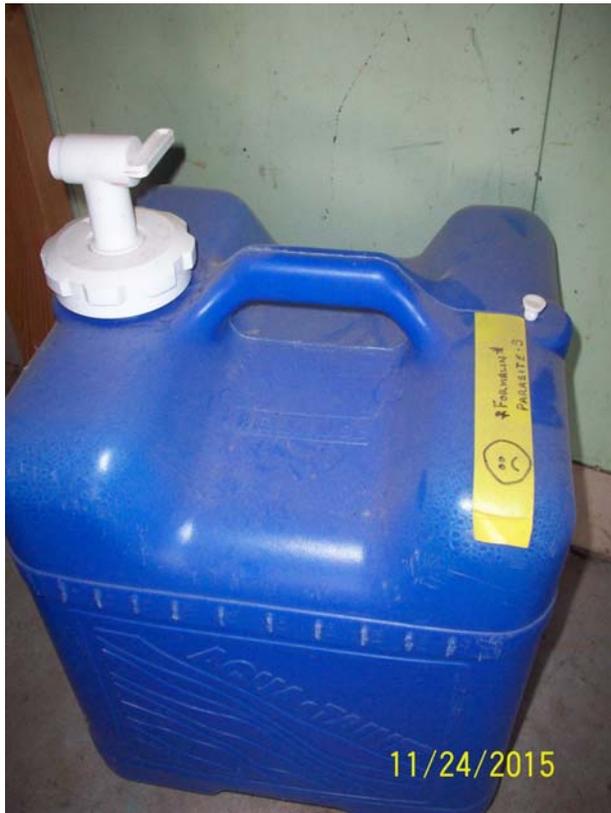
**Photograph 53.** Old container used for storing Formalin.
