Public Trust Program Inspection Report

Summary of Findings:			
<p>The applicant appears to have 25' of frontage based on property pins at the site. The footprint of proposed encroachments appears to provide a 10' set back from the east shared littoral line as projected from assumed upland property line stakes. The footprint of the proposed encroachments does not appear to provide a 10' set back from the west shared littoral line.</p>			
Attachments:			
Sitemap Photos			
Inspector's Signature:

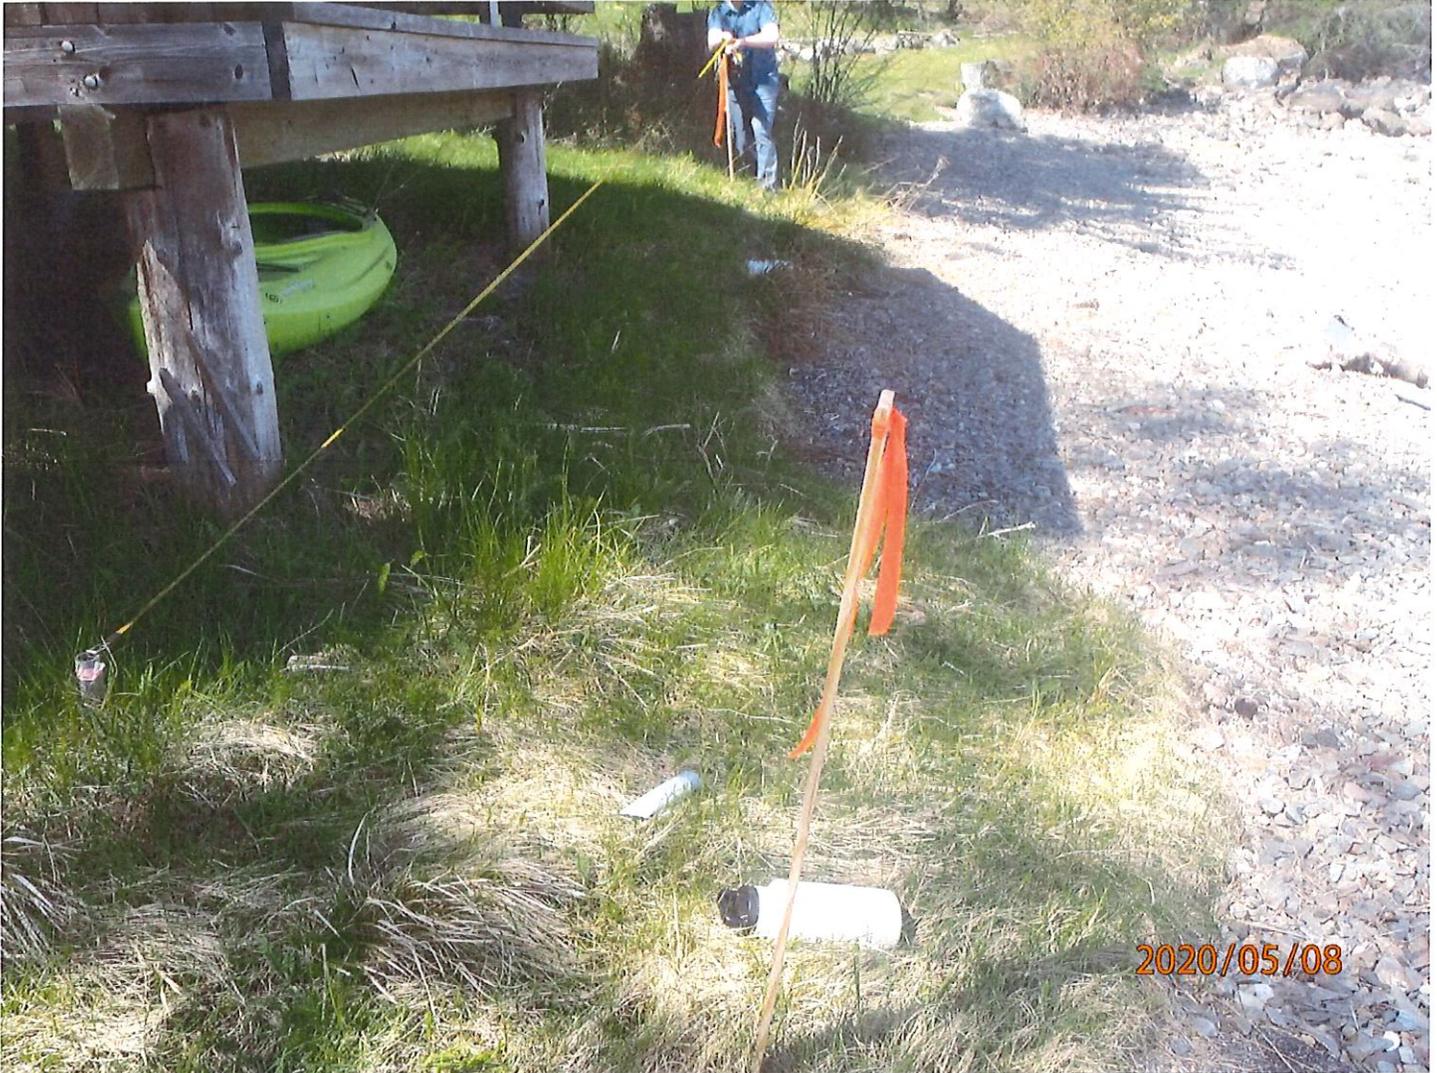
Measuring the applicant's frontage

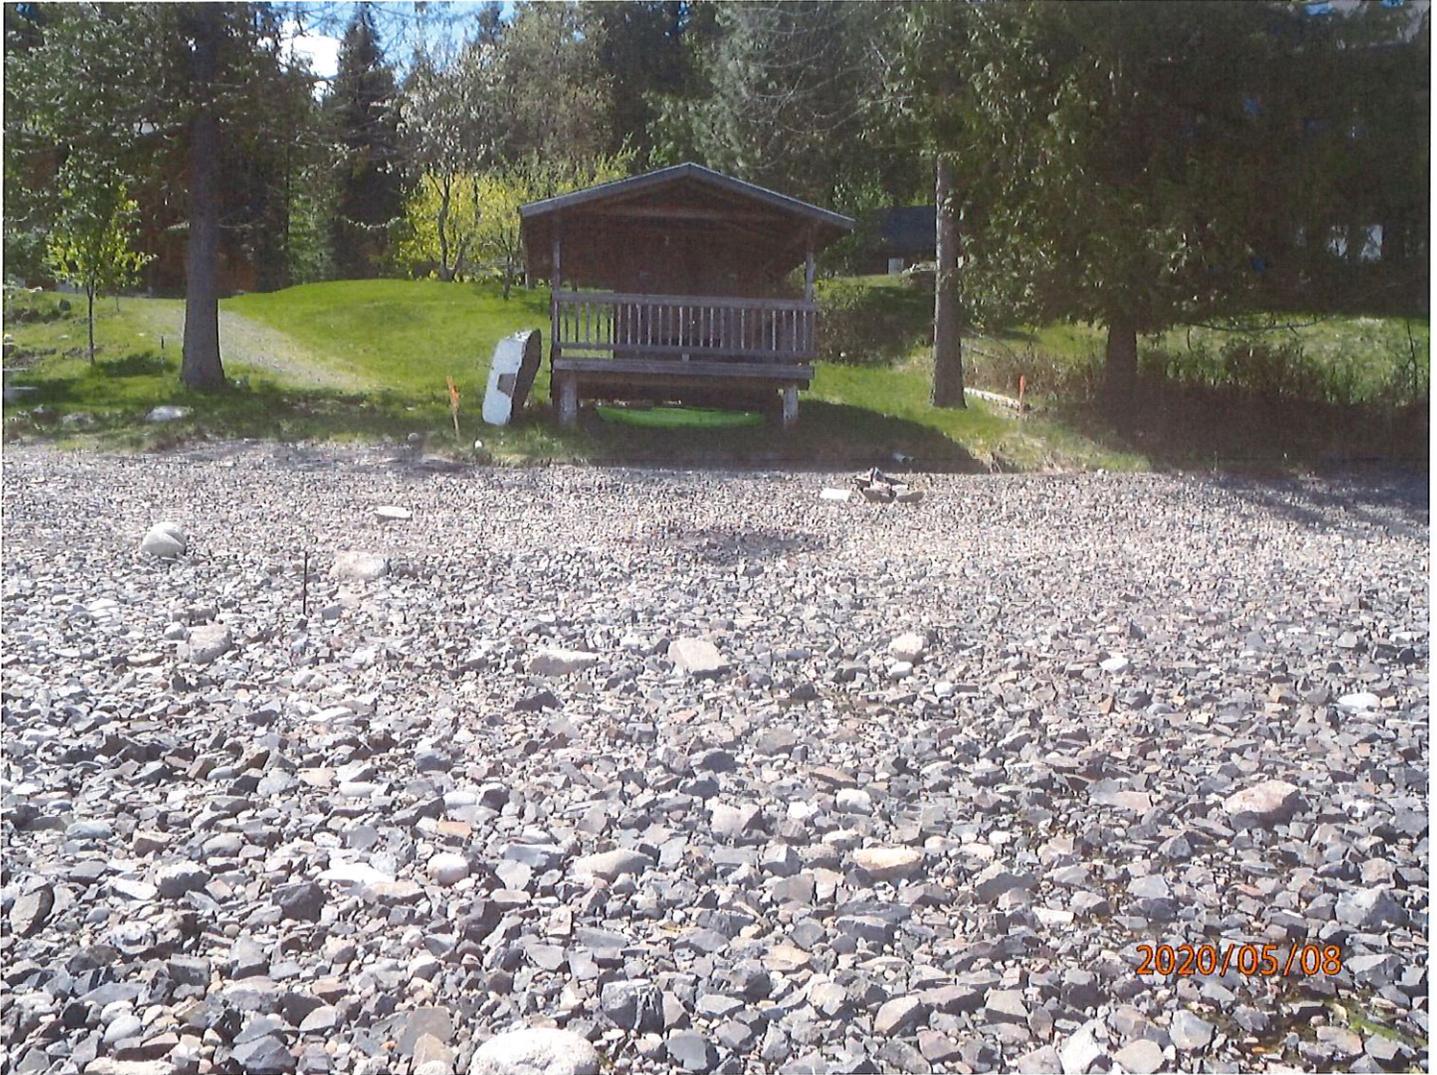
Standing at the current water level of Lake Pend Oreille looking towards the applicant's frontage

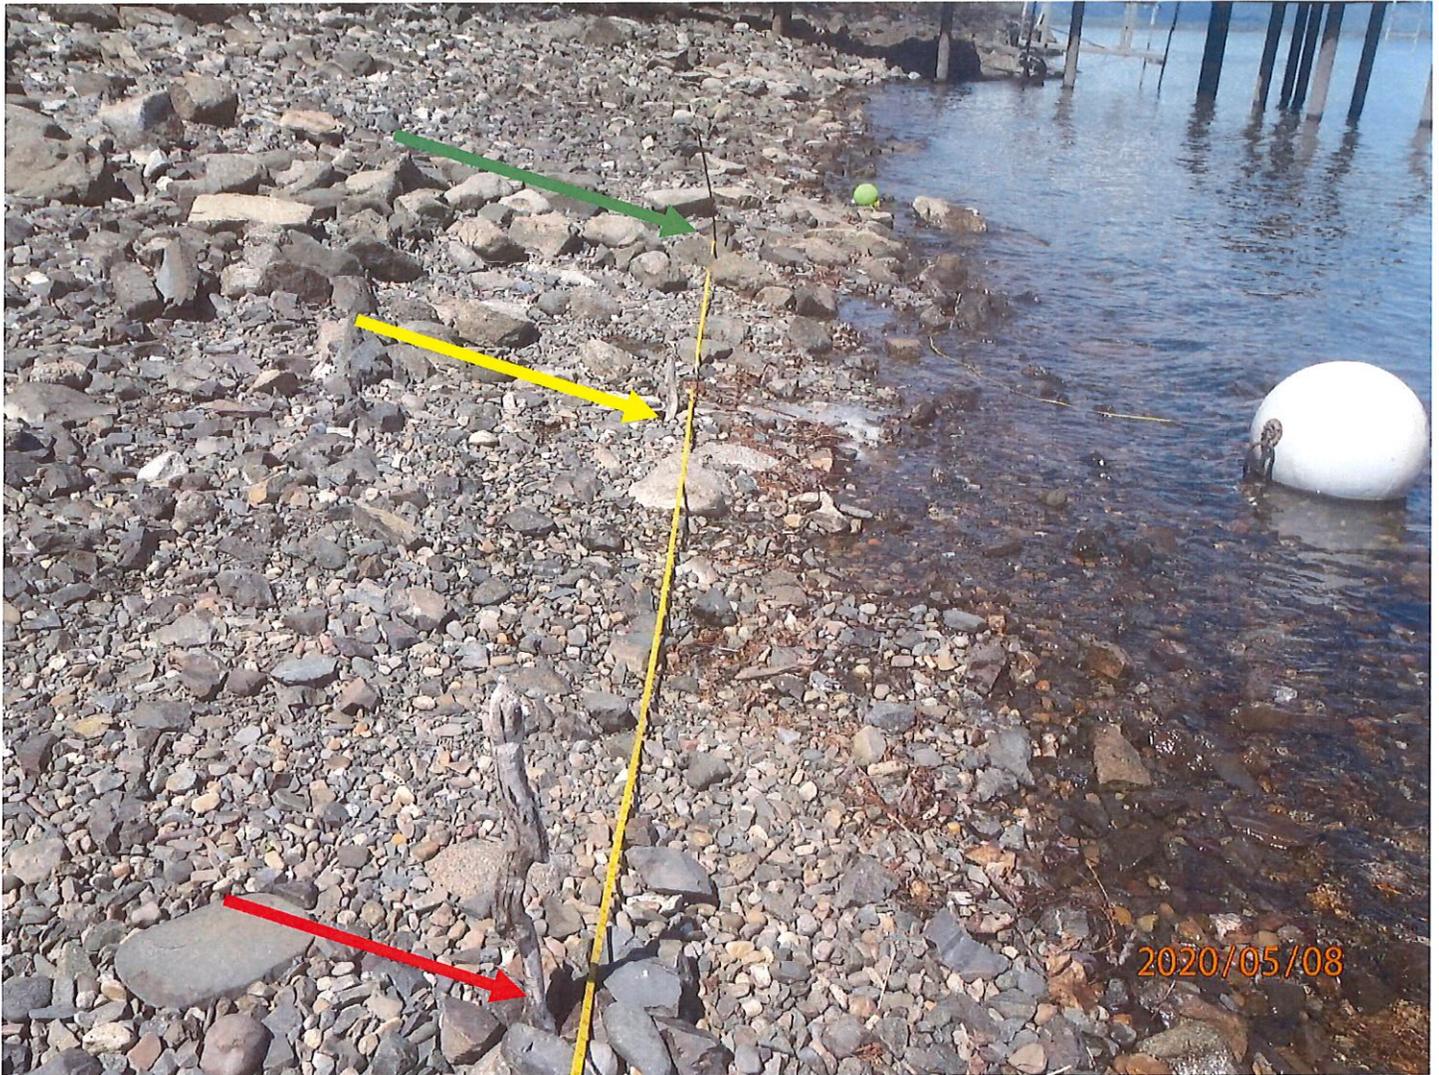
Measuring the **western edge of the dock**, **western edge of the boat lift**, and a **10'** distance west of the **boat lift**

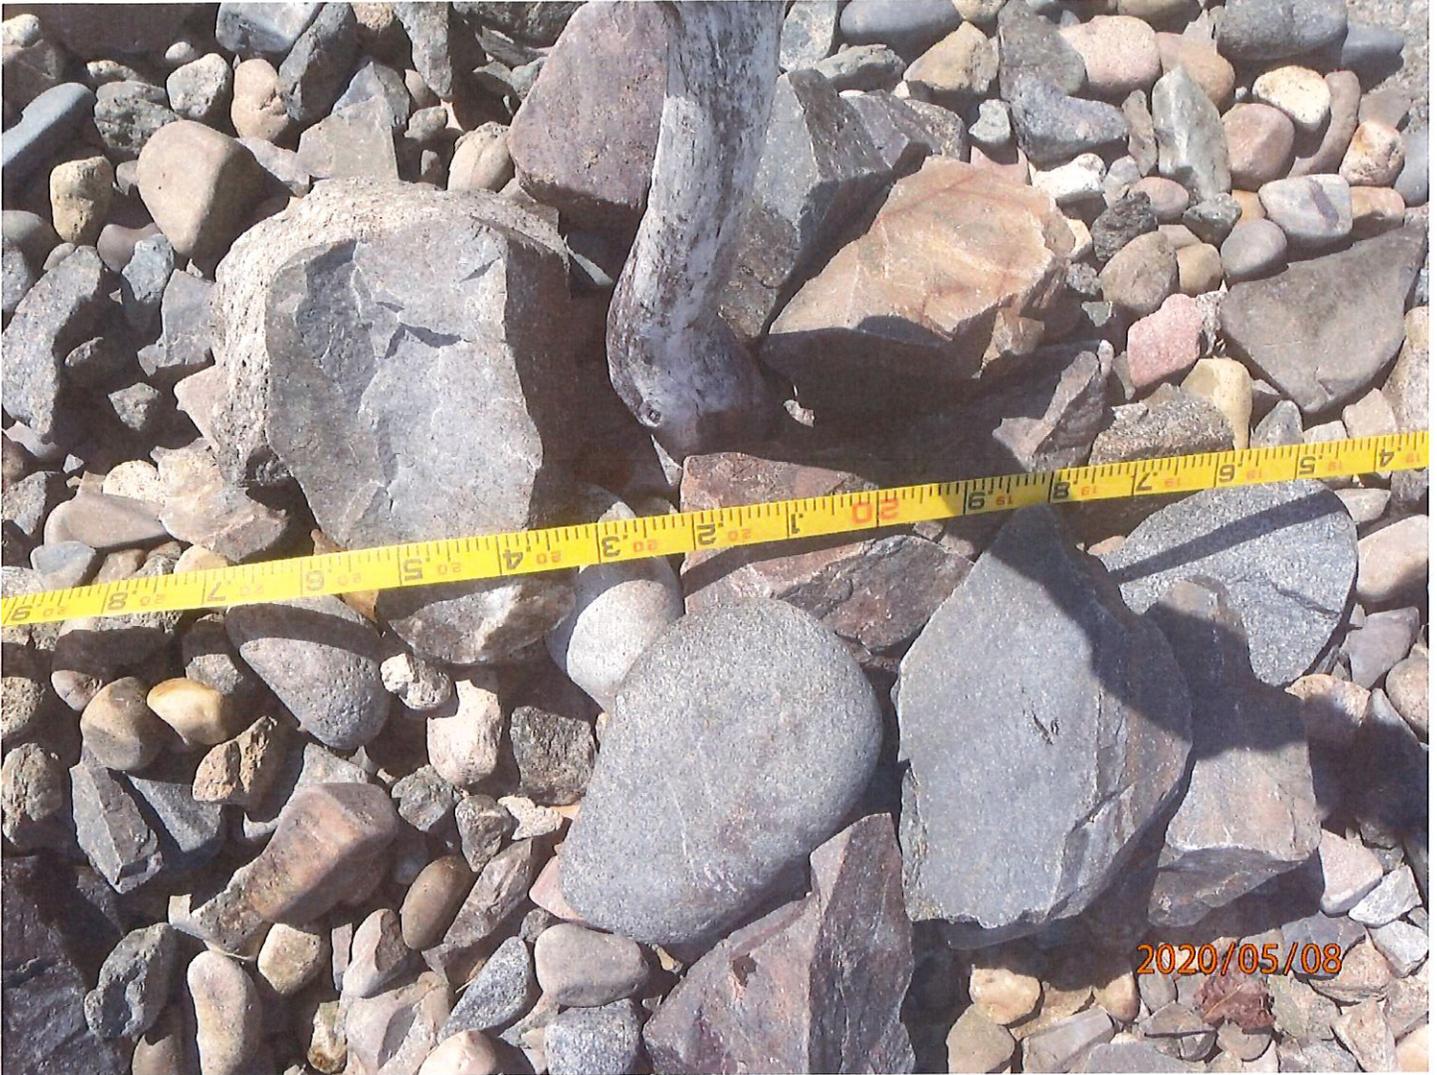
Point representing western edge of the dock

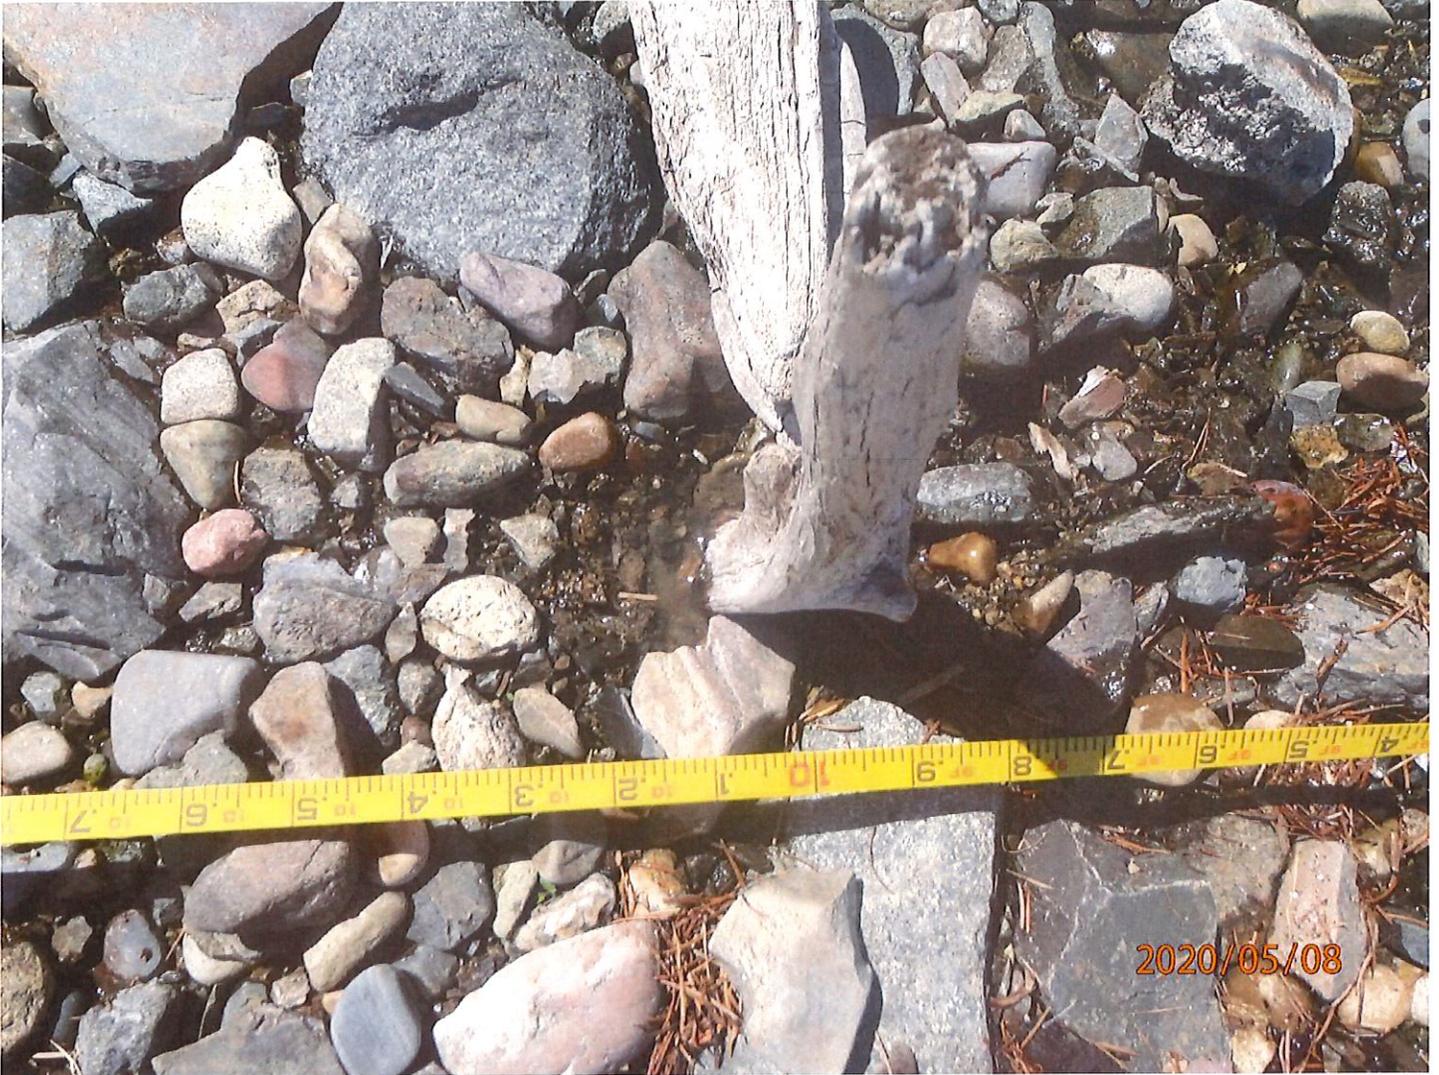
Point representing western edge of the boat lift

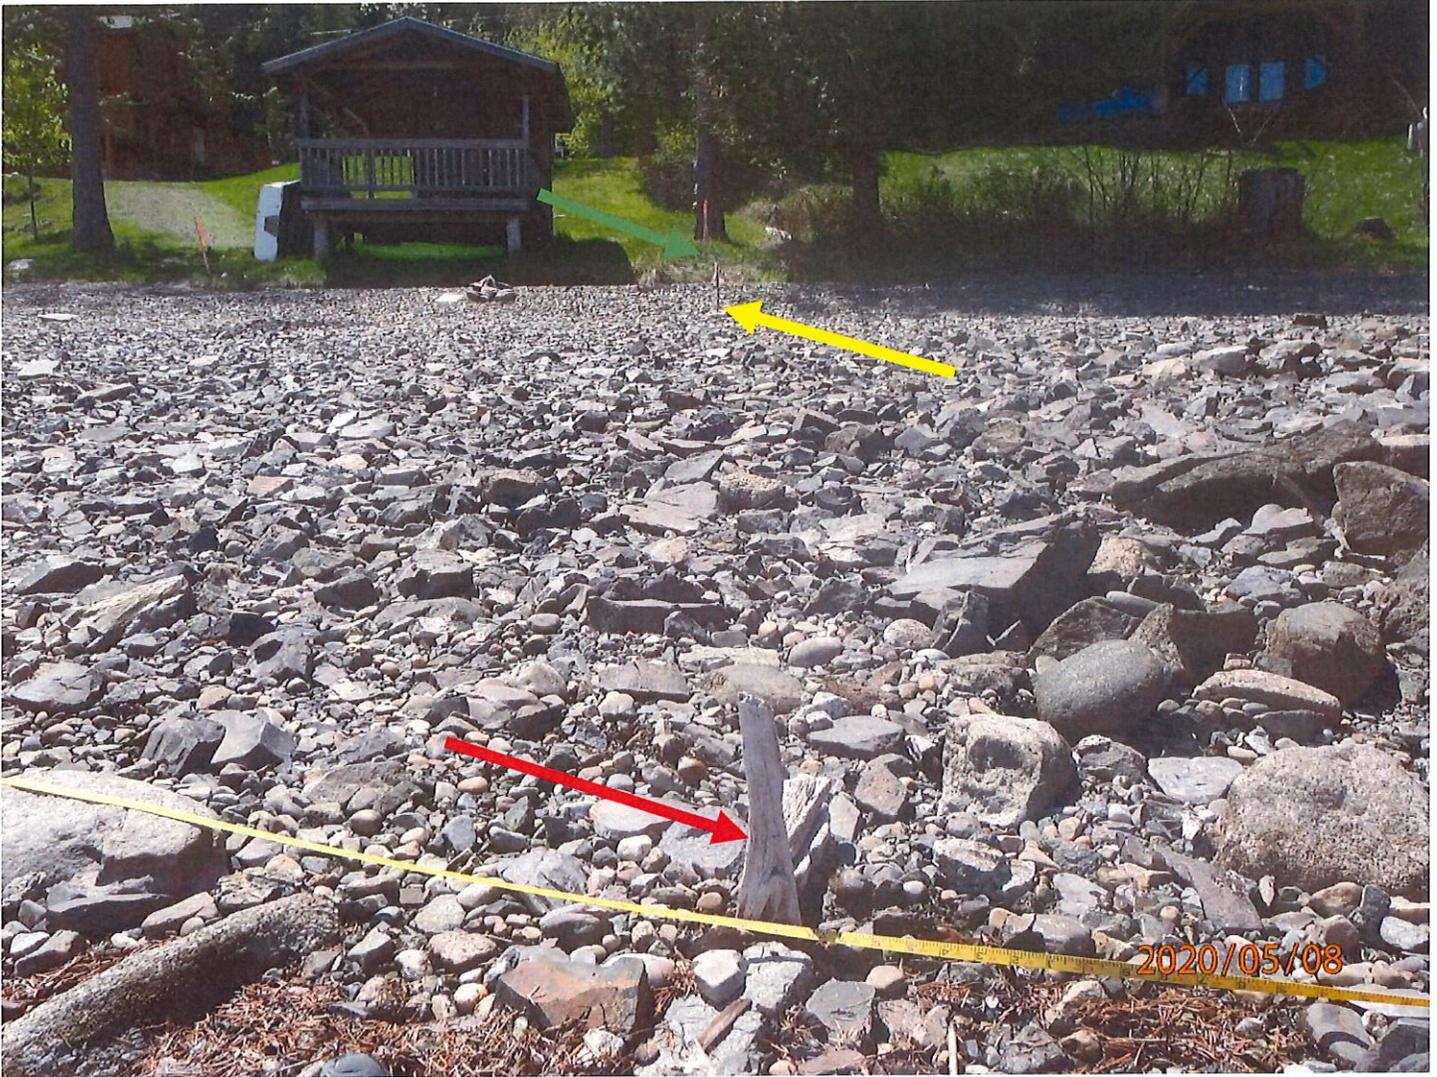
Point representing **west edge of lift** in the foreground with **point representing projected littoral line** and **property stake** in background

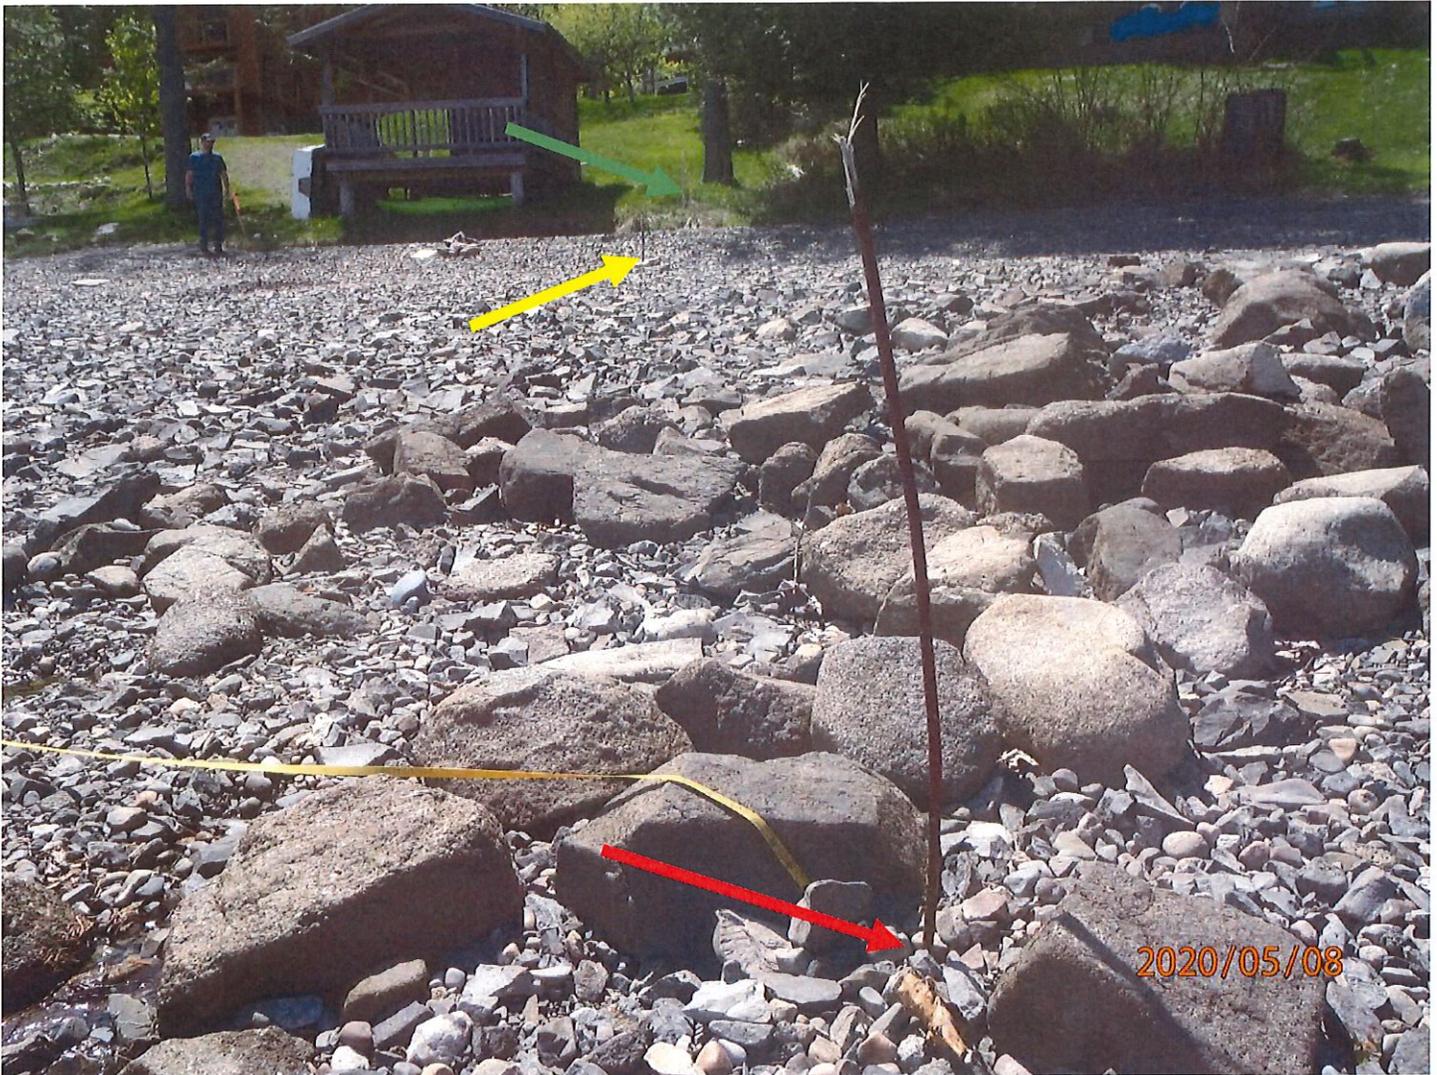
Point representing 10' distance from west edge of boat lift in foreground and point representing projected littoral line and property stake in background

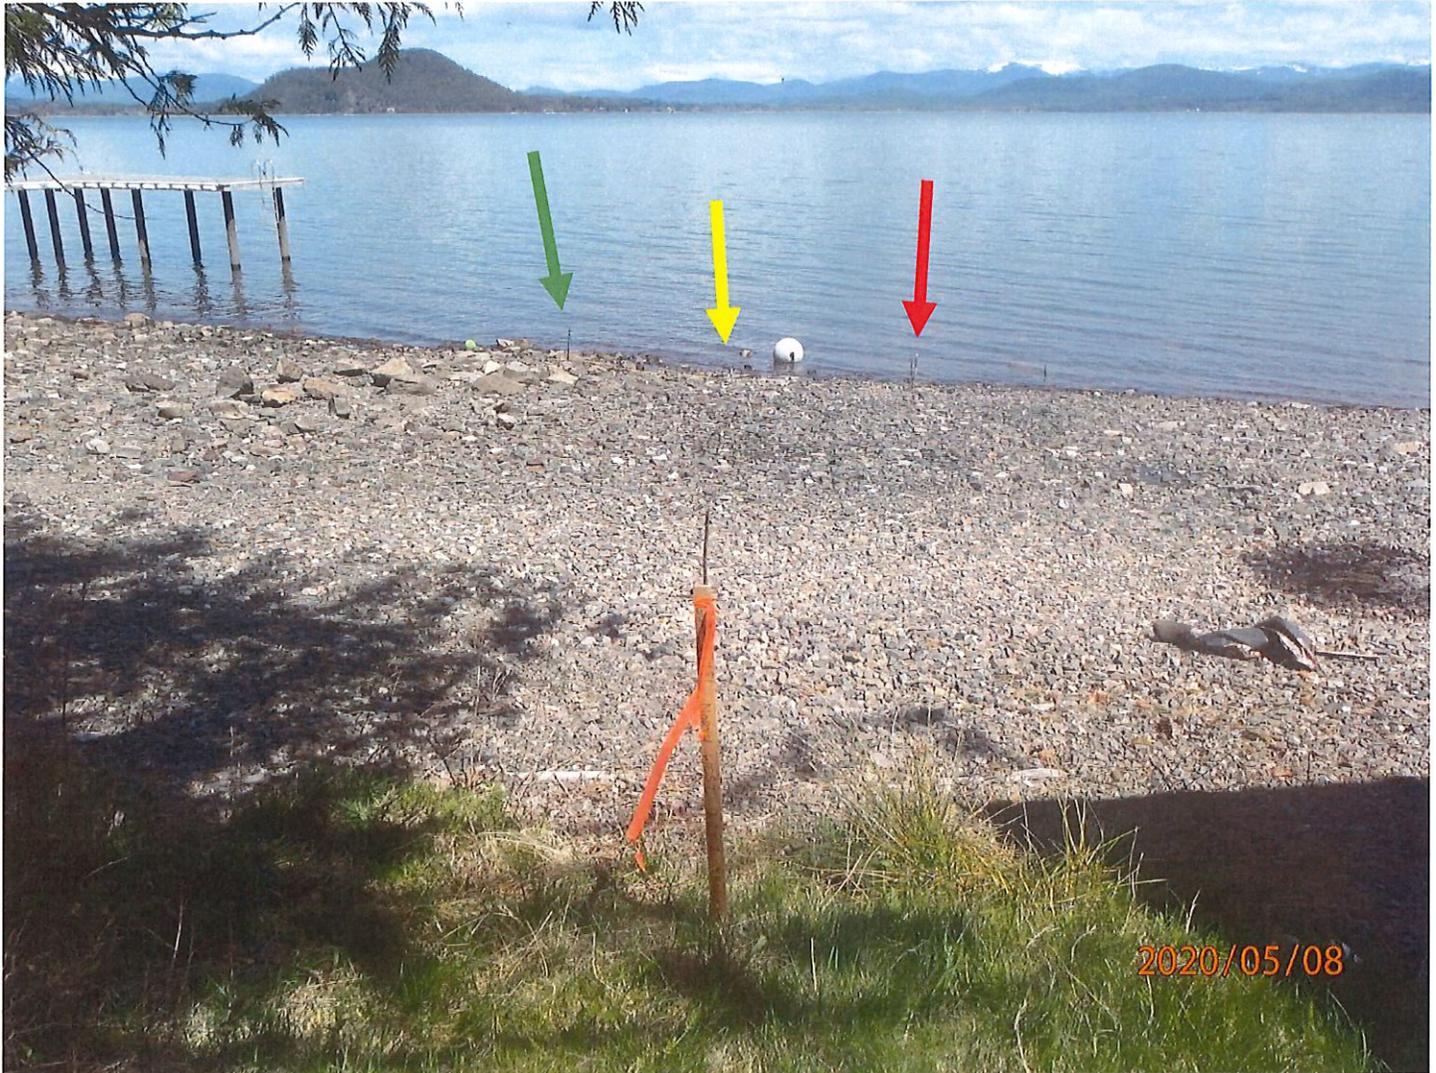
Standing on west property line looking lakeward along littoral line at **point representing west edge of dock**, **west edge of boat lift**, and **10' distance from west edge of boat lift**

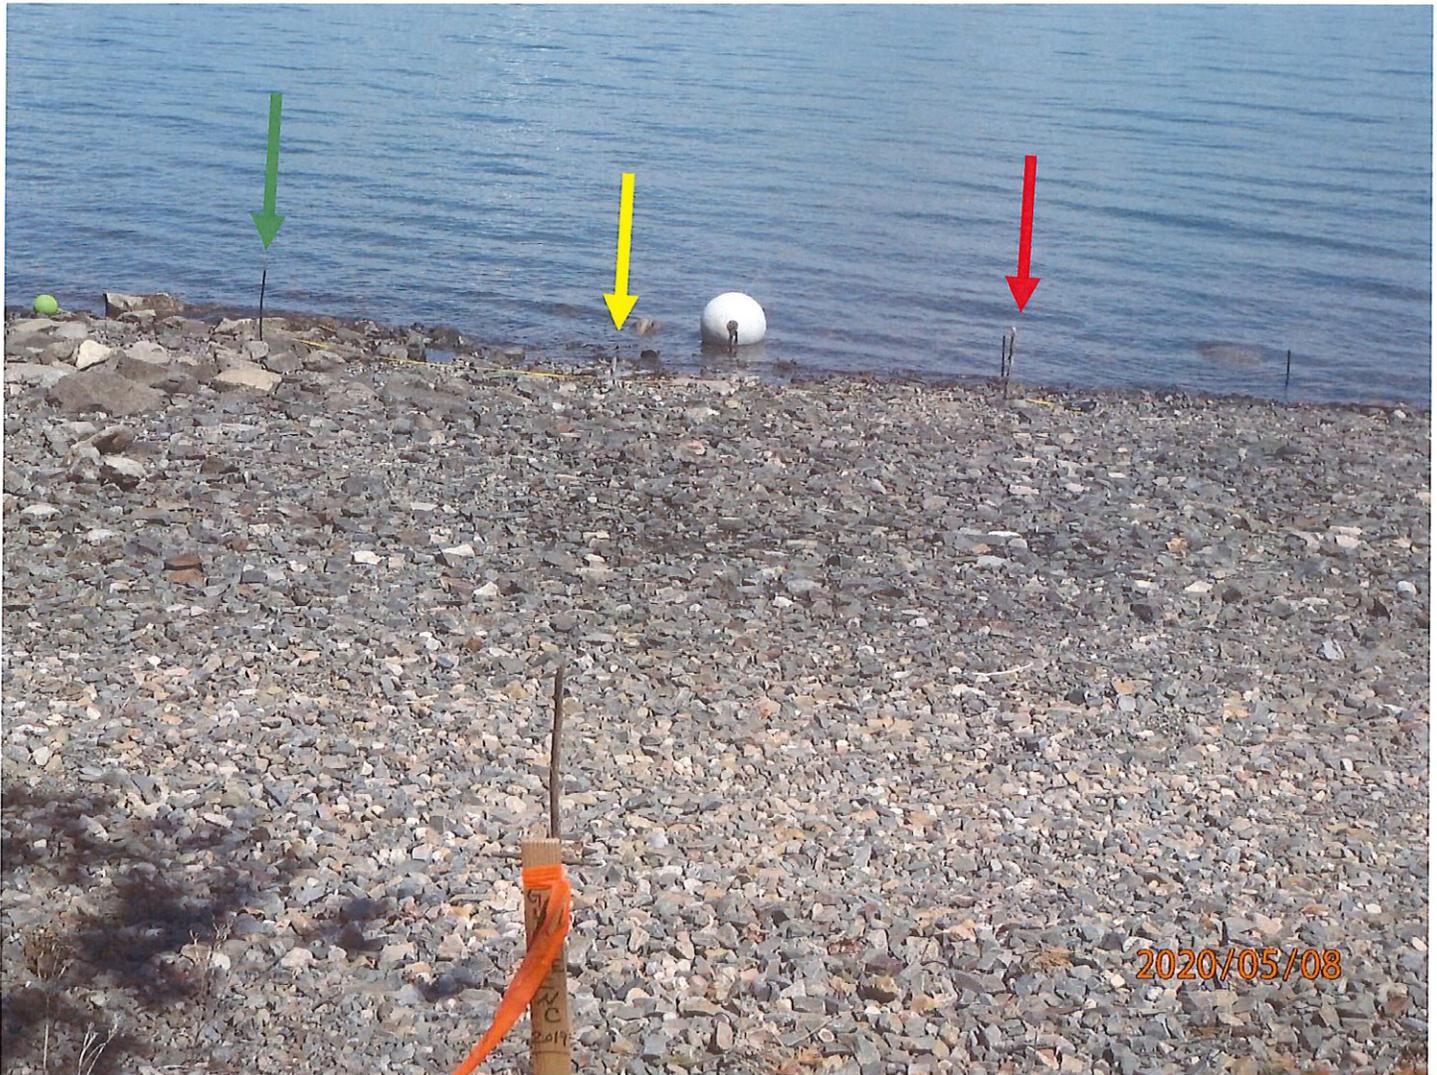
Standing on west property line looking lakeward along littoral line at **point representing west edge of dock**, **west edge of boat lift**, and **10' distance from west edge of boat lift**
