# **Idaho 2020 Interagency Forest Practices Water Quality Audit**

**State of Idaho  
Department of Environmental Quality  
December 2020**

## **2020 Forest Practices Audit Team:**

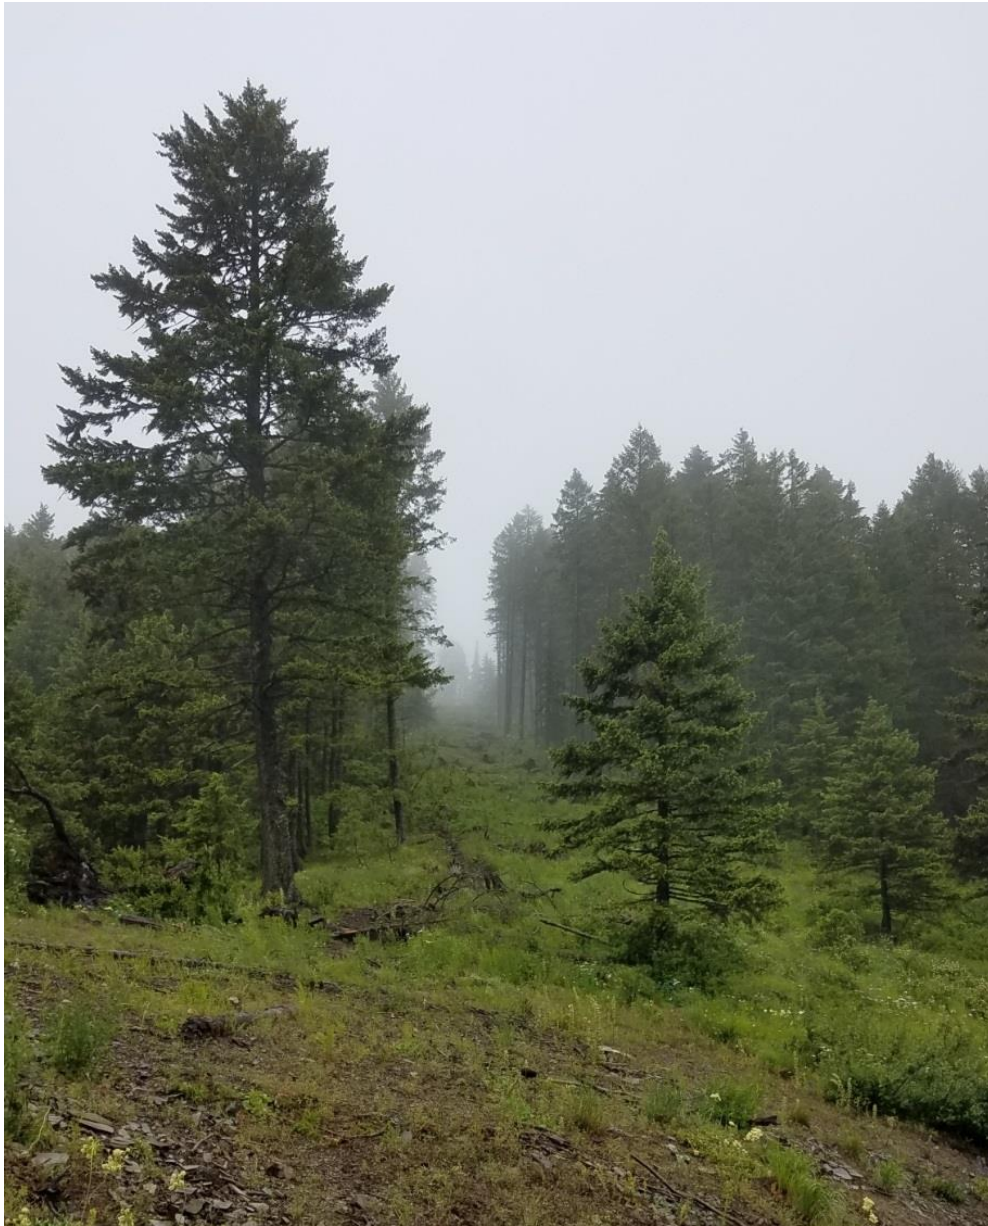
Figure 12. Revegetated skid trail in Heavy Equipment Fire Task Force sale

On the sale we inspected, a fireline had been cut along the top of a ridge. The trees removed had been decked in convenient places along the road and later sold. The fireline had been completely revegetated, and all equipment tracks had been obscured. Being high on a ridge, there was no surface water nearby. We found that all FPA rules had been complied with, and that the level of resource protection was at least as high as a normal sale.

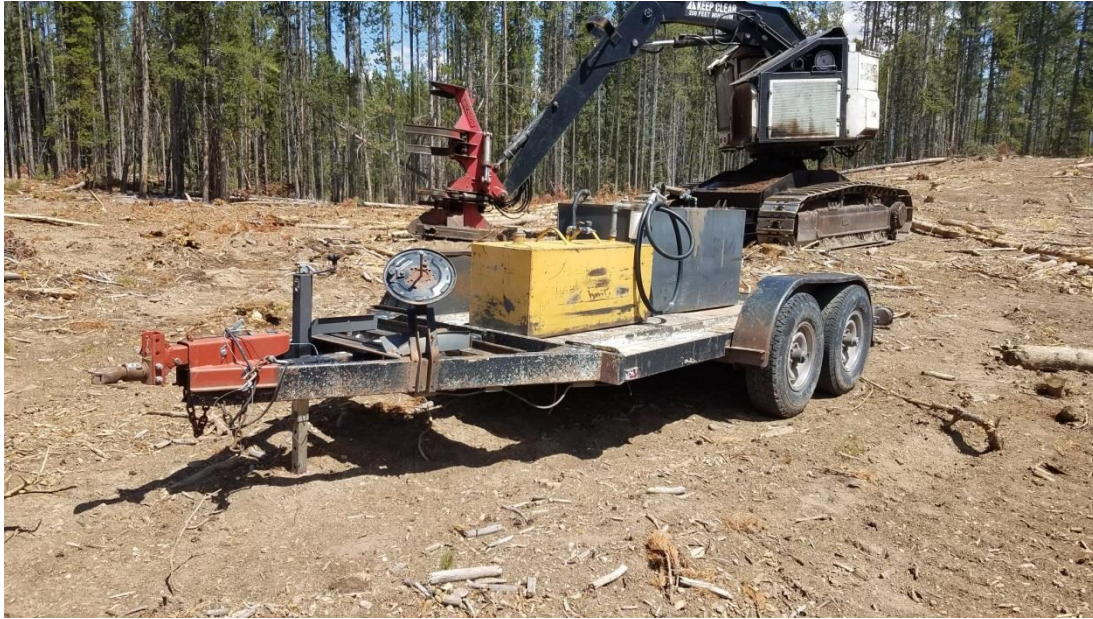
**Figure 15: Uncontained fuel storage tank**

We assessed compliance with 43 chemical and petroleum rules (Table 8; Figure 10). We observed 10 instances of noncompliance, which is a marked improvement from the 38 violations observed in 2016. All of those involved failure to remove petroleum containers or nonbiodegradable waste (060.11 and 060.02c); those rules were only violated twice this year. Landowners have truly cleaned up their operations. Fuel storage is rare on most operations, but in the single case we observed, the tank was not properly contained (060.02). Luckily it was parked far from the stream, and no resource damage had occurred. At the same sale, we found leaking equipment without adequate spillage cleanup (060.12b).

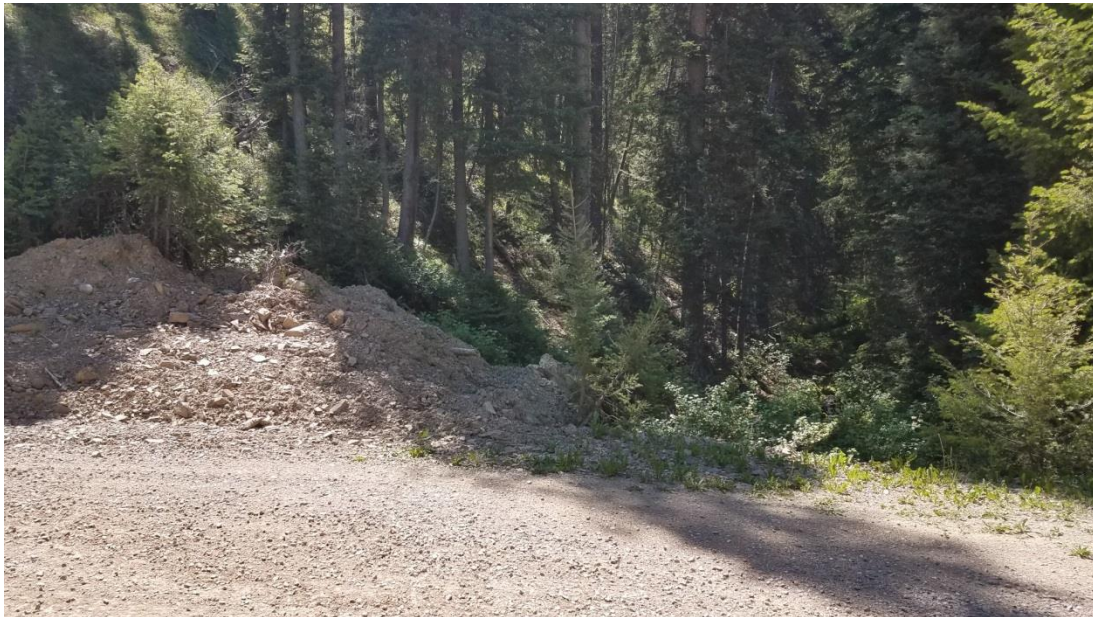
**Figure 16 Pile of road maintenance debris left in SPZ, immediately adjacent to the stream**

1. IDL's inspectors should pay particular attention to the disposal of mineral soil from maintenance and construction activities. There should be no piles of bare dirt left in the Stream Protection Zone (SPZ). Bare roadside ditches should not terminate in a stream.

The second most common problem was incorrect disposal of maintenance and construction debris within the SPZ. In combination, rules 040.03b, 040.03c, 040.02b, 040.04a, 030.06c and 040.04gvi were violated 16 times, almost 20% of the total. Each of these rules requires mineral soil created during road maintenance and construction, such as grader piles, ditch cleanings, and culvert debris, be left in a manner such that it will not enter streams during high water or heavy rain. This problem was concentrated on private industrial forests, although was also found on both State and Federal land.

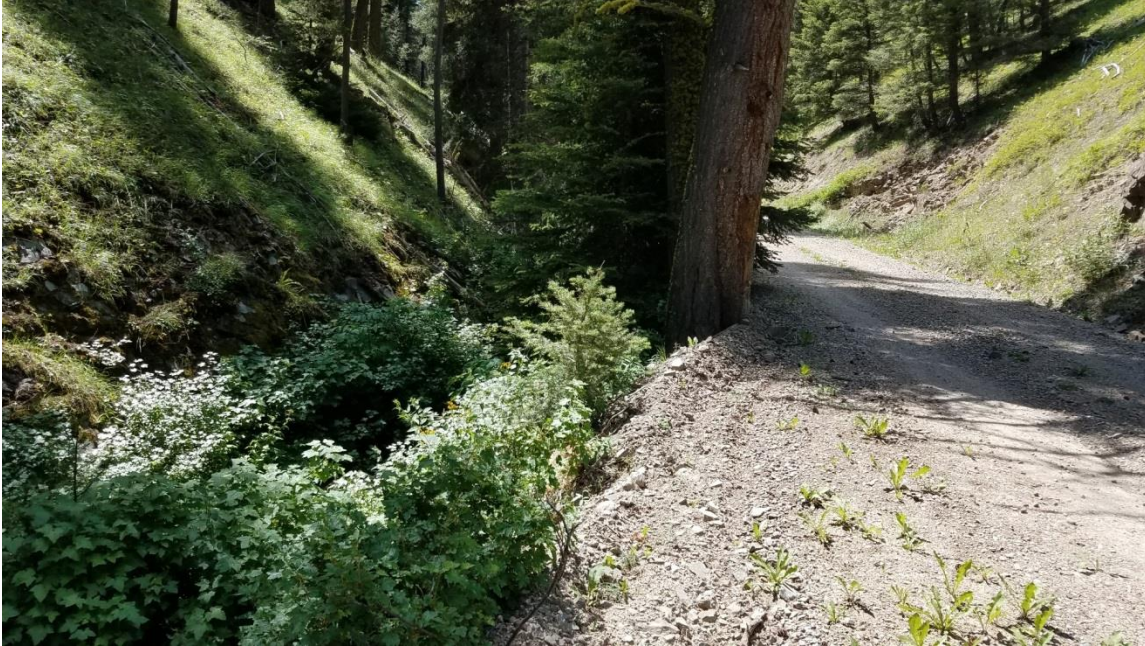
**Figure 17 Long berm of grader debris being pushed into the stream**

2. Federal land managers should ensure that road maintenance associated with a timber sale follows the requirements of the Idaho Forest Practices Act (FPA), especially in regards to grader debris entering the stream.

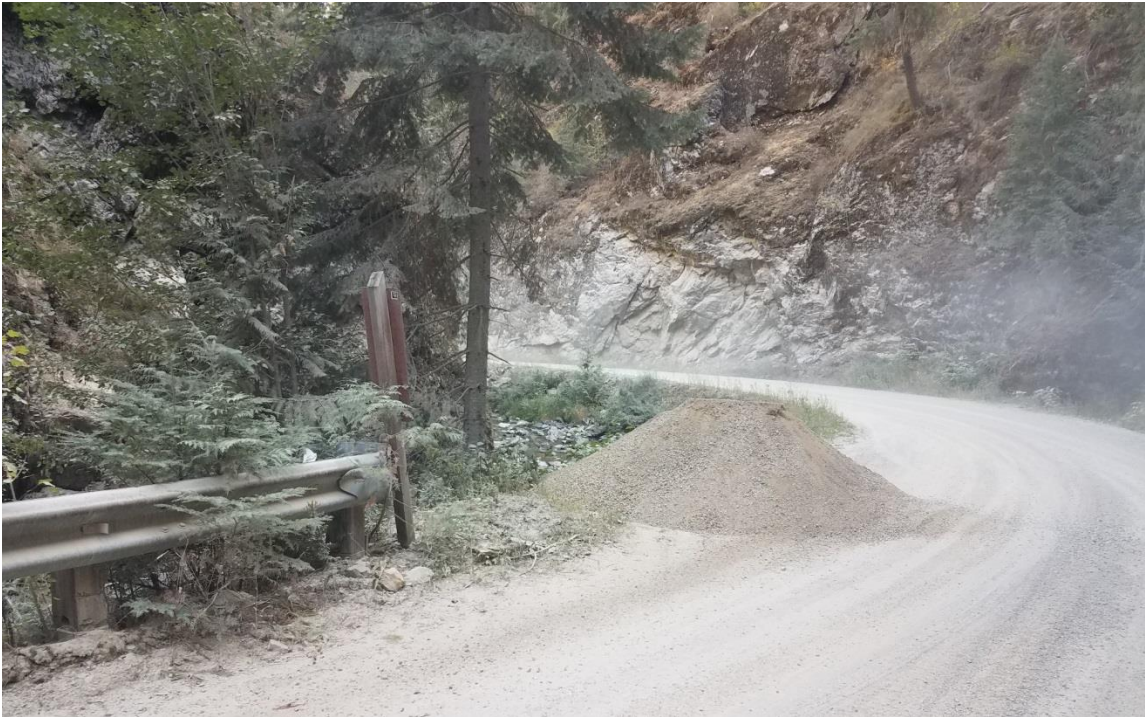
**Figure 18 Pile of road maintenance material stored next to stream**
