**Re: Trestle Creek Project (RP57NR01E166160A; RPO31740000010A, RPO31740000020A, RPO31740000030A), T 57N, R 12E, portion of Section 16, Bonner County, ID:
Wetland Delineation Report - UPDATE for Classification of Wetland Areas**

Photosheet 2
Trestle Creek Project
NEW DATA PLOTS
10/27/22

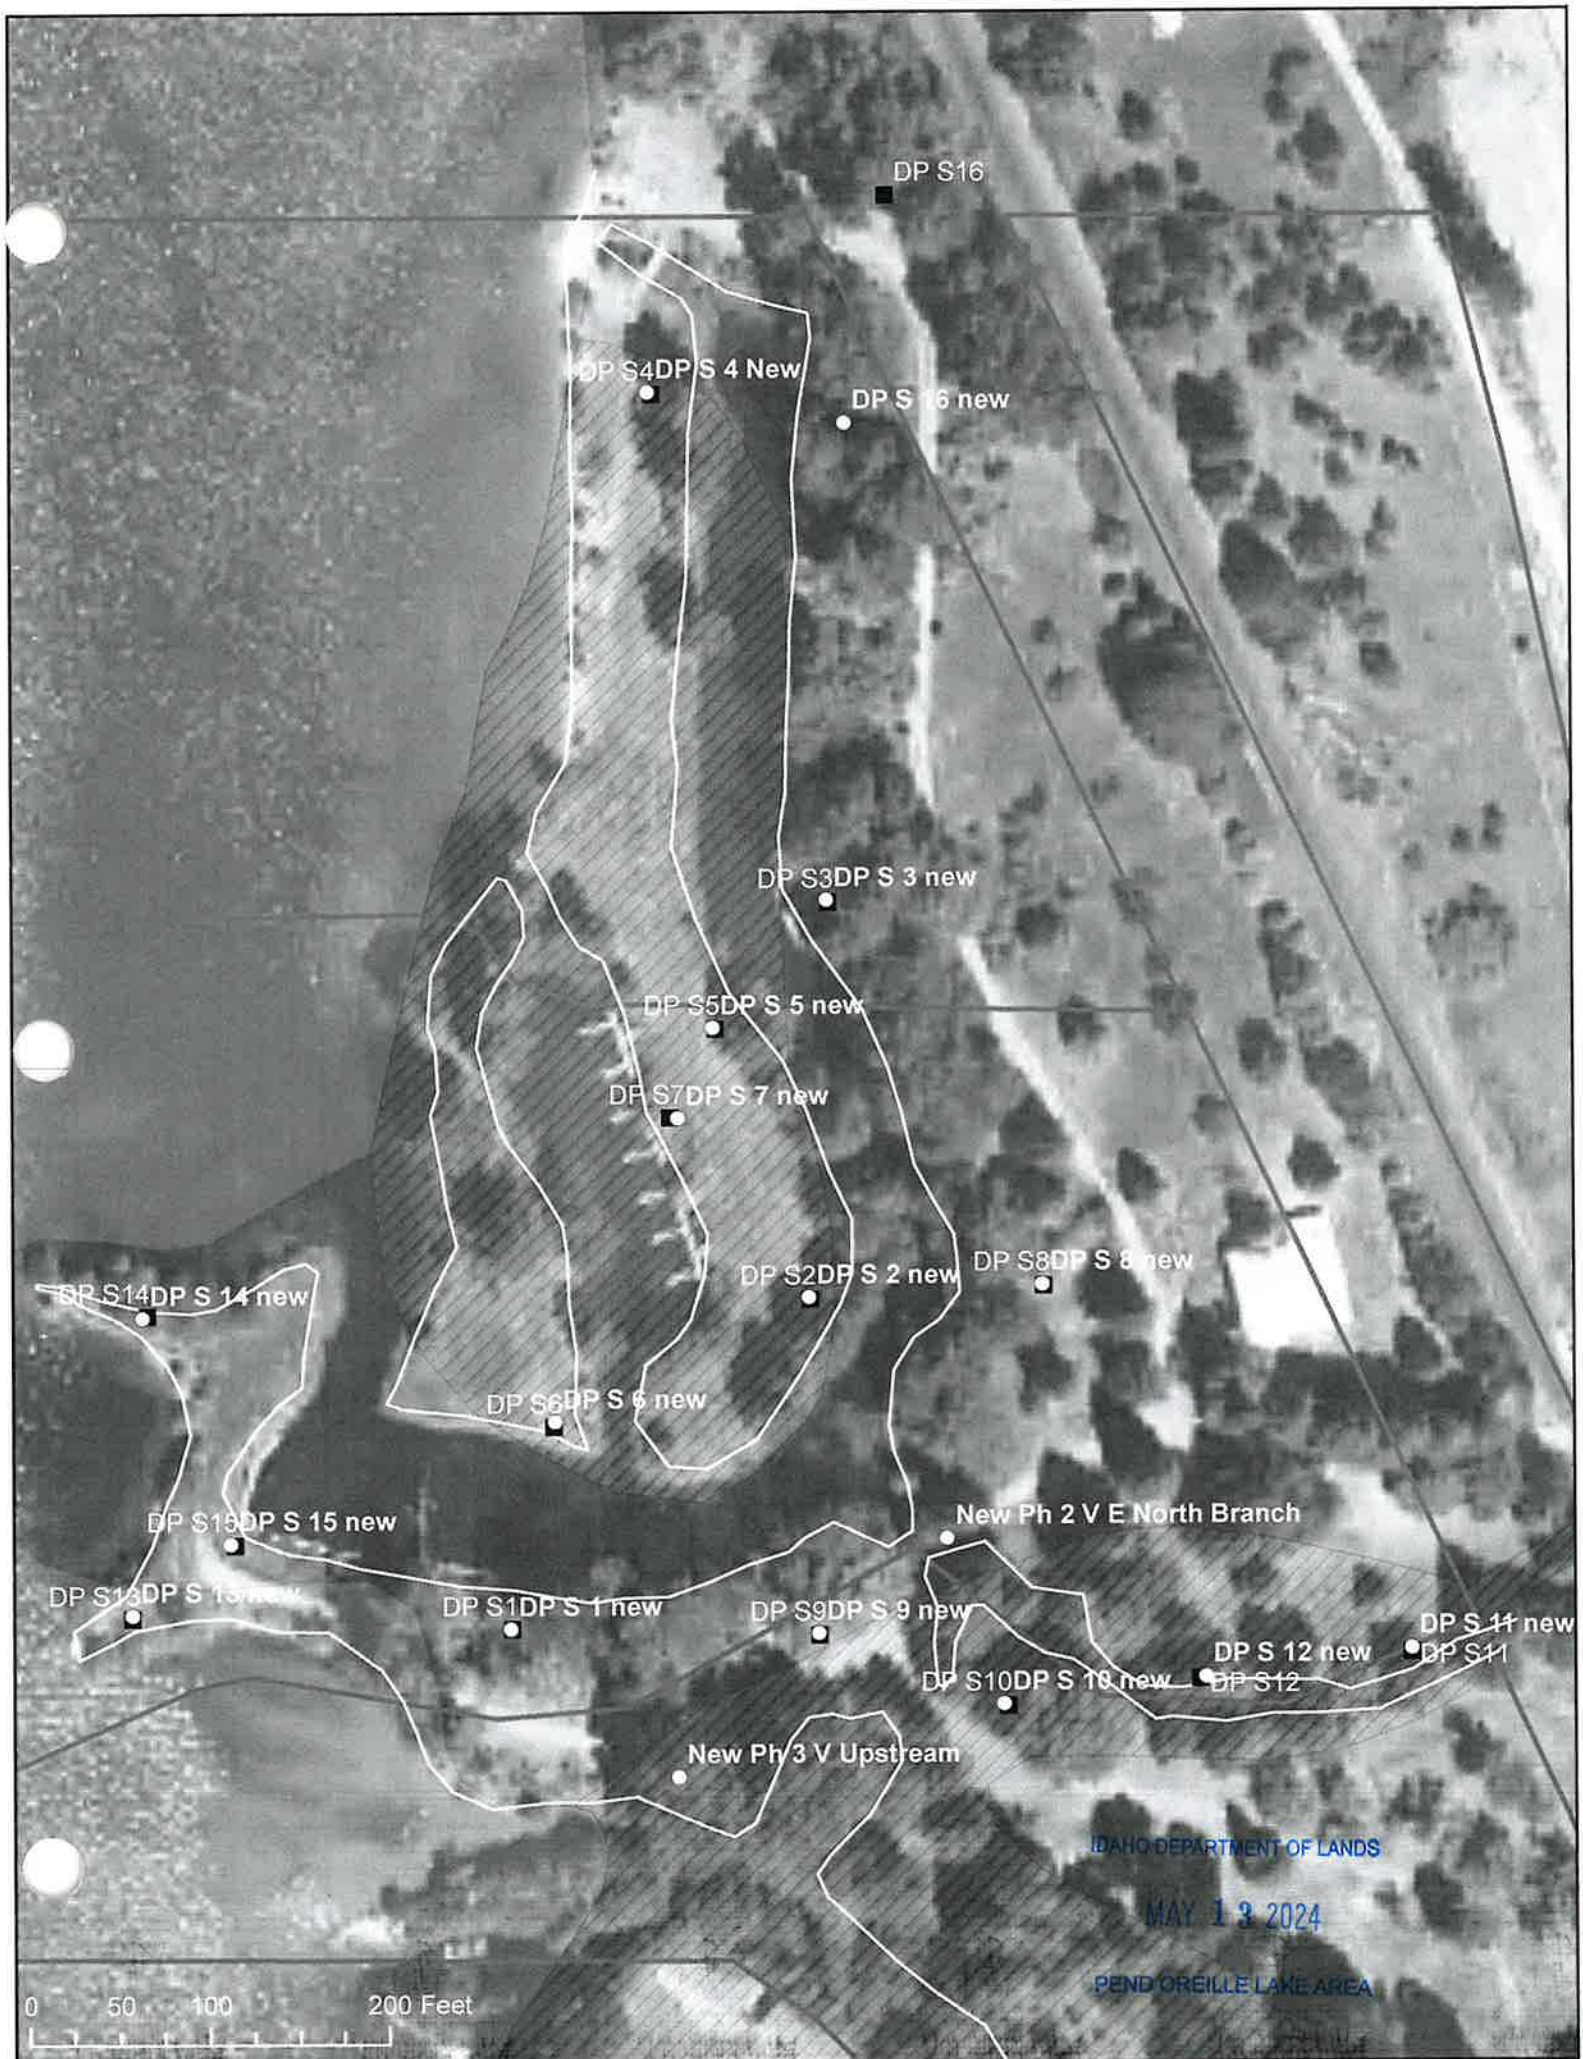
encls: Figure 1: Requested Additional Data Plots and Actual Data Plot Locations

I inputted the .kmz files into ArcGIS, prepared a georeferenced field map, and completed the additional Data Plots at or very near those locations (Figure 1). Below is a summary of the three wetland parameters observed. The complete Data Plots Forms and Photographs at each Data Plot are also attached. A summary table of the Data Plots and the three wetland parameters is shown in Table 1.

None of the 16 additional Data Plots were considered wetland. Although some showed >50% dominance of hydrophytes, these were, for the most part, FAC species (largely cottonwood and red fescue). Soils did not show any evidence hydric conditions, and were mostly low value and high chroma cobbly loams. No evidence of ponding or other hydrology indicators were observed.

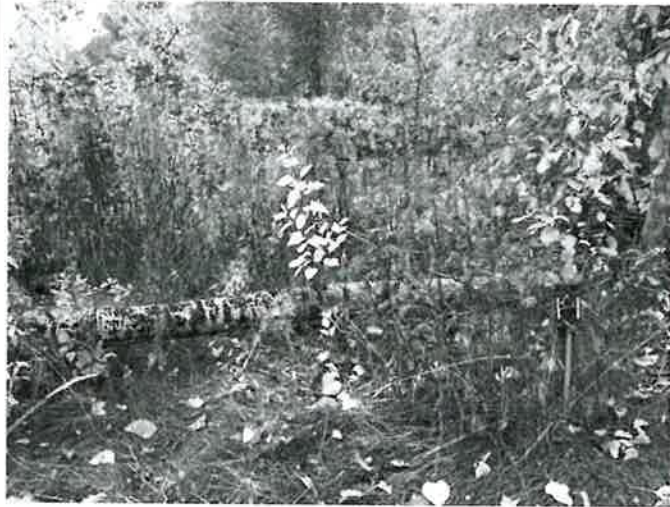
Photo DP S1: View north toward Data Plot 1. Dominated mostly by cottonwood (both mature and saplings) with red fescue. Considerable tansy, knapweed, bluegrass, brome, and thimbleberry. Vegetation is not hydrophytic (40% FAC); soils are cobbly loams below shallow silt loam (not hydric); no hydrologic indicators. Plot about 8' higher than adjacent oxbow. Plot not in wetland.

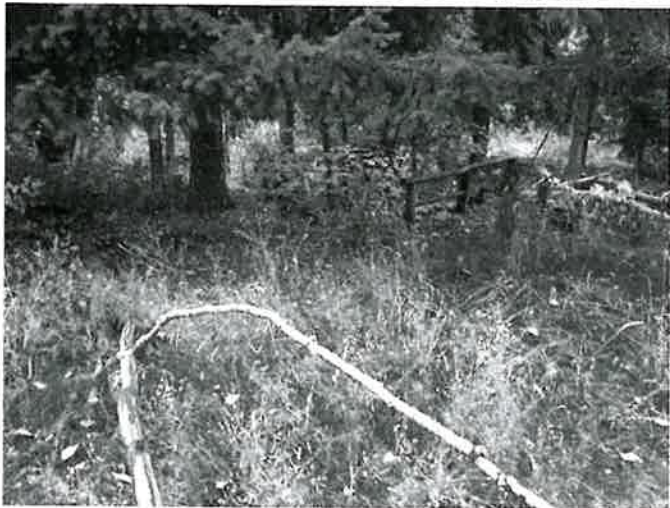
Photo DP S2: View east toward Data Plot 2. Plot is located under large Douglas fir, with orchardgrass, knapweed, and red fescue in groundlayer. Vegetation is not hydrophytic (0% hydrophytes); soils are cobbly loams below shallow silt loam (not hydric); no hydrologic indicators. Plot not in wetland.

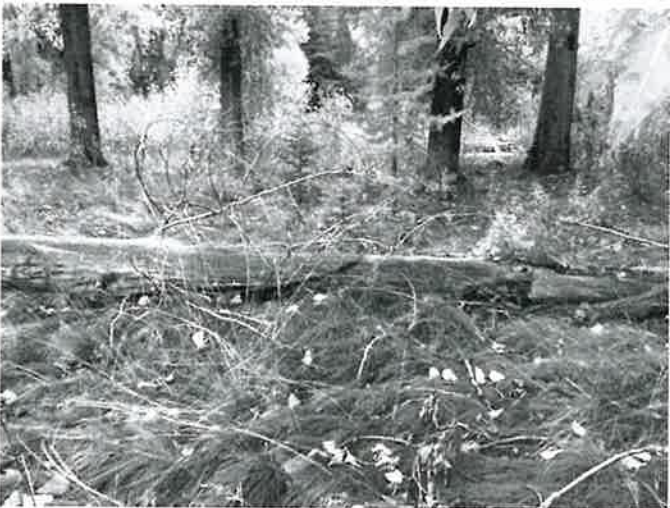
Photo DP S3: View north toward Data Plot 3. Plot is located under cottonwood with red fescue, Douglas fir and grandfir saplings, with some snowberry. Vegetation is not hydrophytic (40% hydrophytes); soils are cobbly loams below shallow silt loam (not hydric); no hydrologic indicators. Plot not in wetland.

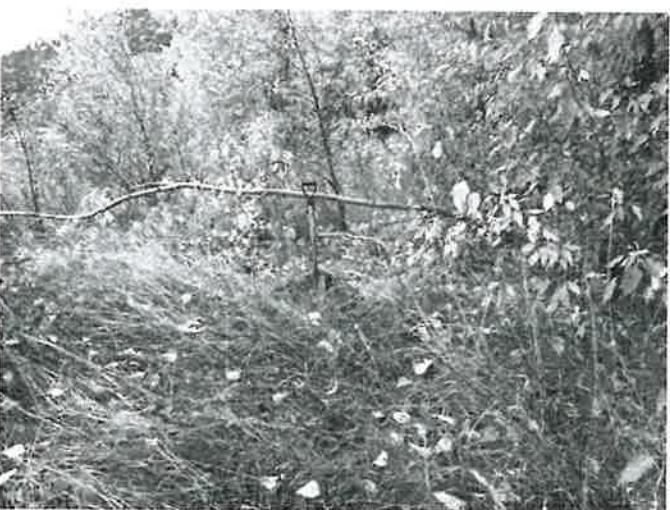
Hydrophytic Vegetation Present? Yes <input checked="" type="radio"/> No <input type="radio"/>	Is the Sampled Area within a Wetland? Yes <input type="radio"/> No <input checked="" type="radio"/>
Hydric Soil Present? Yes <input type="radio"/> No <input checked="" type="radio"/>	
Wetland Hydrology Present? Yes <input type="radio"/> No <input checked="" type="radio"/>	
Remarks: Vegetation is hydrophytic (FAC-dominated). Hydric soils not observed. No hydrologic indicators. Plot is several feet higher than adjacent oxbow and not in a wetland. Located on bench above oxbow. Photo DP S 4.

Photo DP S4: View south toward Data Plot 4. Plot is located under cottonwood (both mature and saplings) with quackgrass, serviceberry, bluegrass, plantain, and meadow fescue. Vegetation is hydrophytic (75% hydrophytes); soils are cobbly loams below shallow silt loam (not hydric); no hydrologic indicators. Plot located much higher than oxbow. Plot not in wetland.

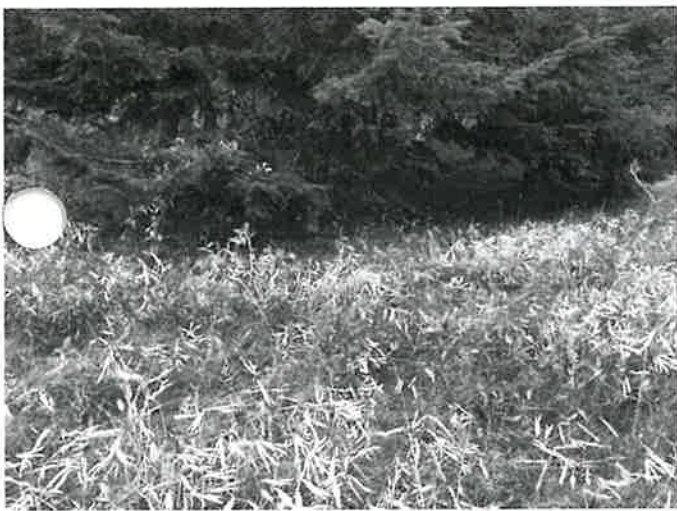
Photo DP S5: View east toward Data Plot 5. Dominated mostly by one large grandfir with red fescue. Considerable sweet pea and orchardgrass. Vegetation is not hydrophytic (33% FAC); soils are cobbly loams below shallow silt loam (not hydric); no hydrologic indicators. Plot about 6' higher than adjacent oxbow. Plot not in wetland.

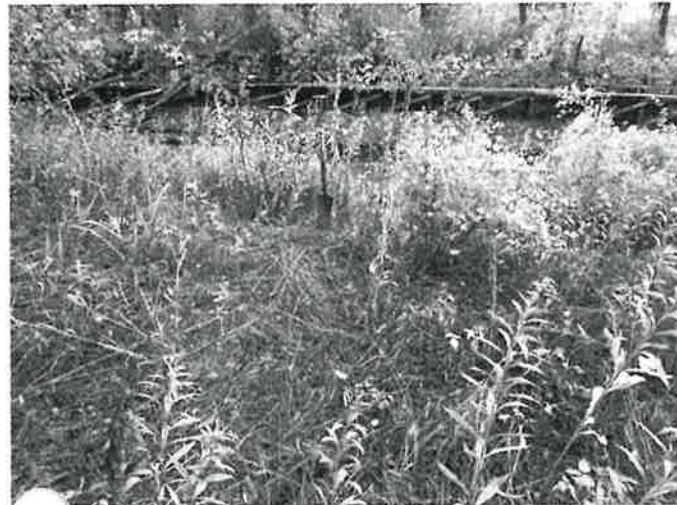
Photo DP S6: View south toward Data Plot 6. Plot is dominated by snowberry and goldenrod. Vegetation is not hydrophytic (33% hydrophytes); soils are cobbly loams below shallow silt loam (not hydric); no hydrologic indicators. Plot not in wetland.

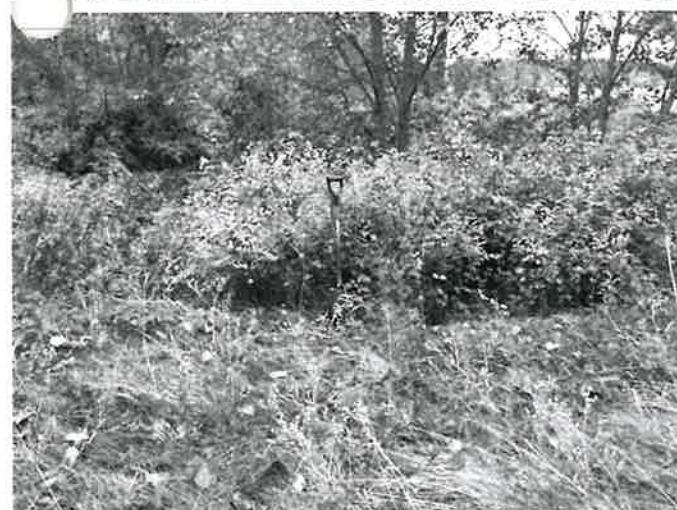
Photo DP S7: View west toward Data Plot 7. Plot contains alder (rooted at base of oxbow, overhanging plot), snowberry and trailing blackberry. Vegetation is not hydrophytic (40% hydrophytes); soils are cobbly loams below shallow silt loam (not hydric); no hydrologic indicators. Plot about 6' higher than adjacent oxbow. Plot not in wetland.

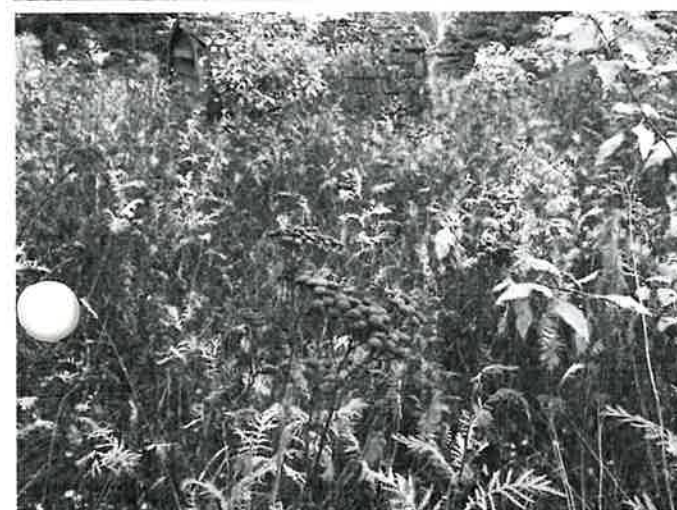
Photo DP S8: View north toward Data Plot 8. Plot contains alder and dogwood (rooted at base of oxbow, overhanging plot), some cottonwood saplings, large amounts of tansy. Vegetation is not hydrophytic (50% hydrophytes); soils are cobbly loams below shallow silt loam (not hydric); no hydrologic indicators. Plot located much higher than oxbow. Plot not in wetland.

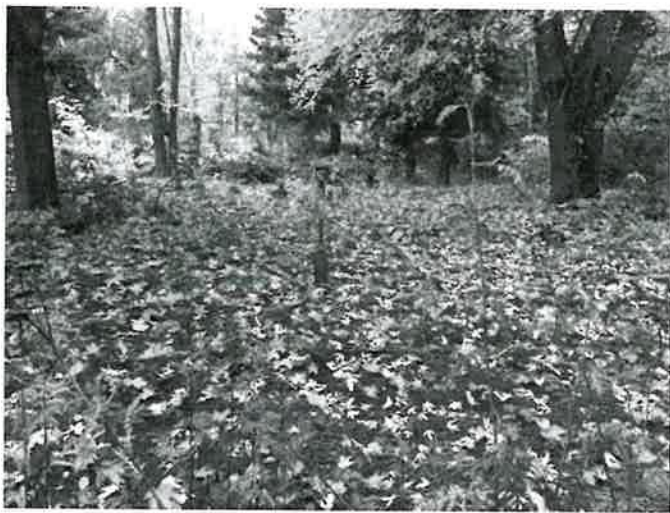
Photo DP S9: View north toward Data Plot 9. Dominated mostly by one large ornamental maple with red fescue, over Douglas fir and grandfir saplings and tansy. Vegetation is not hydrophytic (25% FAC); soils are cobbly loams below shallow silt loam (not hydric); no hydrologic indicators. Plot about 10' higher than adjacent oxbow on bench. Plot not in wetland.

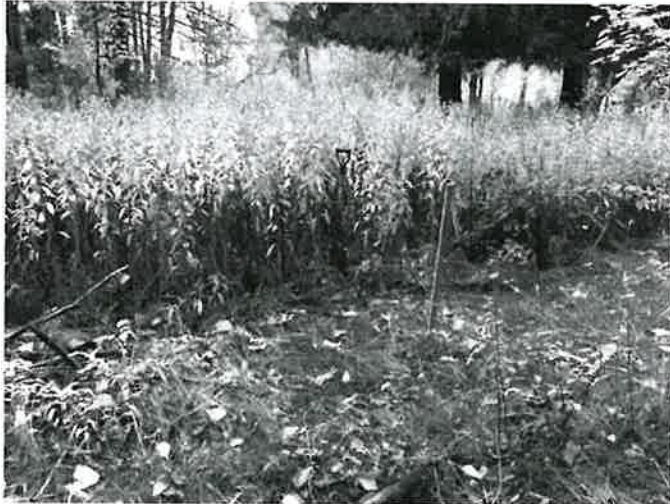
Photo DP S10: View south toward Data Plot 10. Plot is dominated by cedar and grandfir, over snowberry and goldenrod. Vegetation is not hydrophytic (40% hydrophytes); soils are cobbly loams below shallow silt loam (not hydric); no hydrologic indicators. Plot not in wetland.

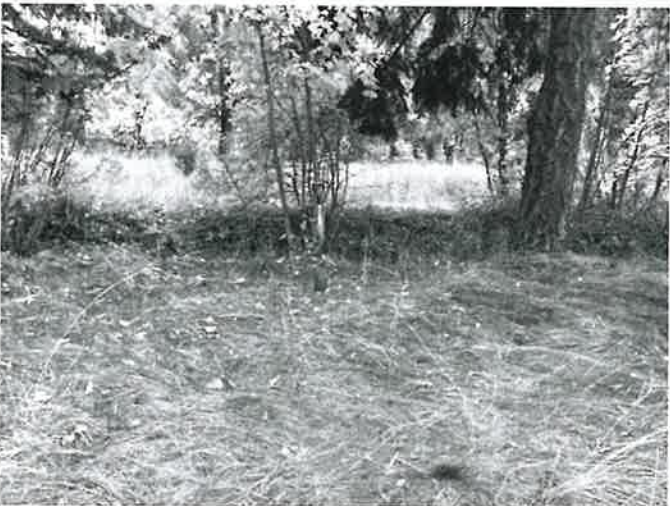
Photo DP S11: View south toward Data Plot 11. Plot contains Douglas fir and ornamental maple, over Oregon grape and red fescue. Vegetation is not hydrophytic (40% hydrophytes); soils are cobbly loams below shallow silt loam (not hydric); no hydrologic indicators. Plot about 3' higher than North Branch Trestle Creek (dry now). Plot not in wetland.

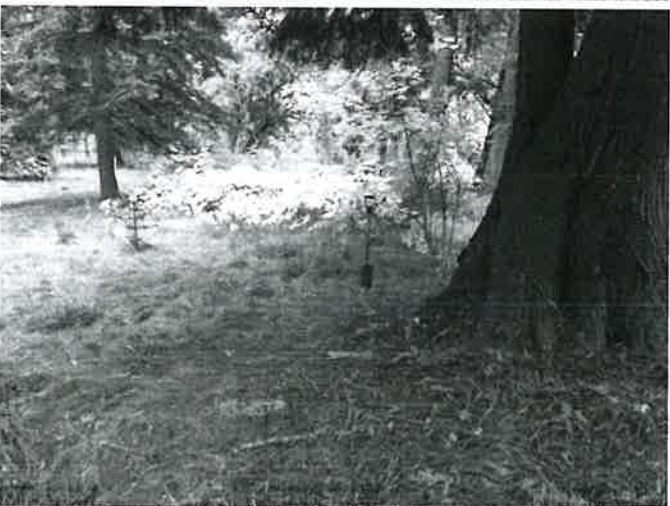
Photo DP S12: View east toward Data Plot 12. Plot contains one large cedar with ornamental maple, over red fescue and thimbleberry. Vegetation is hydrophytic (67% hydrophytes); soils are cobbly loams below shallow silt loam (not hydric); no hydrologic indicators. Plot about 3' higher than North Branch Trestle Creek (dry now). Plot not in wetland.

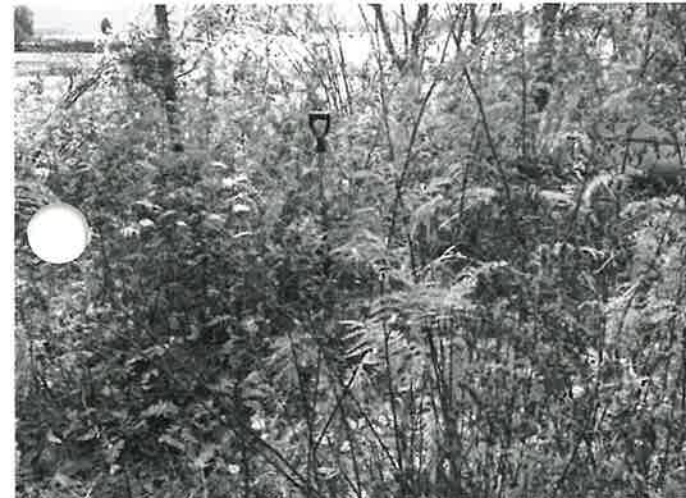
Hydrophytic Vegetation Present? Yes <input type="radio"/> No <input checked="" type="radio"/>	Is the Sampled Area
Hydric Soil Present? Yes <input type="radio"/> No <input checked="" type="radio"/>	within a Wetland? Yes <input type="radio"/> No <input checked="" type="radio"/>
Wetland Hydrology Present? Yes <input type="radio"/> No <input checked="" type="radio"/>	
Remarks: None of required parameters observed. Plot is not in a wetland. About 10' higher than lake on top of peninsula. Photo DP S 13.

Photo DP S13: View southwest toward Data Plot 13. Dominated by cottonwood, dogwood, and rose over considerable amount of tansy. Vegetation is not hydrophytic (50% FAC); soils are cobbly loams below shallow silt loam (not hydric); no hydrologic indicators. Plot about 10' higher than adjacent oxbow on a peninsula. Plot not in wetland.

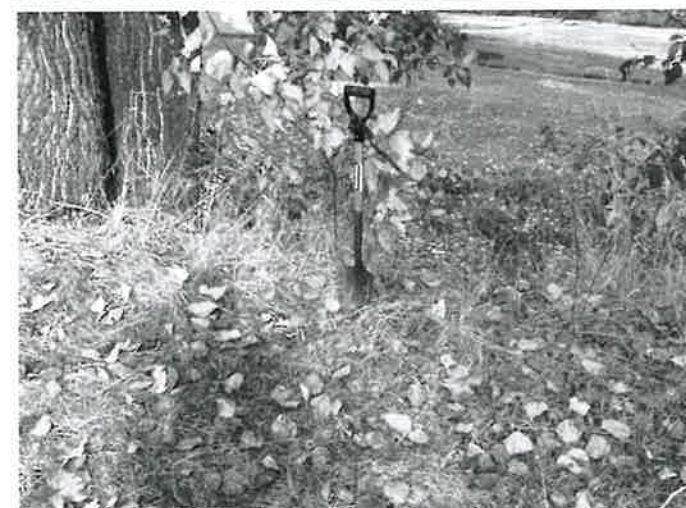
Photo DP S14: View north toward Data Plot 14. Plot is dominated by cottonwood and bentgrass over snowberry and quackgrass. Vegetation is hydrophytic (67% hydrophytes); soils are cobbly loams below shallow silt loam (not hydric); no hydrologic indicators. Plot about 6' higher than adjacent lake area (dry now). Plot not in wetland.

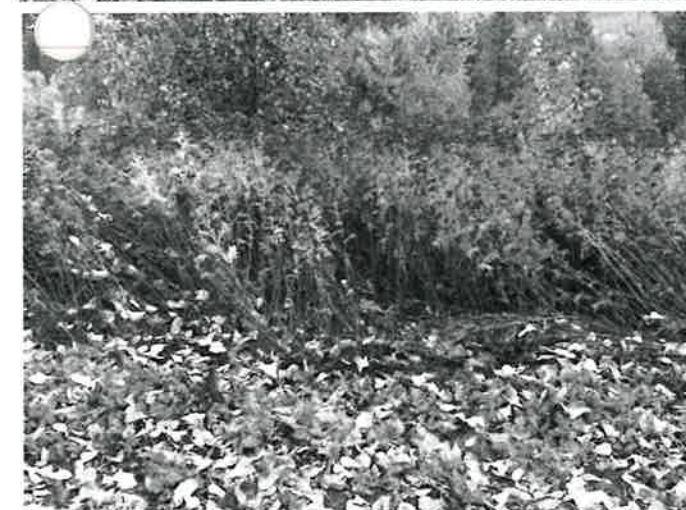
Photo DP S15: View northeast toward Data Plot 15. Plot contains alder (rooted at base of slope), snowberry, and considerable amounts of tansy. Vegetation is not hydrophytic (33% hydrophytes); soils are cobbly loams below shallow silt loam (not hydric); no hydrologic indicators. Plot about 10' higher than oxbow. Plot not in wetland.

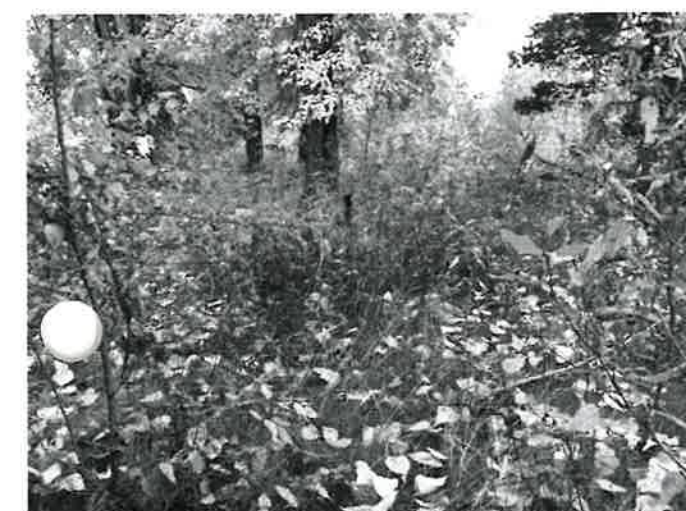
Photo DP S16: View south toward Data Plot 16. Plot contains cottonwood (both mature and saplings) over tansy and red fescue. Vegetation is hydrophytic (60% hydrophytes); soils are cobbly loams below shallow silt loam (not hydric); no hydrologic indicators. Plot not in wetland.

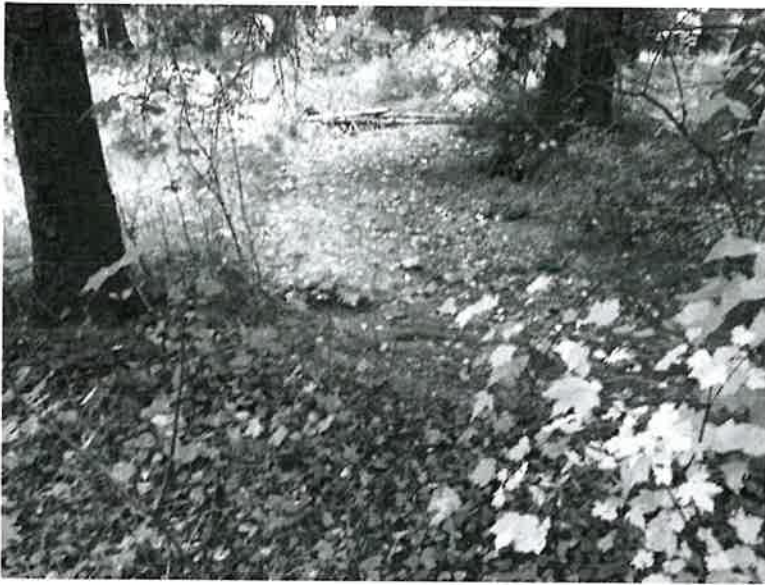
New Ph 2: View east into North Branch Trestle Creek. Dry in October.

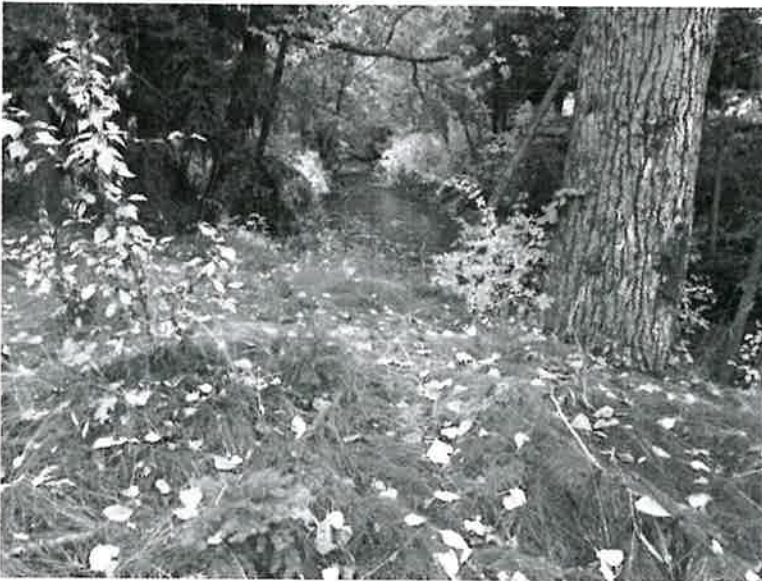
New Ph 3: View southeast into Main Branch Trestle Creek.
