# Two Rivers Park Shoreline Stabilization Basis of Design Report

Prepared for:  
City of Priest River

This Engineering Basis of Design (BOD) Report outlines the technical approach, methods, and design criteria that guide engineering solutions for protecting the site shoreline from erosion and other environmental factors. This BOD Report serves as a foundation for stakeholders including regulatory agencies, city officials, and the public to understand the shoreline stabilization design approach and the rationale for selecting this approach.

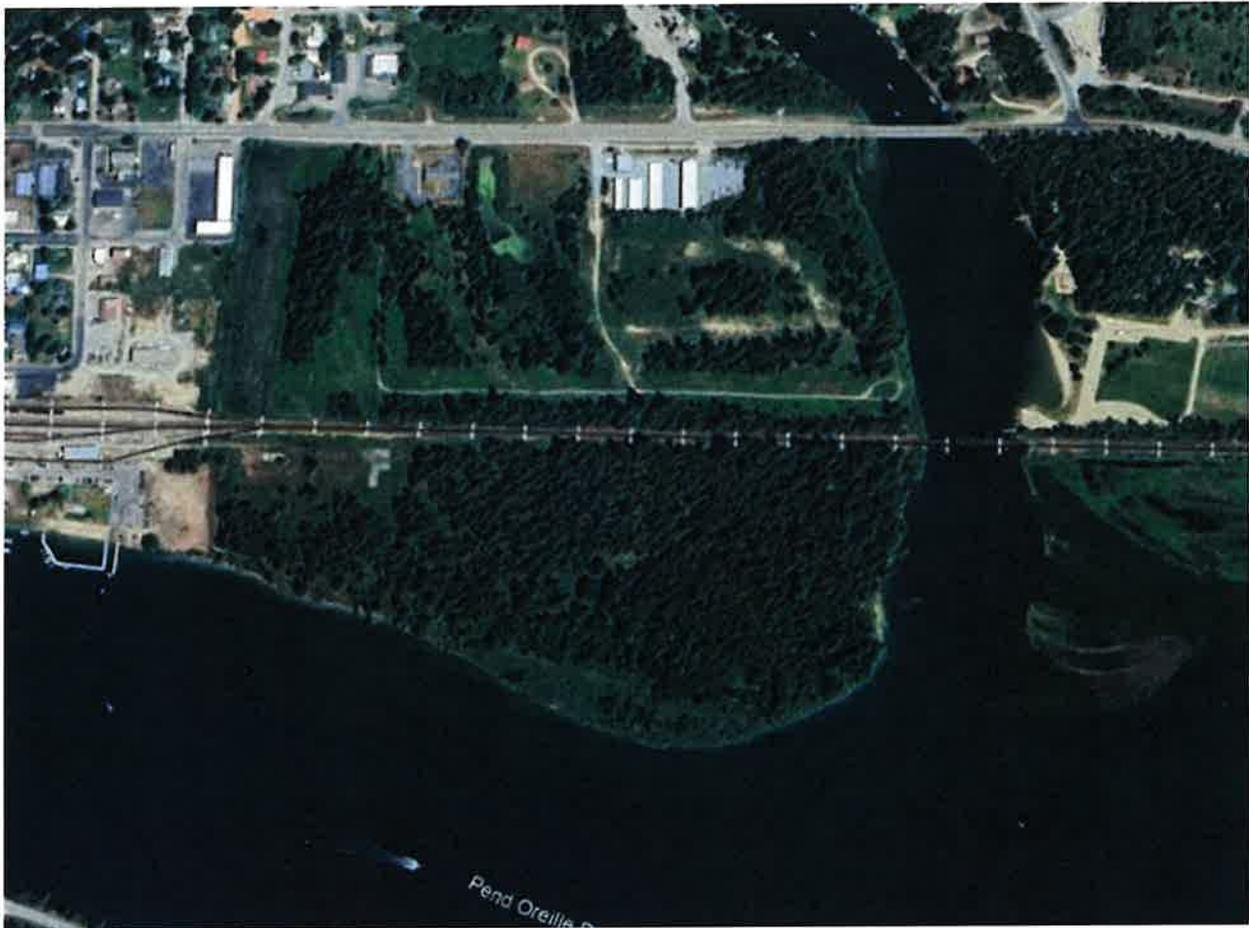
**Figure 2. 2024 Google Earth Aerial During High Water**

The shoreline of the project site is situated at the confluence of the Priest River and the Pend Oreille River (Figure 2). The shoreline experiences accelerated erosion in areas where the two rivers collide. Both rivers are dam-controlled; unnatural seasonal water level fluctuations of more than 12 feet increase the complexity of the shoreline's erosion. The site shoreline is particularly vulnerable to shear forces exerted by the flow dynamics of the two converging rivers. These forces promote lateral displacement in the site's silty sediment. See Appendix A, for a still-photo time lapse of the site between the years 1998 and 2024. This historical imagery illustrates the shifts in sediment along the shoreline of the site and highlights areas sensitive to the behaviors of the Priest and Pend Oreille rivers.

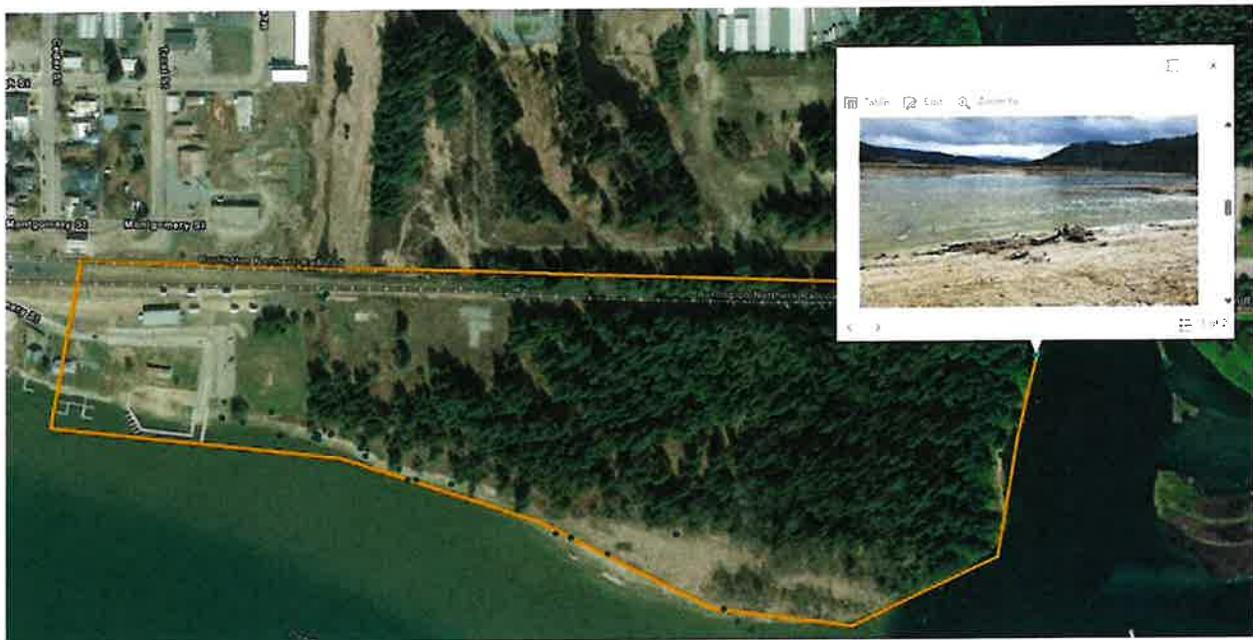
**Figure 3. Photo Documentation in Field Maps**

On March 29, 2024, a site visit was conducted with the City of Priest River, the Idaho Department of Environmental Quality (IDEQ), and Idaho Department of Fish and Game (IDFG) to assess the condition of the project site and focus on the extent of shoreline erosion. Photos were taken during the site visit to document existing and natural conditions. Existing structures, debris, and areas of concern including exposed soil, undercut banks, and evidence of sediment displacement were of particular emphasis. Most photos were documented in a web-based mapping application (ArcGIS® Field Maps), which attached location data to each photo (see Figure 3) and allowed entering written observations. This was useful for documenting where along the shoreline condition changes occurred.

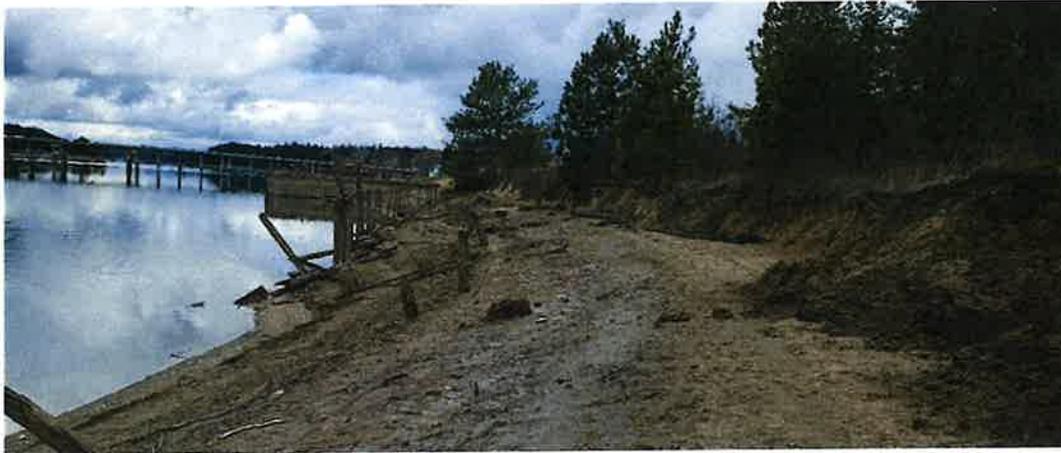
**Figure 4. Zones 1 and 2 Observed Conditions**

The existing shoreline is a vertical face approximately 10 feet tall of fine sands and silts at the summer-pool water surface elevation. Below the summer-pool water surface, the shoreline is devoid of vegetation. Above the summer-pool water surface, the shoreline is naturally vegetated as observed in Figure 4.

- Large wooden piers staked at the low-water line.
- Steep, eroding banks (approximately 5-feet in height) near or at the high-water line (Figure 5).

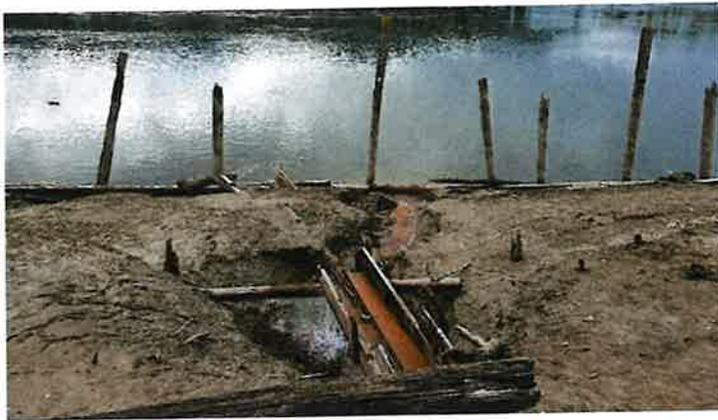
**Figure 6. Stormwater Outlet between Zones 1 and 2**

Zones 1 and 2 are divided by an existing stormwater outlet, which has a constant flow that will be addressed as part of the shoreline protection design (Figure 6).

There is one stormwater outfall on the Pend Oreille River shoreline located near the west end of the property approximately 350 feet east of the City’s concrete pier by the water intake. The outfall consists of a three-sided wooden trough. The wooden trough is in disrepair and collapse may be imminent. There is substantial shoreline erosion around the stormwater outfall as seen in Figure 6.

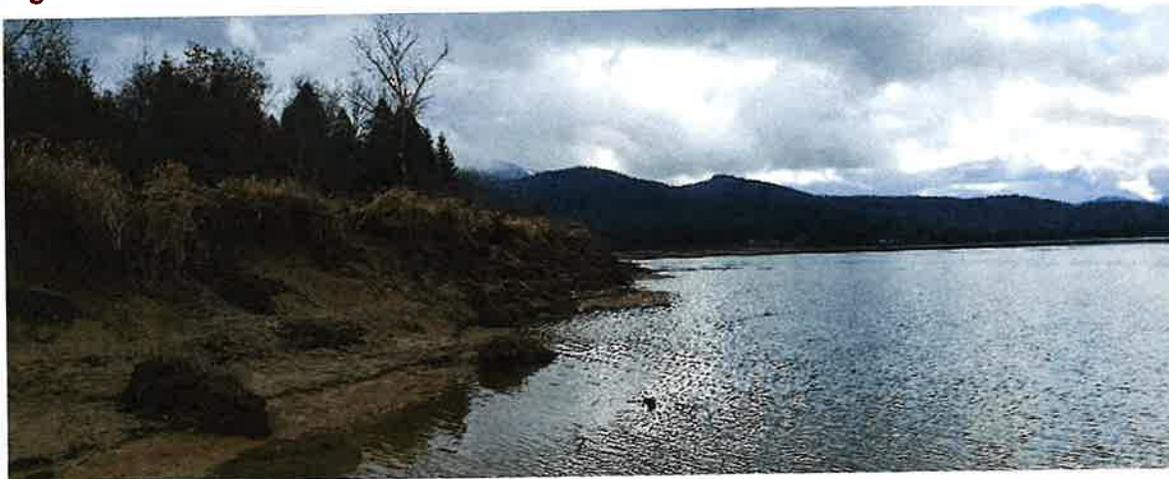
**Figure 7. Zones 3 and 4 Observed Conditions**

Erosion conditions for Zones 3 and 4 appear to be similar to Zones 1 and 2 but with far more sloughing. The large wetland vegetative top layer appeared to be creating a cantilever failure scenario where the topsoil layer is strongly held together by plants, but the weaker, less cohesive layer of soil underneath is eaten away until the top layer eventually fails. Figure 7 shows the transition from Zone 3 into Zone 4 around the shoreline bend and is generally representative of the observed conditions.

Zone 3 is the first half of the degraded wetland zone, characterized by its shape in relation to Pend Oreille River. This is considered the inner bend Zone because the shoreline bends away from the directional flow of water. The shoreline stretches 775-feet and has a 4:1 stable slope above OHW mark and a 1:2 unstable slope between OHW mark and ordinary low water (defined as elevation 2055' NAVD88; OLV) mark. Moderate river velocities and poorly-rooted vegetation have driven the majority of erosive conditions. Within the design considerations, the objectives are to avoid continued wetland degradation and maintain a permeable barrier for wetland watering. The City is very interested in potential rehabilitation of the wetland in an effort to address public concern of further degradation. The addition of native plant species has been discussed and the City will take the lead in discussions with IDFG for long-term wetland maintenance.

Zone 4 is a continuation of the degraded wetland, spanning approximately 825-feet, and positioned in a bend leaning towards Pend Oreille River. This location is particularly susceptible to hydrodynamic stresses created by the river's curvature, which amplifies water velocity and turbulence. These conditions pose a significant risk of bank erosion and sediment displacement, further degrading the wetland's ecological function. The wetland's compromised state reduces its natural resilience to such forces, diminishing its capacity to stabilize sediments, filter pollutants, and provide habitat for aquatic and terrestrial species. Zone 4 begins with similar sloping characteristics as Zone 3 (i.e., a 4:1 stable slope above the OHW mark and a 1:2 unstable slope between the OHW mark) and transitions into steeper, less stable conditions as it approaches the confluence of Pend Oreille and Priest rivers.

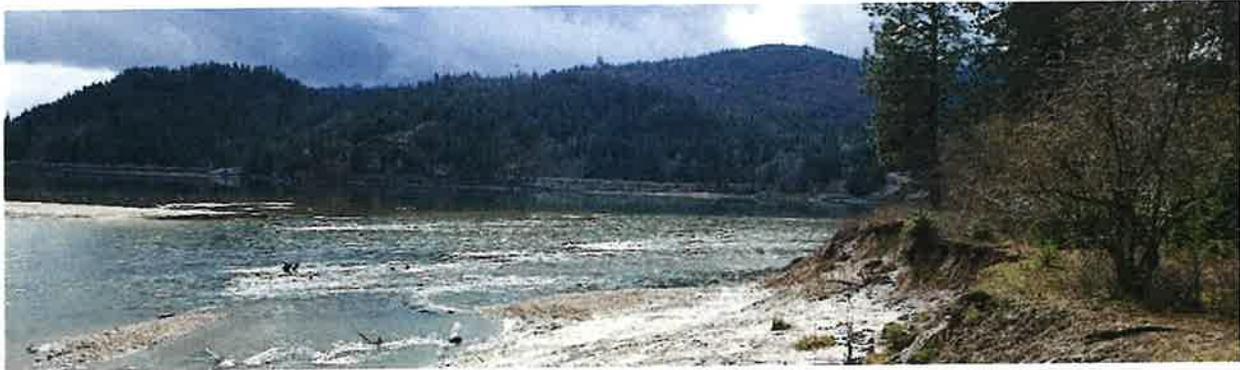
**Figure 8. Zone 5 Observed Conditions**

The confluence of the Priest River and the Pend Oreille River (Zone 5) appears to experience the most rapid erosion. The length of Zone 5 is approximately 250 feet and is characterized by a relatively steep bank between the high- and low-water levels. Bank failure was observed at the end of this Zone, which is approximately located at the mouth of Priest River as shown in the Bonner County Flood Insurance Study (FIS) report (Agency, 2014). This bank failure is most likely where flows are most turbulent as the two rivers collide.

Zone 5 experiences significant scouring due to its position at the confluence of the two rivers, where merging flows generate intense turbulence and localized erosion. The converging water currents amplify velocity gradients and increase the shear stress on the riverbed and banks, making this area particularly vulnerable to sediment displacement and channel instability. The City suspects boat wakes also negatively impacts this Zone. For safety reasons, the City will restrict public access to water since conditions are not ideal for recreational activity. The City has discussed that a viewing patio may be more ideal. This corner of the Site stretches 450-feet

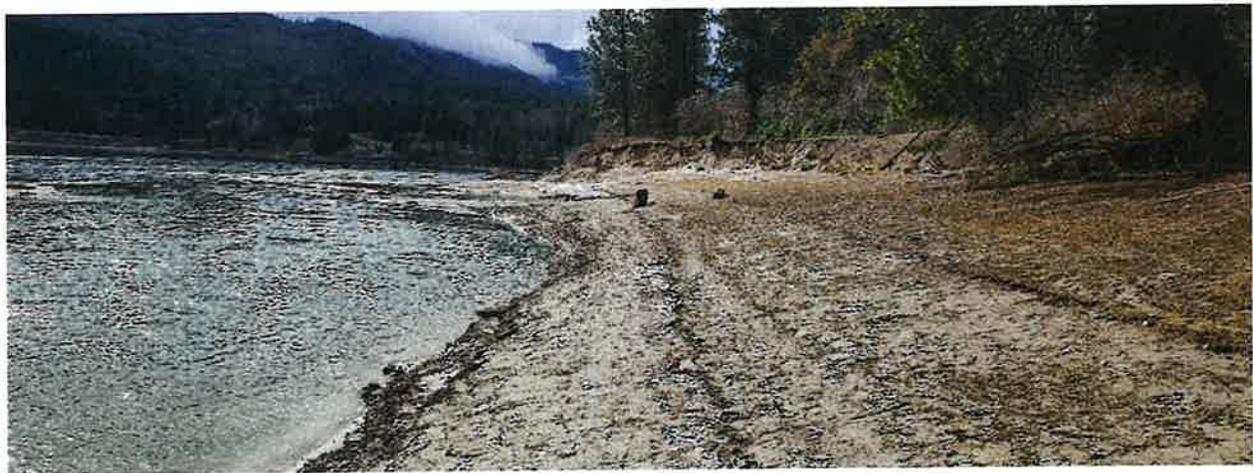
**Figure 9. Zone 6 Observed Conditions**

North of the point of confluence and south of the Burlington Northern Railroad right-of-way on the west side of the Priest River is the final stretch of shoreline (Zone 6), which is approximately 700 feet long. Existing conditions are similar to the first half of shoreline around the wetland (Zone 2) with shallow, silty sand slopes meeting steep banks with a vegetative cap. See Figure 9 for the observed conditions of Zone 6.

At the end of Zone 6, the Priest River appears to be “pinched” by the railroad crossing. It is assumed that Priest River’s flow velocities would be greater here and will need to be considered for the shoreline protection design.

Zone 6 is a 325-foot segment situated between the river confluence and a railroad crossing, where hydraulic and structural factors converge to shape its stability challenges. This area is influenced by Priest River velocities that experience mild contraction scour resulting from the railroad construction, which narrowed the river channel and intensified localized flow velocities. Additionally, the slope between the OLW and OHW marks is unstable, prone to erosion, and displaces sediment during fluctuating flow conditions. Behind the shoreline exists a highly valued forested area exhibiting mature tree growth and biodiversity. The public expresses concern regarding future construction within this region.

To address these issues, stabilization measures could include the application of riprap to protect the toe of the slope from scouring forces and live staking with native plant species above the OHW mark to enhance soil cohesion and promote long-term slope stability. Alta's goal is to protect the forested area from future degradation and to prevent disturbing the existing vegetation.

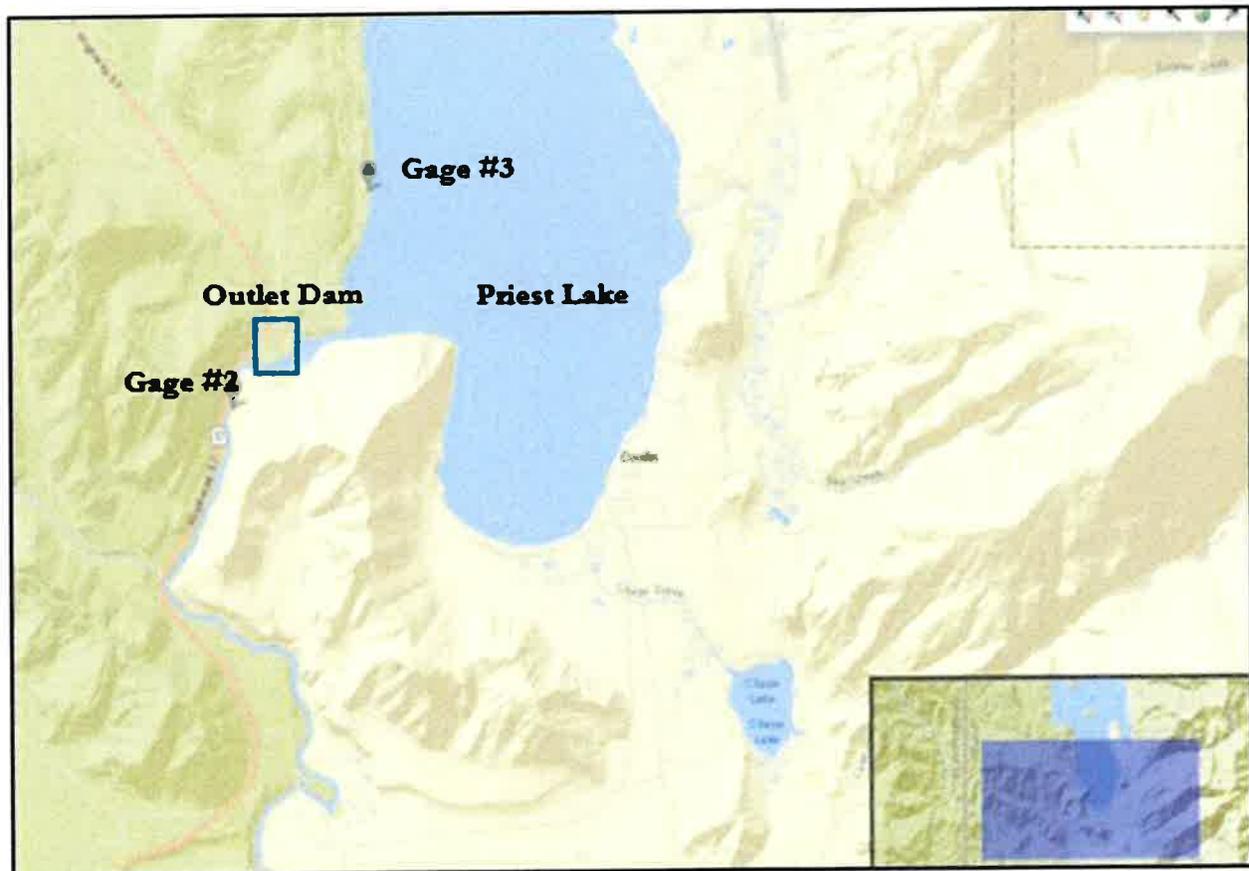
**Figure 10. Location of Outlet Dam with respect to Priest Lake**

The portion of the Priest River that intersects with the Pend Oreille River is considered the Lower Priest River. The Lower Priest River begins 44 miles upstream of the project site at Priest Lake, which is held by the Outlet Dam (Figure 10).

Flow to the Lower Priest River is controlled by the Outlet Dam, which raises and lowers Priest Lake levels seasonally. These flows range between 60 cubic feet per second (CFS) (~27,000

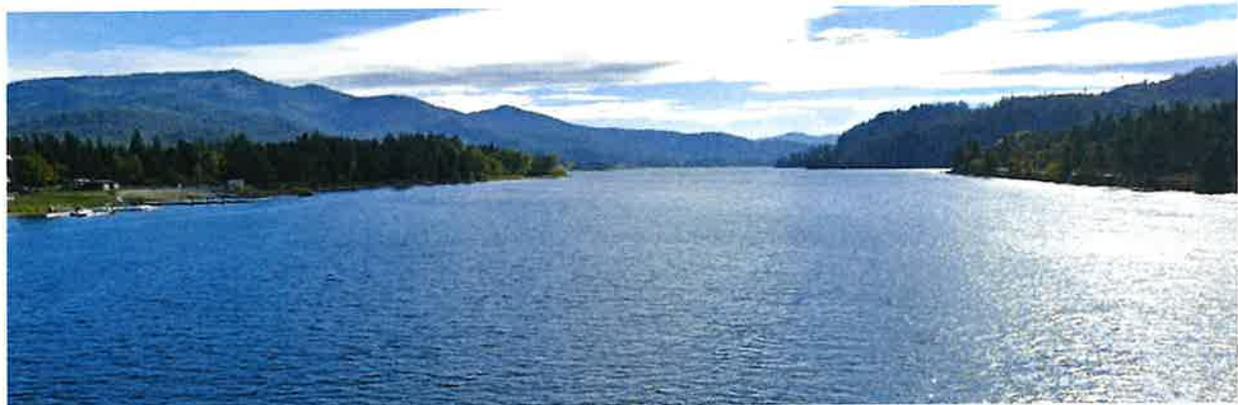
**Figure 13. Pend Oreille River Upstream of Albeni Falls Dam during Summer-Pool**

Pend Oreille River (Figure 13) is a major waterway geomorphologically shaped by glacial, tectonic, and fluvial processes such as the Priest River. Pend Oreille River is the main outflow from Lake Pend Oreille, which is approximately 148 square miles, 1,152 feet deep, and holds around 14.2 trillion gallons of fresh water. Geomorphology varies between steep, confined reaches and wider, lower-gradient stretches where the Pend Oreille River exhibits meandering and braided patterns (Harvey, 1999). Sediment transport and deposition have created floodplains, terraces, and gravel bars that provide habitats for riparian and aquatic species.

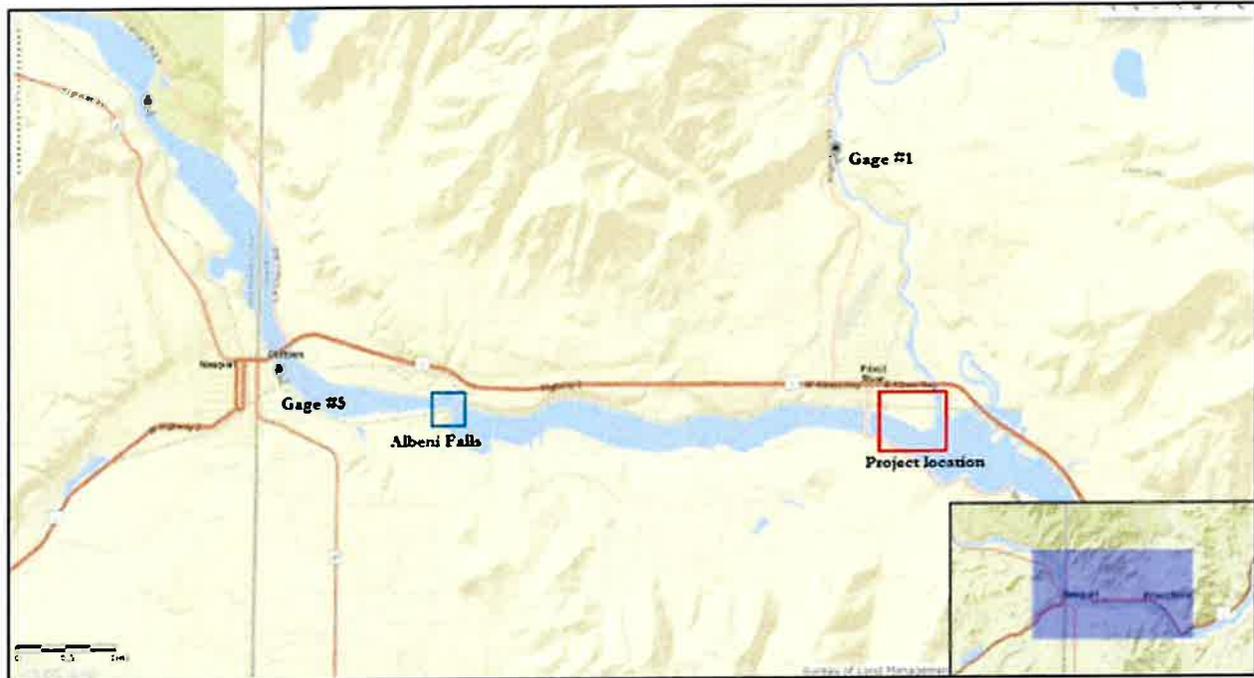
**Figure 14. Location of Albeni Falls Dam with respect to the Two Rivers Park site**

Albeni Falls Dam is located approximately 5 miles downstream of the Priest River and Pend Oreille River confluence (Figure 14). Albeni Falls Dam is operated by the U.S. Army Corps of Engineers (USACE) and serves as a multipurpose solution for the towns adjacent to the Pend

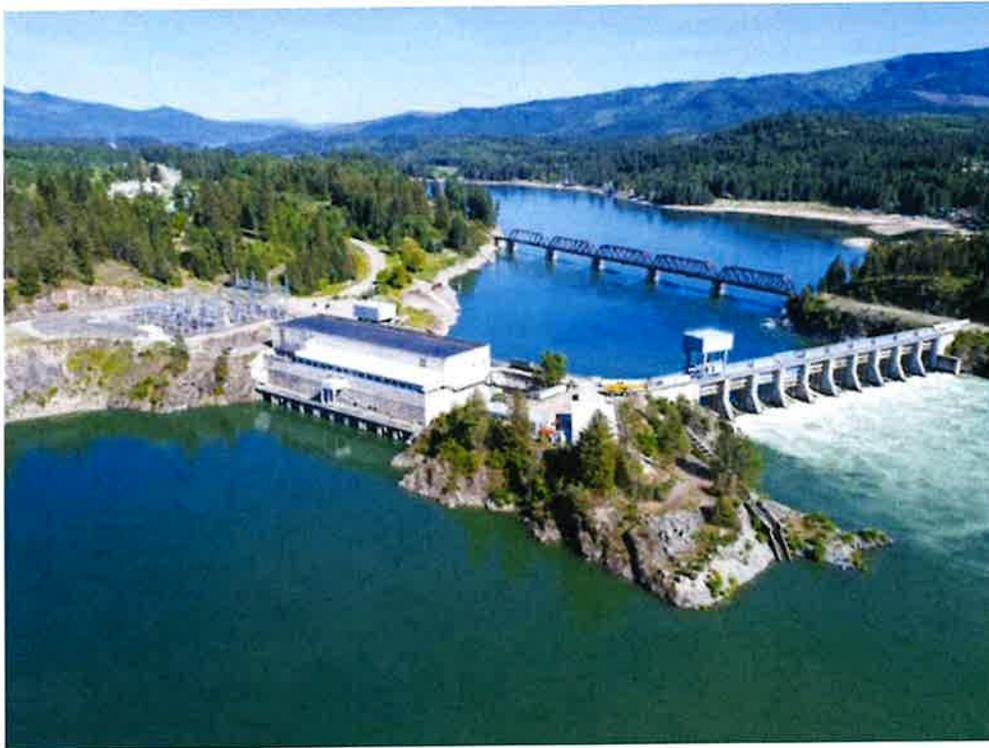
**Figure 15. Pend Oreille River flowing through Albeni Falls Dam**

Normal dam operations maintain an outflow of approximately 10,000 CFS (low-water/winter-pool conditions) and 11,000 CFS (high-water/summer-pool conditions) through an 11-gate spillway (Figure 15); however, flows can be as high as 60,000 CFS during the year as indicated by 2024 flow data. Fluctuations in dry and wet seasons drive the behavior of dam control. Historical peak flow for Albeni Falls Dam is recorded at 200,000 CFS (U.S. Army Corps of Engineers, n.d.). See Appendix B for target Pend Oreille Lake levels and additional considerations for dam control (U.S. Army Corps of Engineer District, 2013).

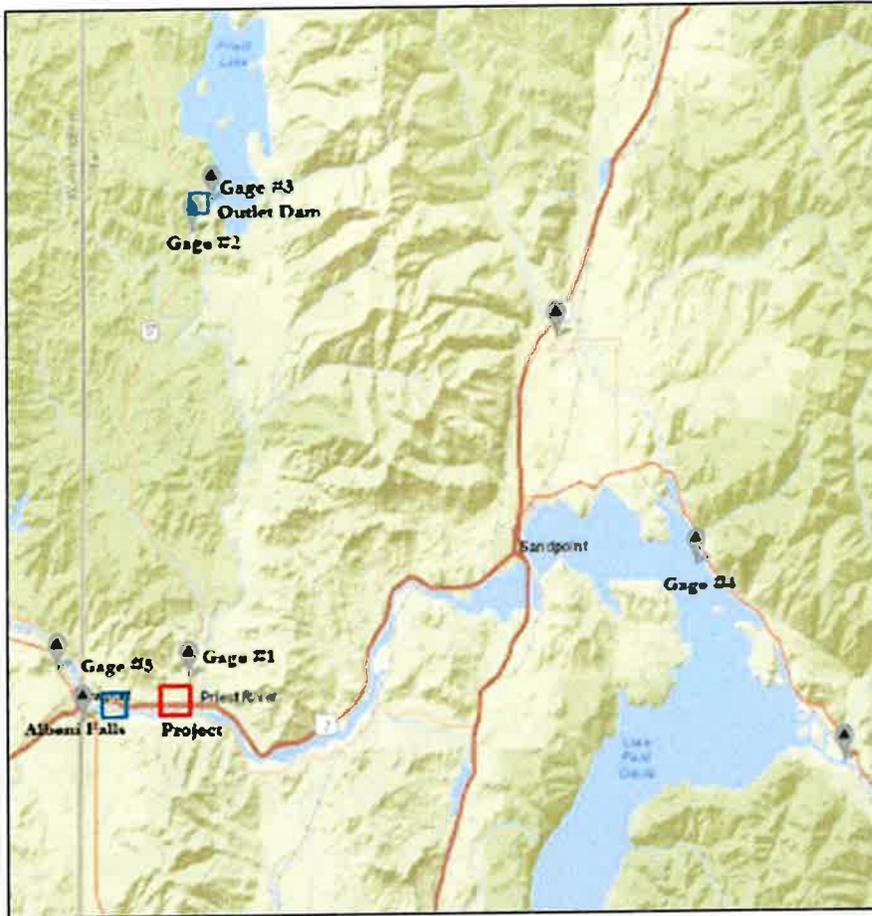
**Figure 16. Gage Proximities to the Two Rivers Park**

Gage data collected for the project area highlight seasonal variations in water elevations for Lake Pend Oreille, the Pend Oreille River, and the Priest River (USGS, n.d.). Gage data was recorded from five locations within the influencing watersheds of Priest Lake and Lake Pend Oreille. Table 1 and Figure 16 provide a summary and location of each gage, respectively.

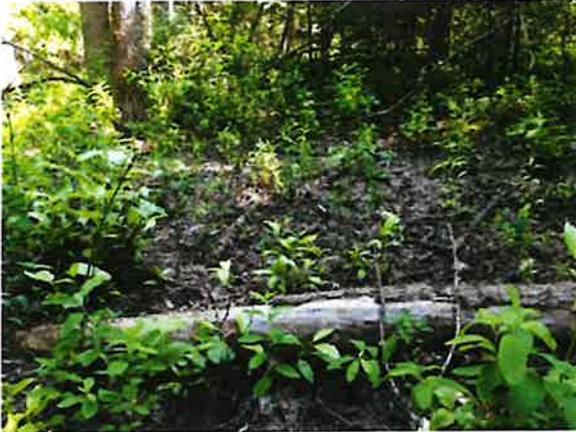
**Figure 17. Photo Sheet Joslyn Property: June 12, 2023**

Photo 1: View east into Wetland "B" from Wetland Boundary Flag B-5. Small isolated swale with cottonwood and few spiraea. Hydrophytic vegetation and evidence of short-term early season ponding. This wetland depression is small and does not appear to have any surface connections to other areas.

evaluation of site conditions, vegetation (Figure 17), soils, hydrology, and wetland boundaries. Additionally, the report examines the regulatory implications of the findings, providing essential information for decision making and compliance with federal, state, and local environmental regulations. See Appendix E for the delineated wetland zones (Tetra Tech, Inc., 2024).

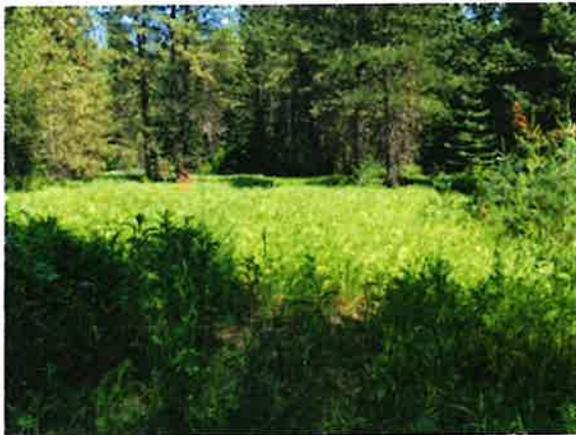
Photo 2: View east into meadow area at Data Plot 12. Ponderosa pine over meadow foxtail and tansy; soils 3/4 (non-hydric), no evidence of ponding.

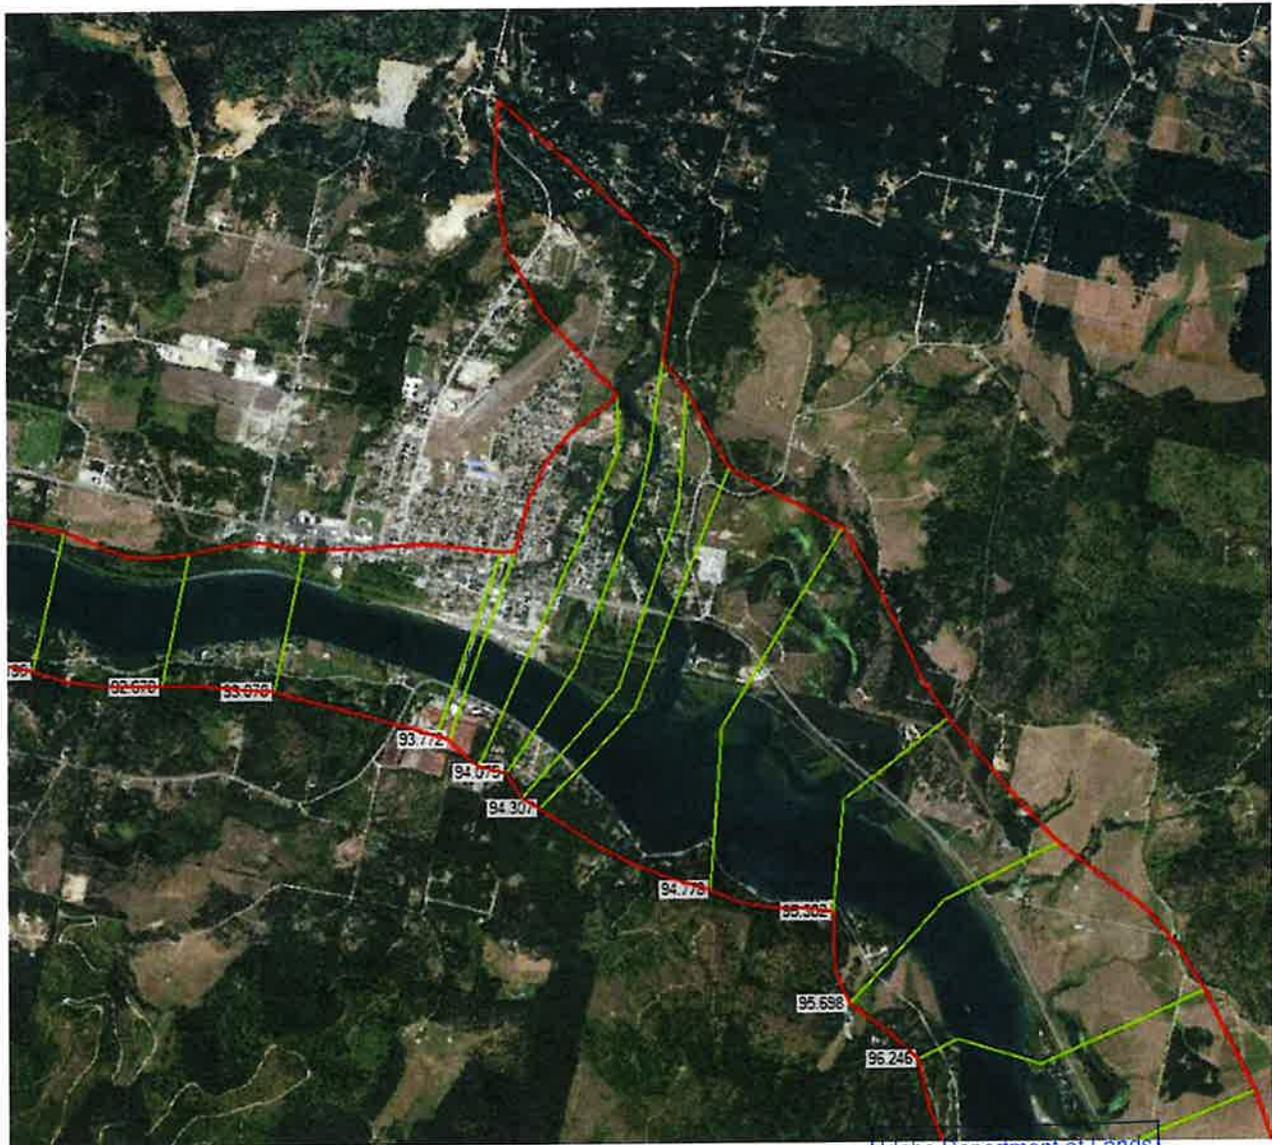
**Figure 18. USACE HEC-RAS 1D Model Cross Sections**

Alta acquired the USACE Hydrologic Engineering Center's River Analysis System (HEC-RAS) 1D model (Figure 18), which highlights dam influence on the upstream water systems. Green lines shown in Figure 18 represent the cross-section locations, while boundary conditions for the model are marked in red. The USACE HEC-RAS 1D model provides average velocity and shear stress estimates for the channel and overbank areas, treating the Priest River as a low point in their cross-sections (Figure 19). Figure 19 is an example of a cross-section profile at station 94.307. Looking at Figure 18, this station cuts through Pend Oreille River, Two Rivers Park, and Priest River. The model calculated averages between defined channel boundaries marked by red dots in the cross-section (Figure 19) and across inundated overbanks. However, it does not offer specific velocity or shear stress data for bank locations or detailed interactions at the confluence of the Priest and Pend Oreille rivers. To achieve this level of detail, a HEC-RAS 2D model would need to be constructed.

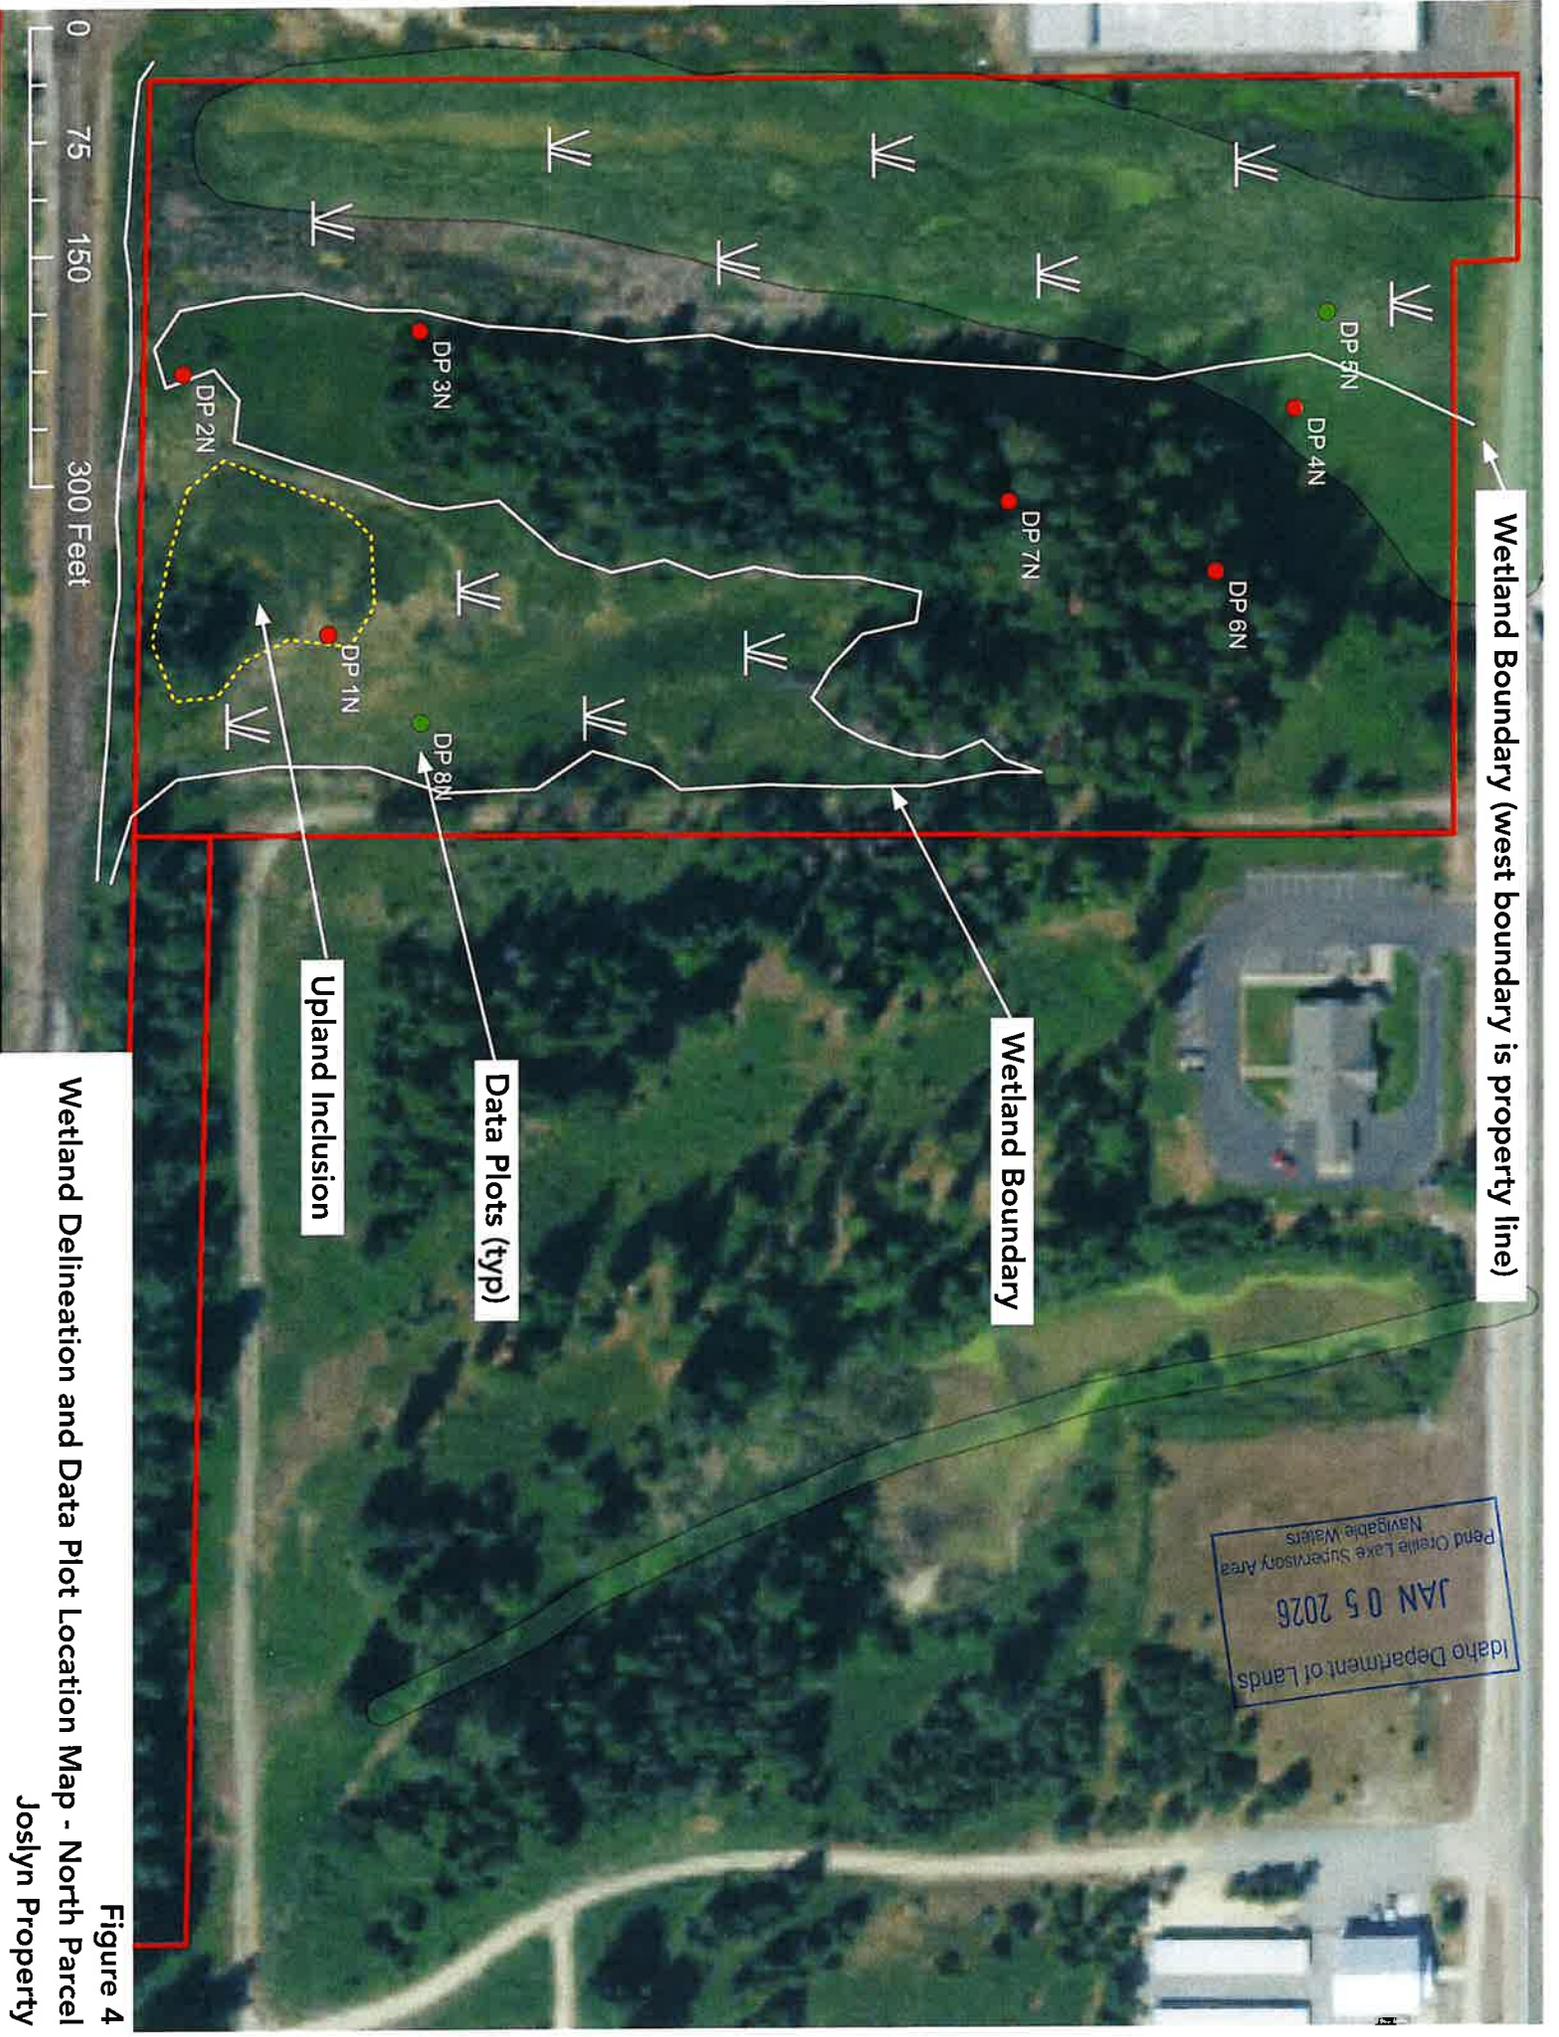
**Figure 3**  
**Wetland Delineation and Data Plot Location Map**  
 Pond Oreille Lake Supervisory Area  
 Navigable Waters  
 Idaho Department of Lands  
 JAN 05 2026  
 Joslyn Property

The upland / wetland boundaries were determined largely by hydrophytic vs non-hydrophytic vegetation, topographic relief, and evidence of or observed hydrology.

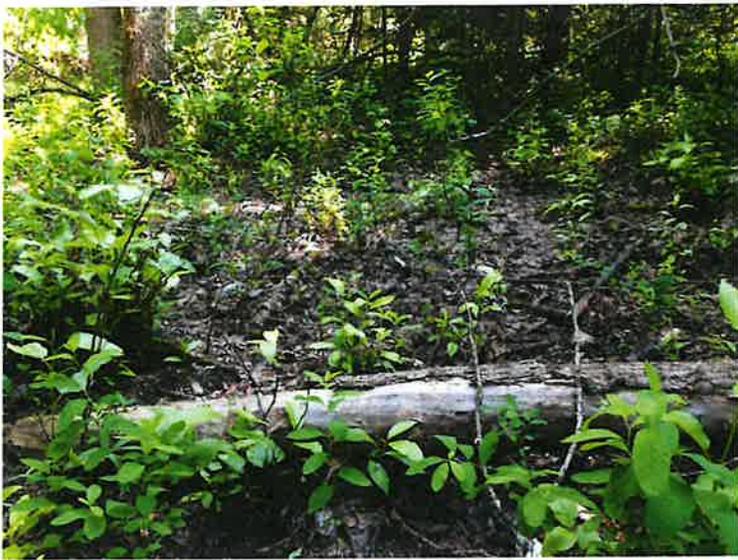
Photo 1: View east into Wetland "B" from Wetland Boundary Flag B-5. Small isolated swale with cottonwood and few spiraea. Hydrophytic vegetation and evidence of short-term early season ponding. This wetland depression is small and does not appear to have any surface connections to other areas.

Two classifications of wetlands are present on the southern parcel where shoreline improvements are to occur. The smallest delineated wetland, referred to as Wetland B, is approximately 0.02-acres and is considered isolated from surface water connections. Shoreline improvements will not disturb this wetland.

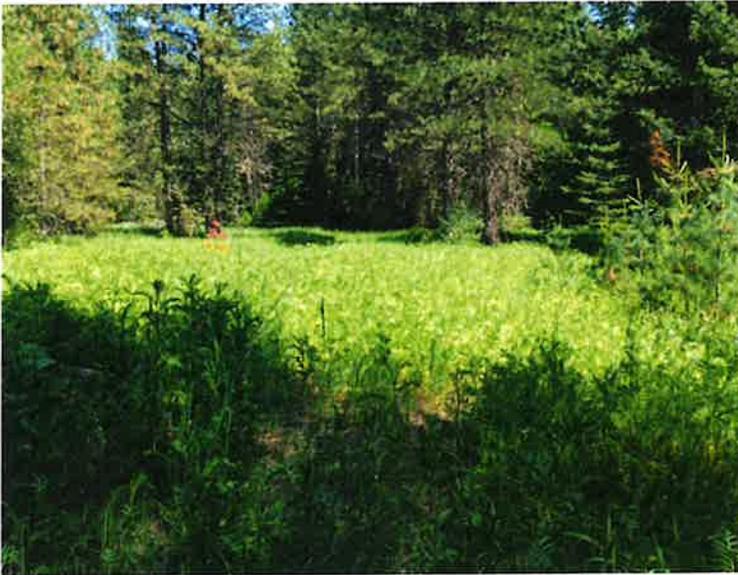
Photo 2: View east into meadow area at Data Plot 12. Ponderosa pine over meadow foxtail and tansy; soils 3/4 (non-hydric), no evidence of ponding.

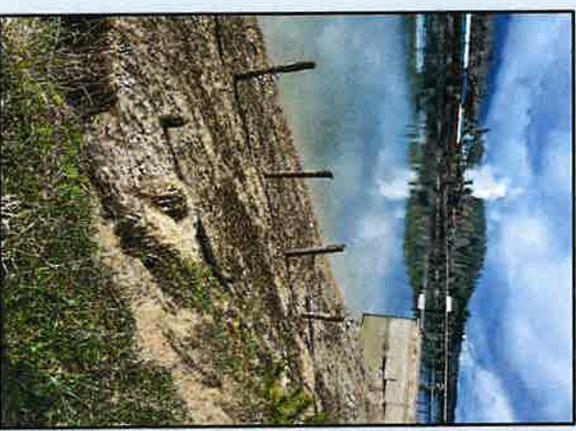
*Photo 1: Zone 1 (Marina) at Low Water*

- Zone 1 Length: 300'
- Zone 2 Length: 900'
- 1H:1V Bank above OHW
- 4H:1V between OHW and low water.
- Existing Debris and Wood Piles
- Stormwater structure that will need new outlet and stabilization
- Less impact from river velocities

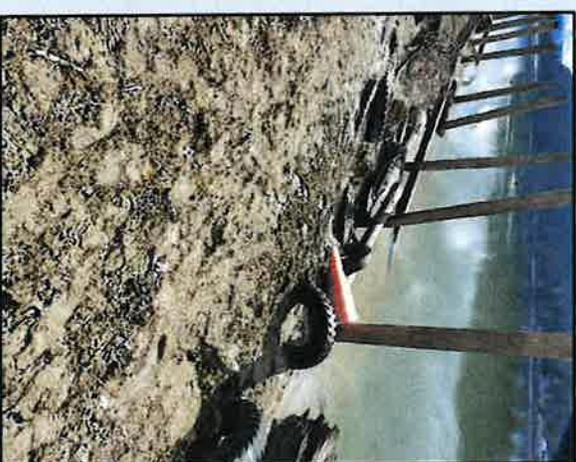
*Photo 2: Ex. Debris*

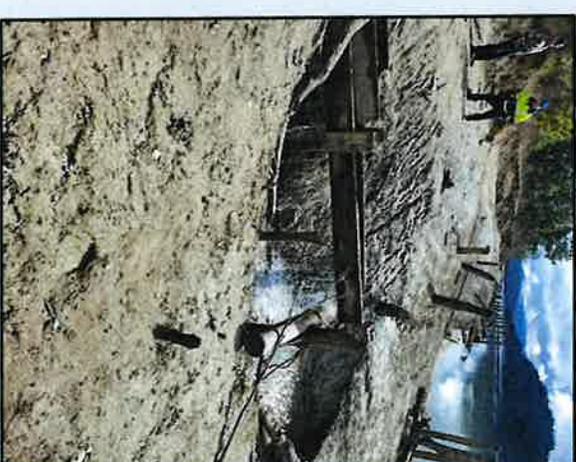
*Photo 3: Ex Stormwater Outlet and Zone 2 at Low Water*

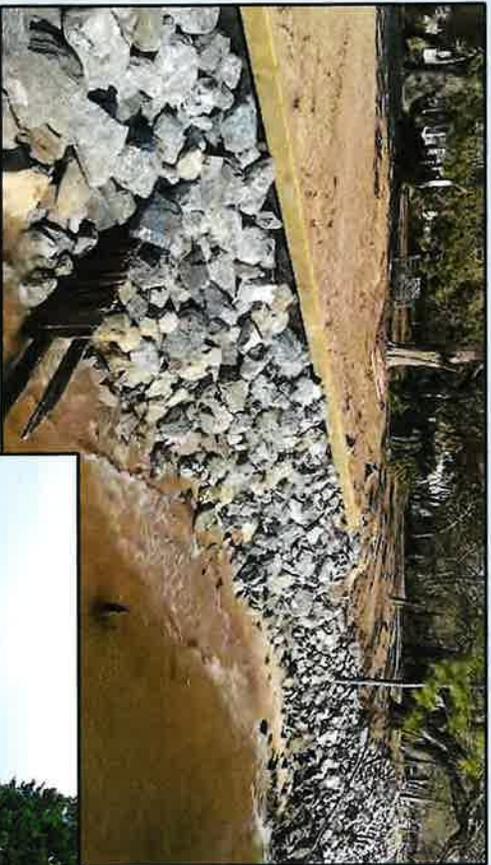
## Zone 2: Stabilization Concept (left of the outfall structure)

-Rip rap toe

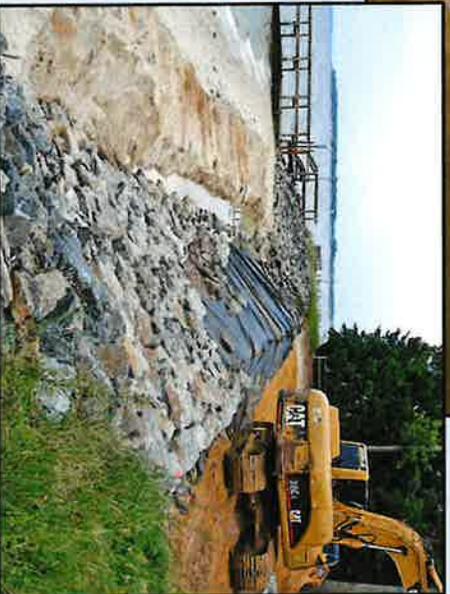
-Beach created out of less erosive material such as small rock

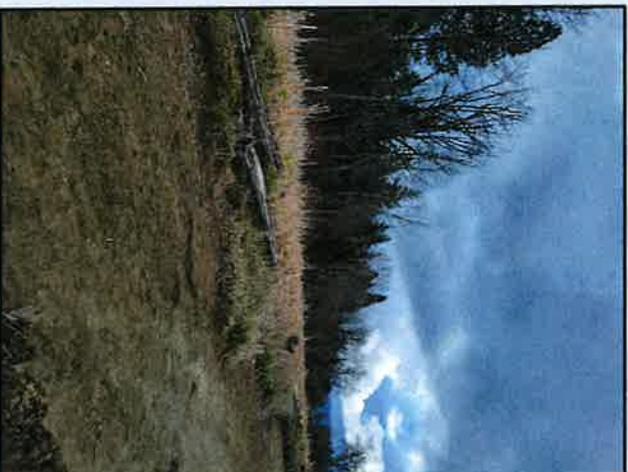
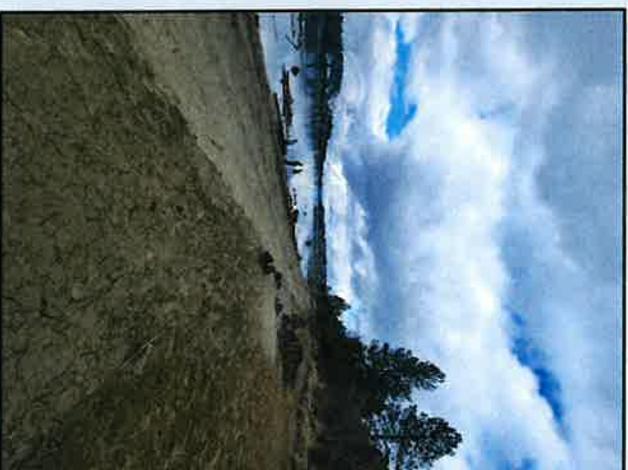
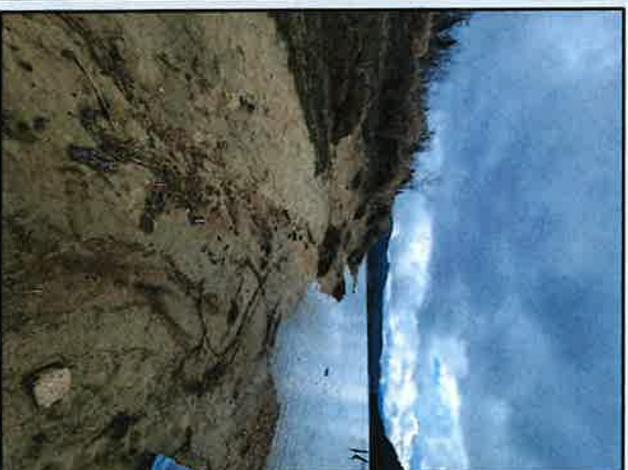
- Zone 3 Length: 700'
- Zone 2 Length: 750'
- 4H:1V Bank above OHW
- Wetland Plateau to 1H:2V between OHW and low water.
- Moderate river velocities at Zone 3 to higher velocities at Zone 4

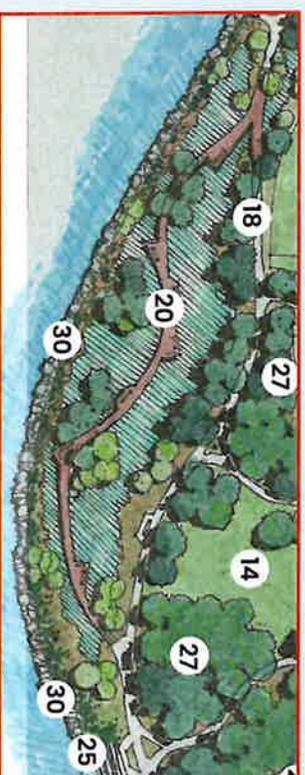
# Zone 3 & 4: Design Considerations

- Design for differential velocity impact and loss of sediment in the wetland
- Facilitating wetland habitat, consider more permeable options to allow for flow of water in and out of wetland territory
- Design for breaking down water energy to avoid scour effects
- Ability to withstand a 100-year flooding event
- Compatibility with large slopes

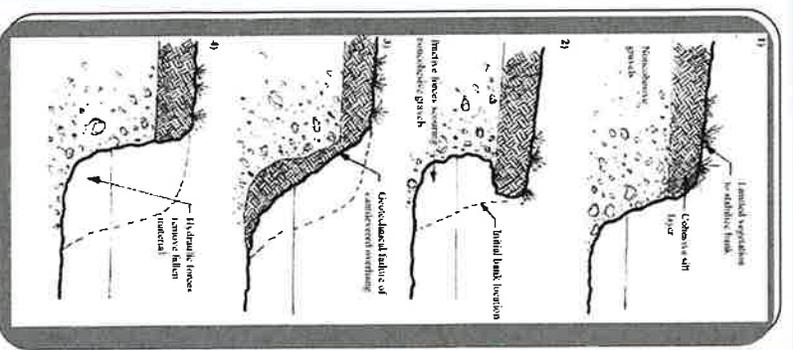
Fig. 3.5 Stratified Streambanks and Combination Failures (Adapted from Johnson and Sygula 1993)

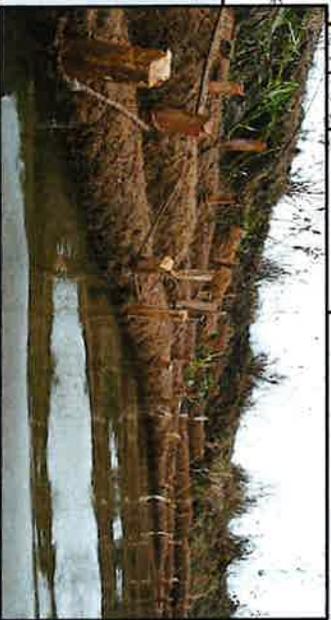
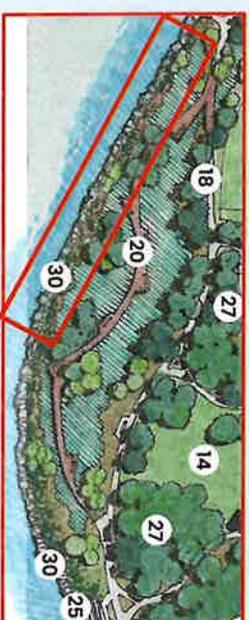
- Stabilizes bottom of slope with dead stakes and coconut rolls
- Promotes fish habitat when submerged

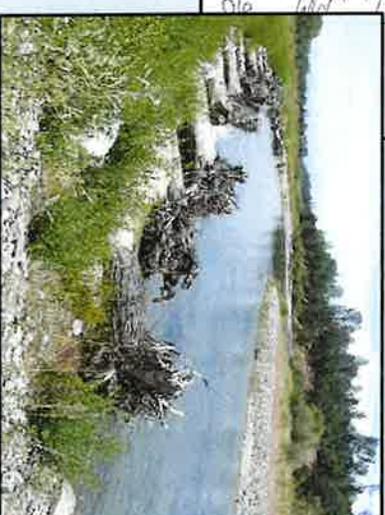
- Stabilizes bottom of slope with boulders and root wads
- Promotes fish habitat when submerged
- Installation disturbs existing wetland

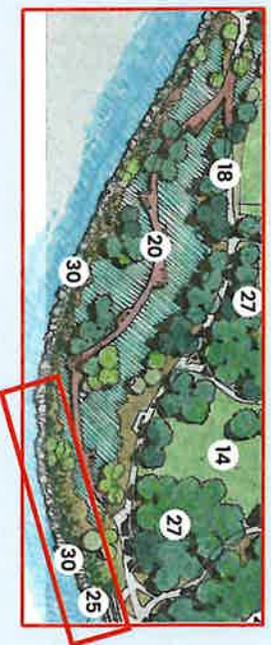
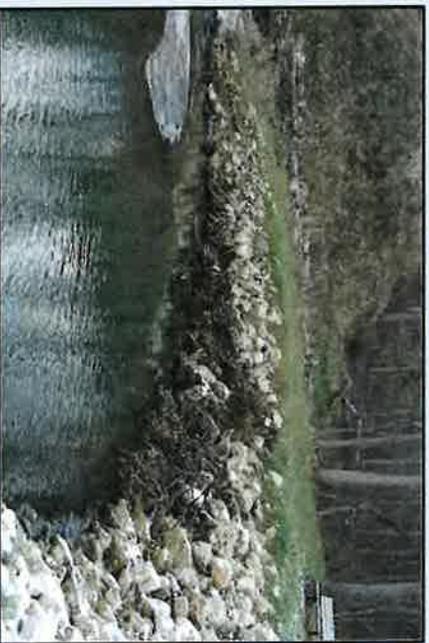
- Assumed higher velocities
- Add more rock
