# Two Rivers Park Shoreline Stabilization Basis of Design Report

Prepared for:  
City of Priest River

This Engineering Basis of Design (BOD) Report outlines the technical approach, methods, and design criteria that guide engineering solutions for protecting the site shoreline from erosion and other environmental factors. This BOD Report serves as a foundation for stakeholders including regulatory agencies, city officials, and the public to understand the shoreline stabilization design approach and the rationale for selecting this approach.

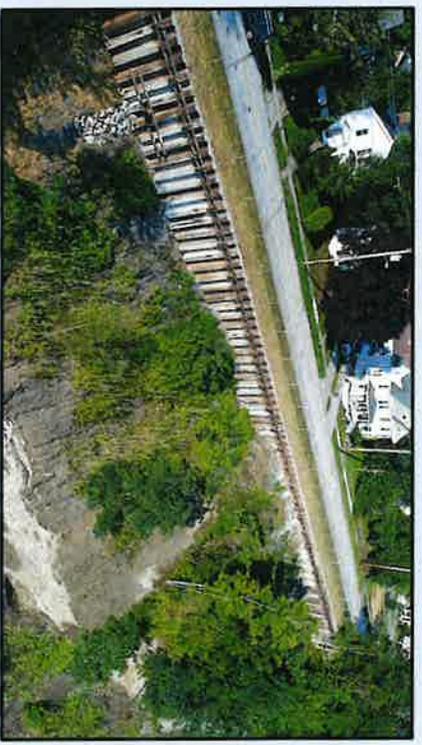
- Sheet pile around entire wetland boundary
- Would involve cut and fill method
- Potential 50' expansion of wetlands
- Not permeable, would need to space accordingly for water flow in and out of wetland
- Restricts wetland access to kayakers

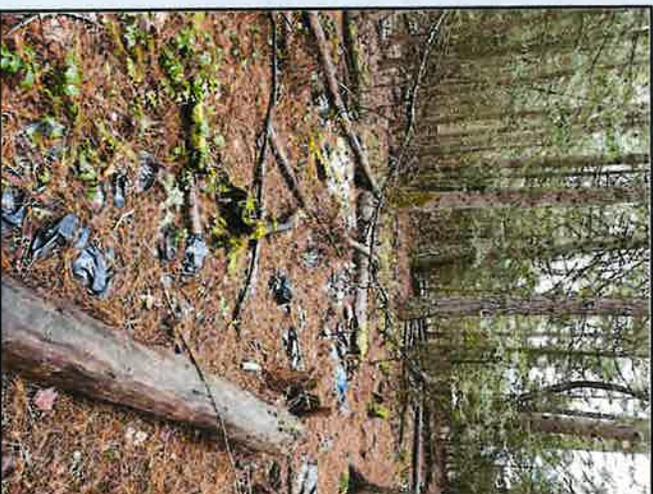
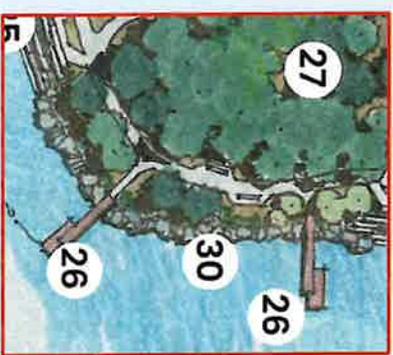
- Zone 5 Length: 250'
- 1H:1V Bank above OHW
- Wetland Plateau to 2H:1V between OHW and low water.
- Point of Confluence
- Appears to experience high river velocities

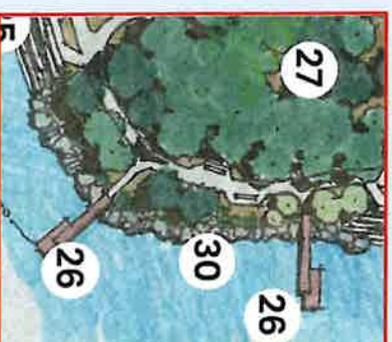
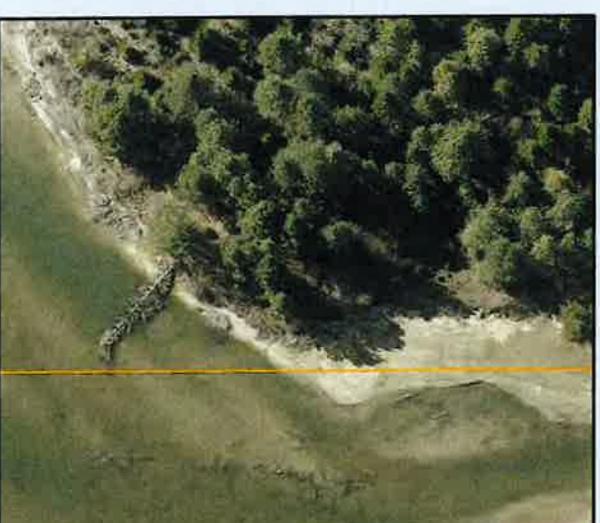
## Zone 5: Design Considerations

- Zone of confluence, high erosion
- Pitched rip rap, we can determine size of rock depending on velocities at the confluence, as well as forces impacting this area
- Survives 100-year flooding event
- Hard armor suggestion
- Influenced by secondary flow channels from Priest River
- Fluctuation in water levels pose challenge for implanting vegetation

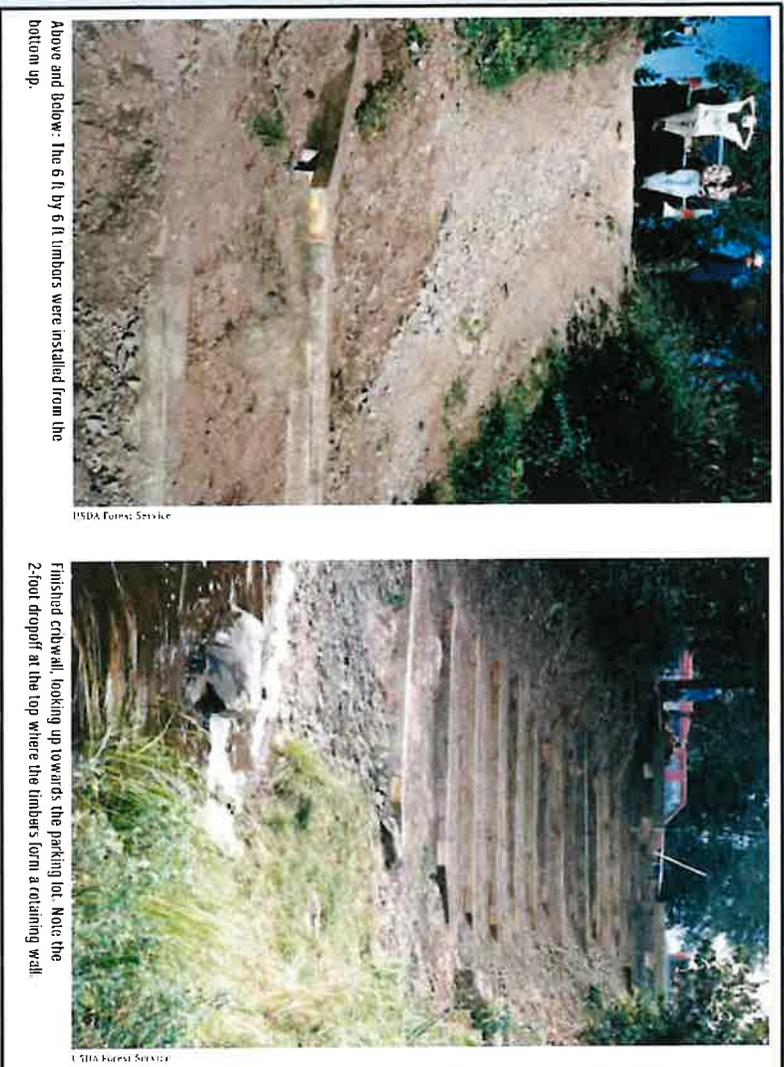
- Targeting areas where pedestrian access is desired
- Terraced Crib design method
- Removes usage of traditional building materials (concrete and steel)
- Protects against further erosion

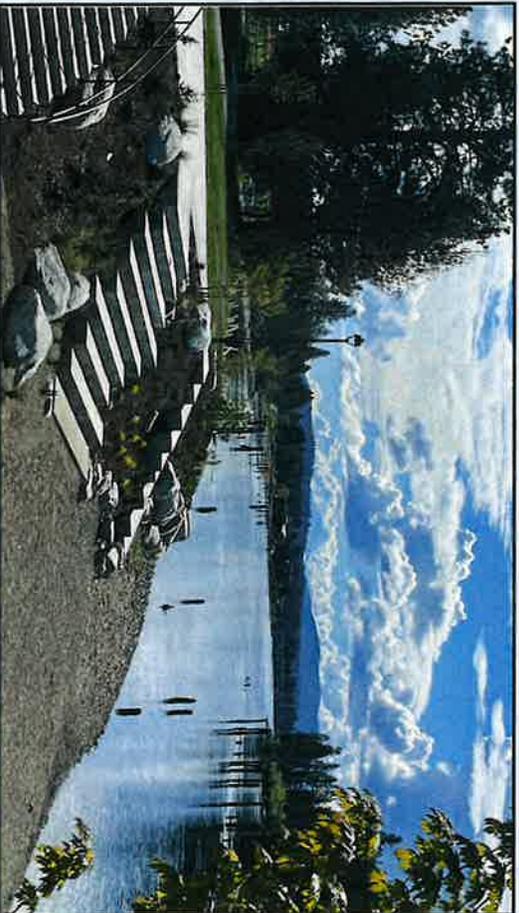
- Atlas beach inspiration
- Traditional building materials
- Combination of rip rap and concrete steps

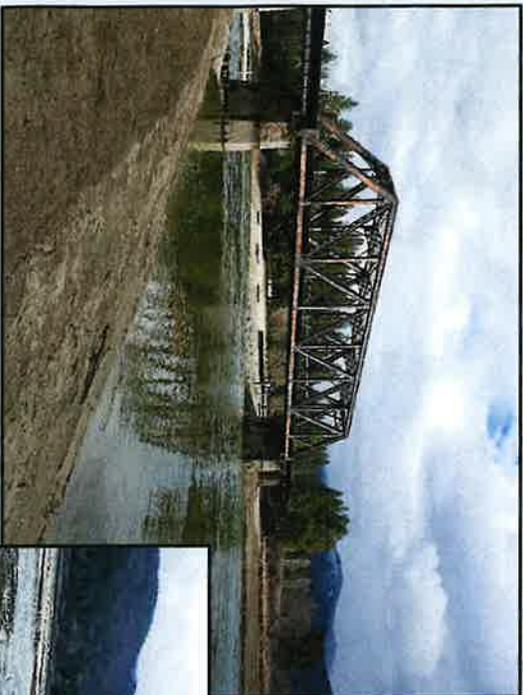
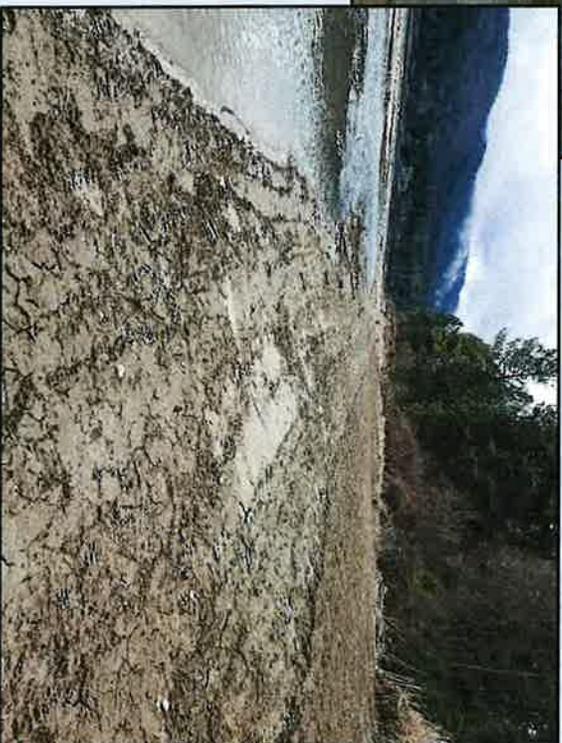
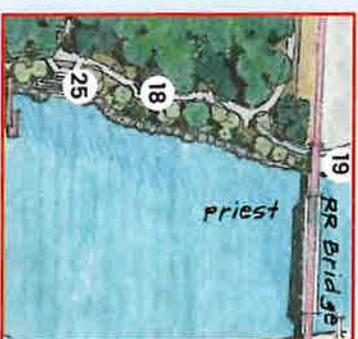
- Zone 6 Length: ~700'
- 1H:3V Bank above OHW
- Wetland Plateau to 1H:1V between OHW and low water.
- Bound between a high scour zone and railway bridge

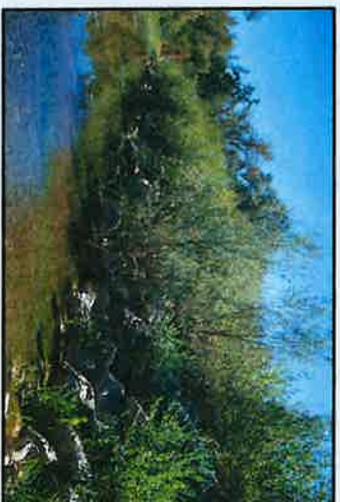
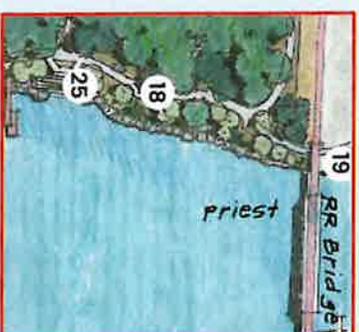
-Consider vegetated rip rap with live staking as “bulkhead”

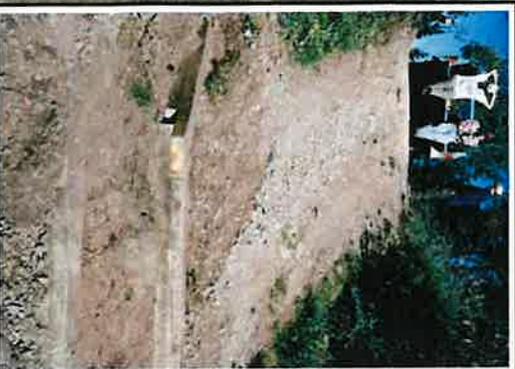
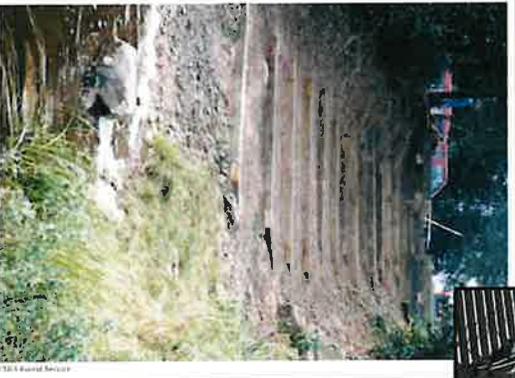
## A: Terraced crib steps

Above and Below: The 6 ft by 6 ft frames were installed from the bottom up.

Instead of a wall, looking up towards the parking lot. Note that Zone 5 dropped at the top where the timber's form a retaining wall.

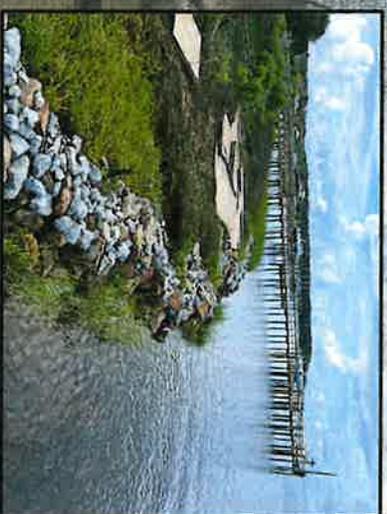
**A: Rip rap w/ green bulkhead**  
**\*live staking also an option\***

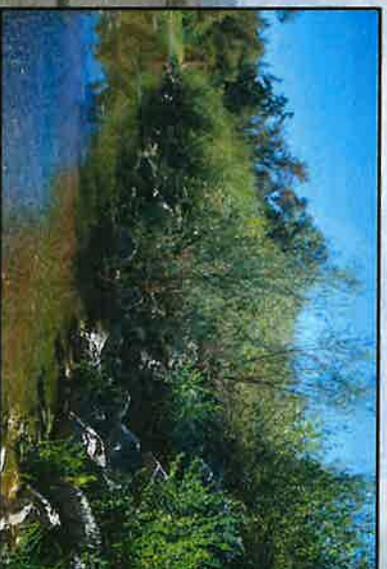
**B: Vegetated rip rap**

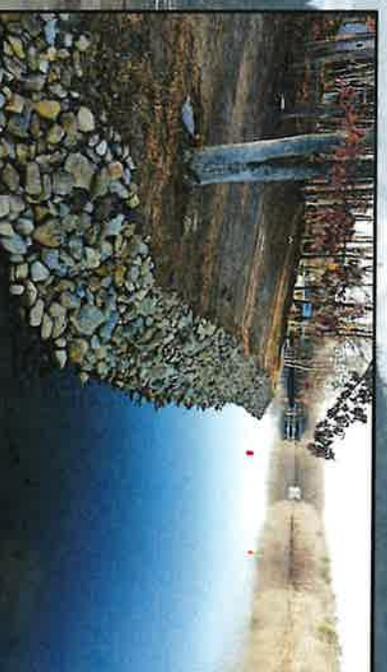
**C: Rip rap**
