**DPW PROJECT 17905**  
**CLARK FORK FISH HATCHERY COMPLEX - 9 Buildings**  
**IDAHO DEPARTMENT OF FISH AND GAME**  
**CLARK FORK, IDAHO**

**ASBESTOS-CONTAINING BUILDING MATERIAL AND LEAD PAINT**  
**SURVEY AND ASSESSMENT REPORT**

September 2016

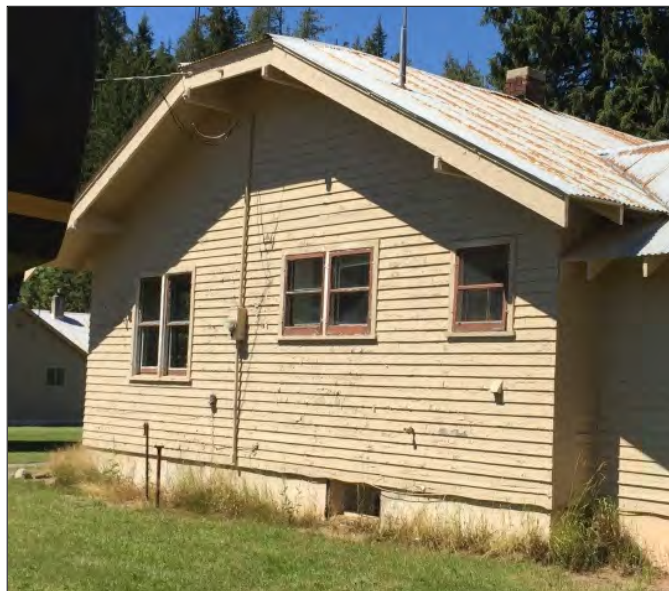
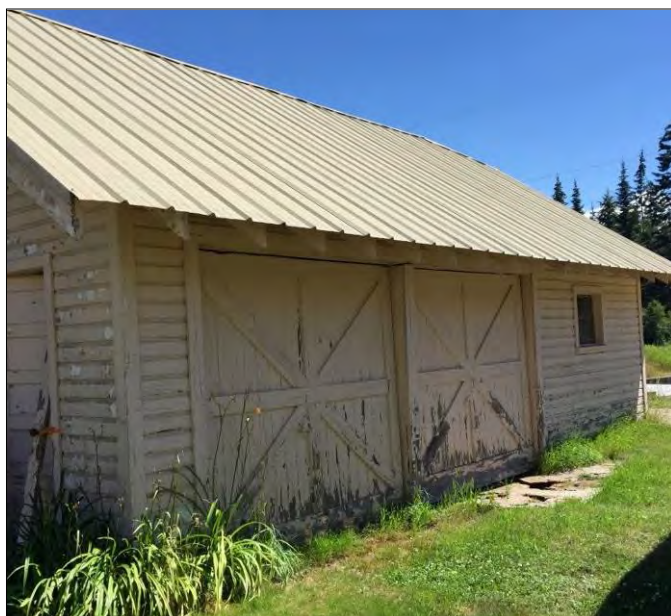
However, the lead-containing paint present on the exteriors of the West Garage, Hatchery Building, Shop/Freezer Building, and the Main House is in fair-to-poor condition (unstable, >10% to <25% flaking or damage). In addition the majority of the exterior paint found on the Summer Quarters and East Garage are in poor condition (extremely unstable >25% damage). A substantial amount of the paint is loose and peeling (flaking) off of these buildings. The flaking paint needs to be stabilized and cleaned up as soon as possible, and the associated waste disposed of properly at an approved landfill. Once the damaged and flaking

exterior paint has been stabilized place the remaining lead-containing paint in an operation and maintenance program and maintain in-place until the material can be removed and disposed of properly.

Control access to the materials, ensuring that the materials are not subjected to sanding, grinding, cutting, drilling, and/or abrading, until a competent abatement contractor can abate the lead-containing paint.
